MILE HIGH PHOTO - DENVER

**Prepared for the City of Littleton
Office of Community Development**

BRIEF HISTORY / ARAPAHO HILLS

PROPOSED NATIONAL REGISTER HISTORIC DISTRICT / ARAPAHO HILLS

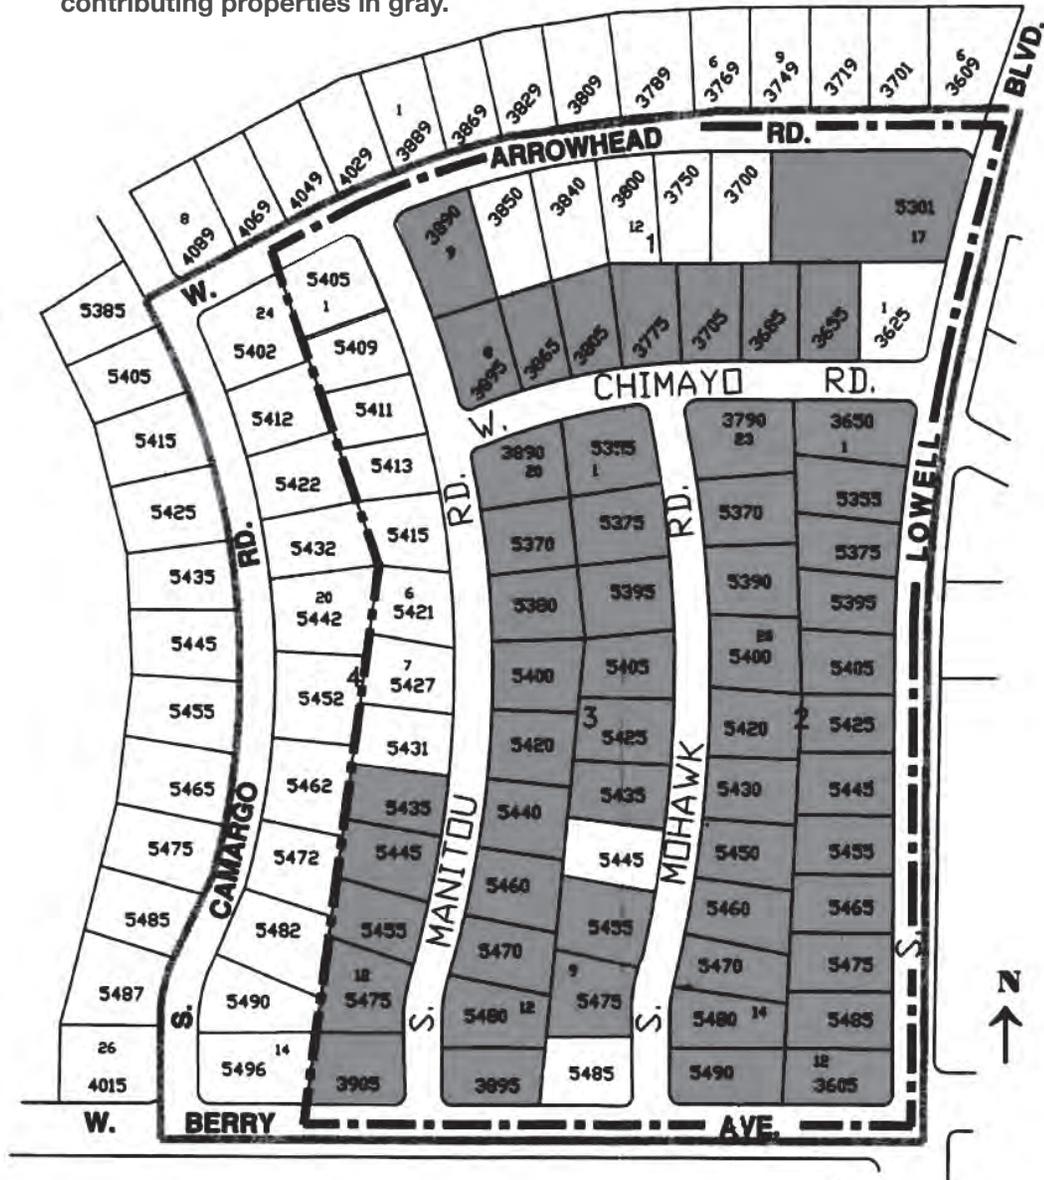
- Original Arapaho Hills Subdivision Boundary
- - - Proposed National Register District Boundary with contributing properties in gray.

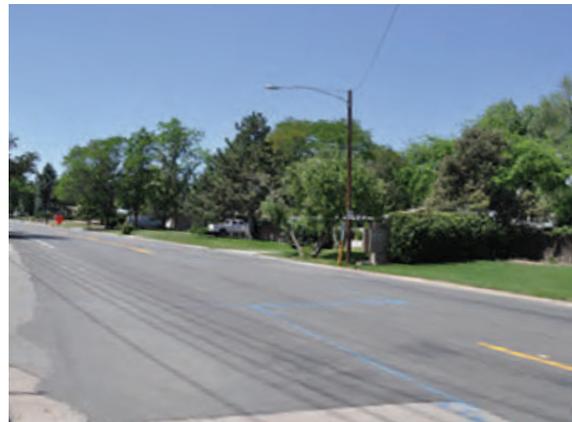
Lowell, which carries the heaviest traffic adjacent to the neighborhood, forms the east perimeter of Arapaho Hills.

This view shows the west side of Lowell looking south from Chimayo. The houses, positioned behind a 25' setback, are largely concealed by landscaping. No sidewalks appear on Lowell or Berry, only curbs.

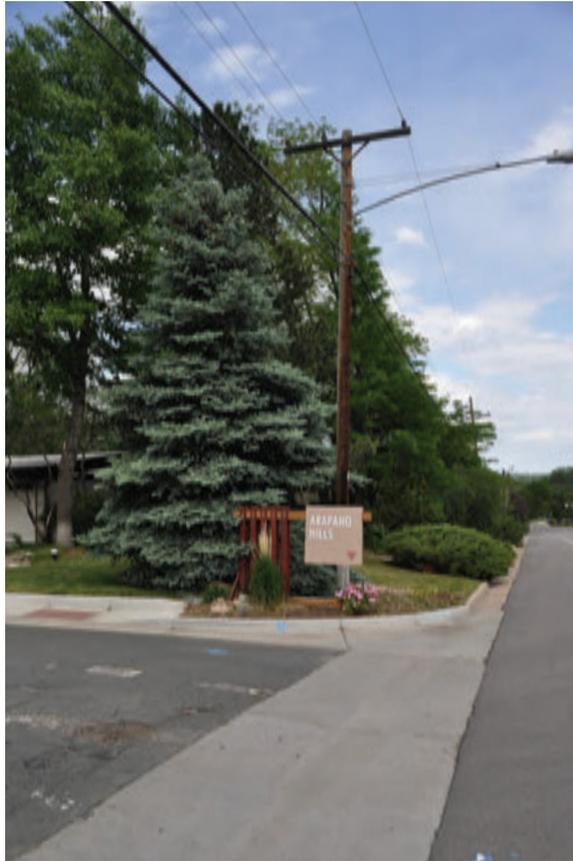
West Berry Avenue, at right, is also a major thoroughfare but carries less traffic than Lowell. Here seen looking east, it forms the south boundary of Arapaho Hills. A contemporary, design-appropriate neighborhood sign appears at the corner of Berry and Manitou.

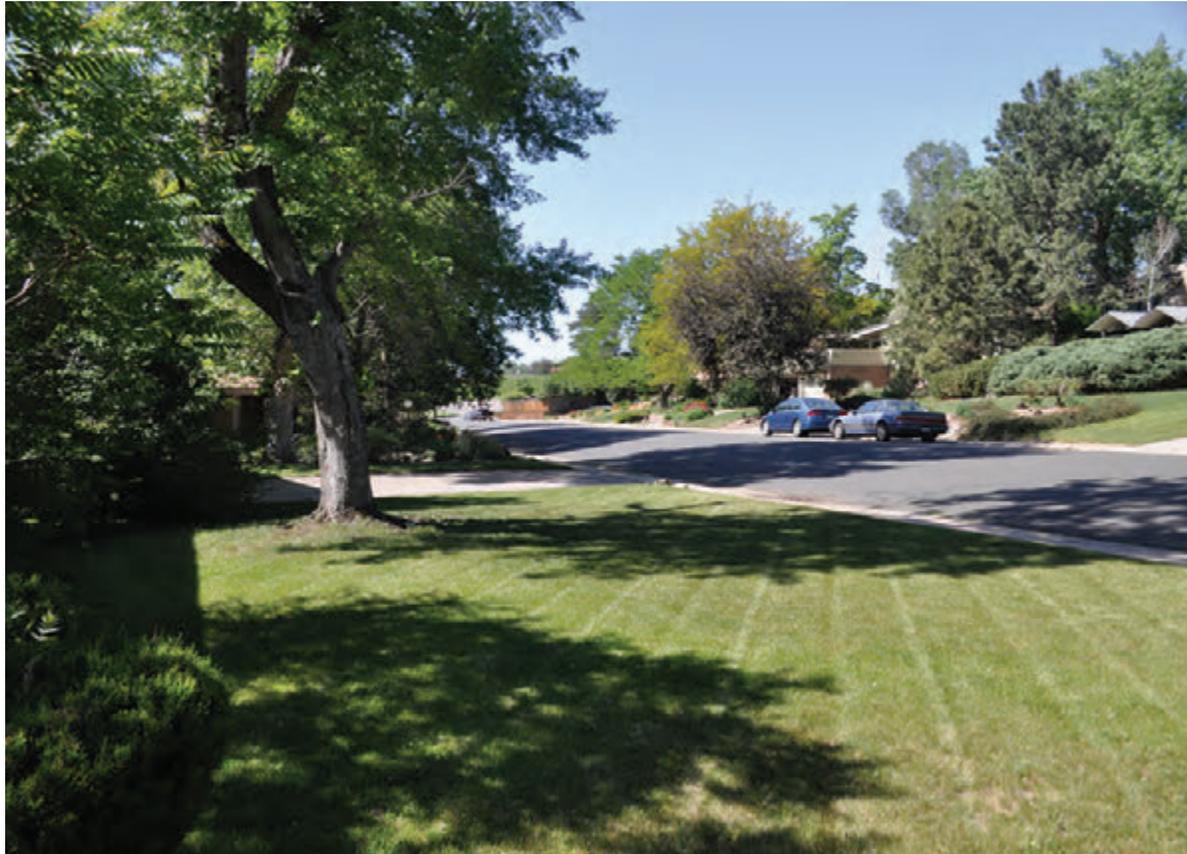
This view also looks east on Chimayo, just west of Mohawk.

The streets are paved in asphalt. Narrow sidewalks with angled curbs and gutters were cast in place as a single concrete unit on the interior of the neighborhood. Known as "Hollywood" curbs, these provide a visually consistent transition between the street and driveways by eliminating the need for curb cuts.

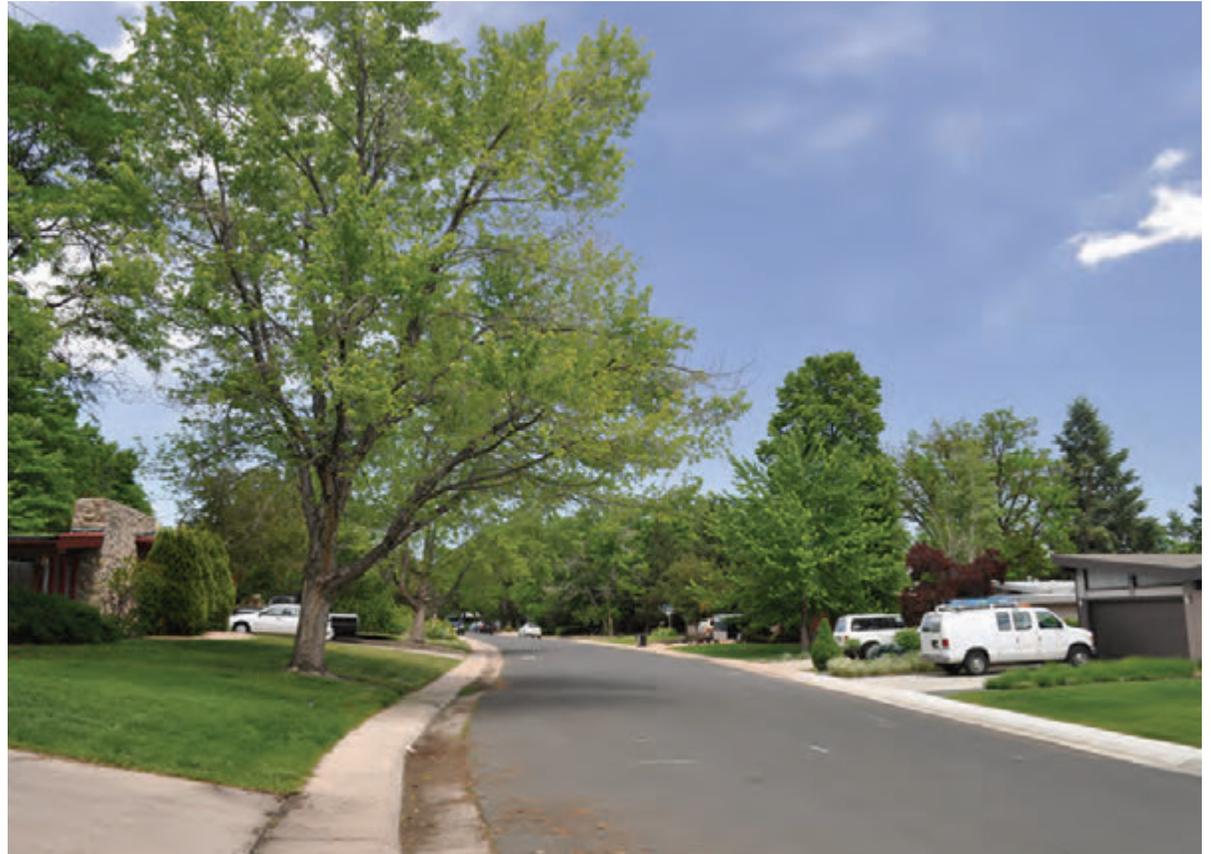
The gentle curve of the street is clearly visible in this view looking northward on Mohawk.

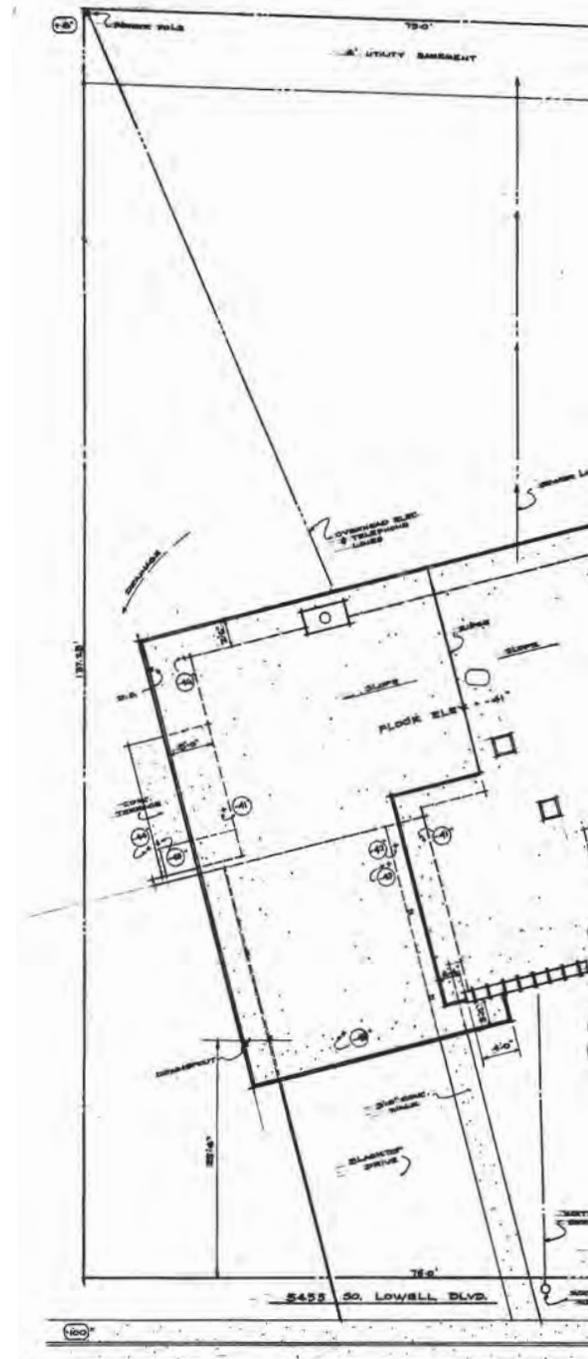
Incoming electric, telephone and sewer lines are noted, along with the locations of downspouts and site drainage. An eight foot utility easement appears at the rear of the lots.

Bruce Sutherland's lot design for 5455, 5445 and 5425 South Lowell Boulevard of December 18, 1958. Drawing courtesy the Arapaho Hills Archive.

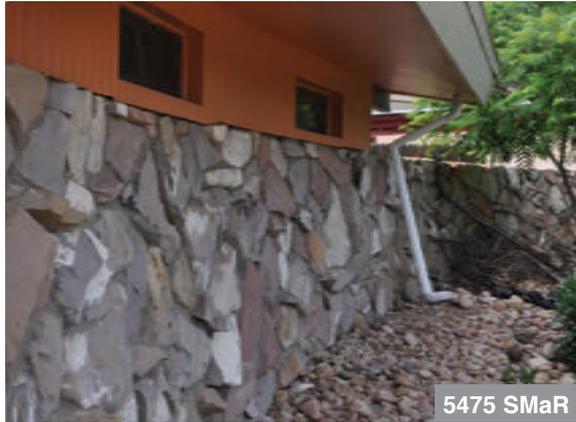
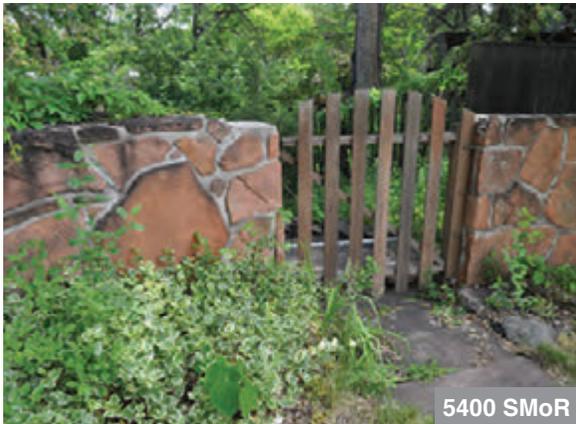
This curved wall forms the face of two adjacent carports. Between, it creates a high garden wall that separates the public and private areas of the yards.

A lower wall with wood gate extends from the face of the house to the lot line. Both are constructed of the same masonry.

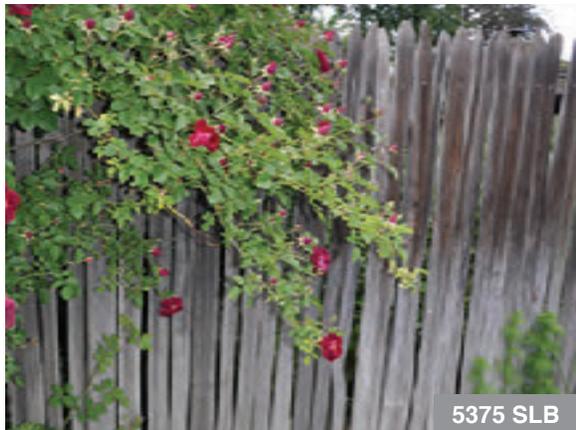
5375 SLB

This rustic fencing material is formalized for use in a front yard by the addition of a simple horizontal cap.

Informal grapestake fences commonly appear between back yards.

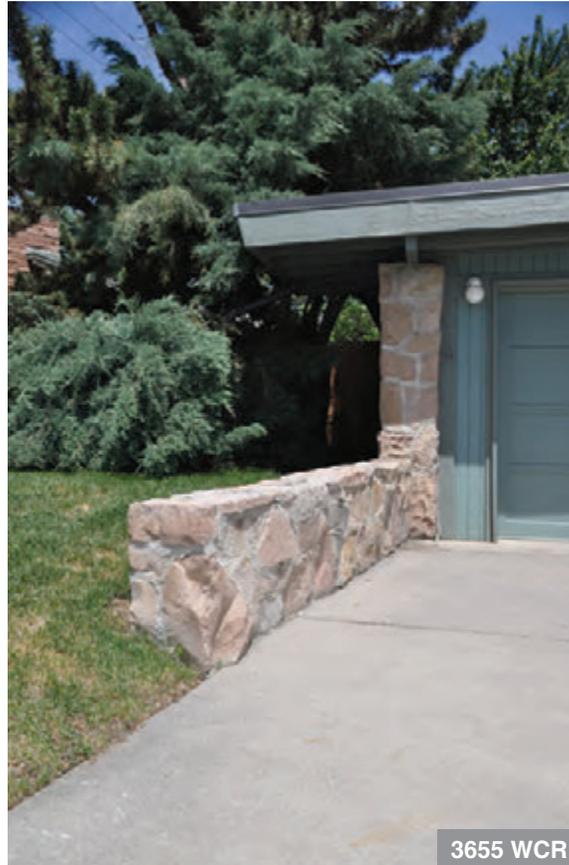
3655 WCR

Masonry is also used for retaining walls, negotiating grade changes within and between lots. This rhyolite retaining wall steps down from the side wall of a garage.

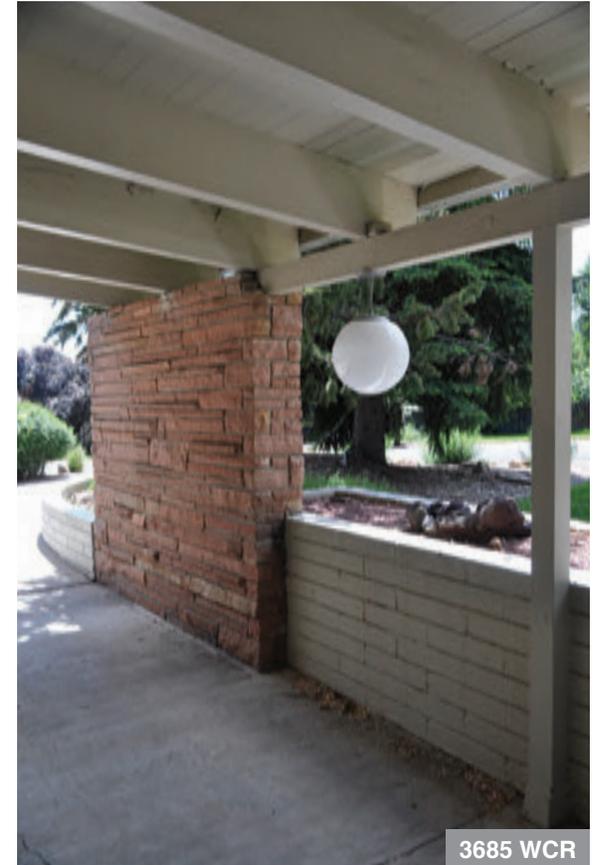
3685 WCR

Two concrete block walls, one high and one low, flank the red sandstone masonry wall that carries this carport roof.

To the right, the wall also defines a planter. To the left, it forms a retaining wall along the curvilinear driveway.

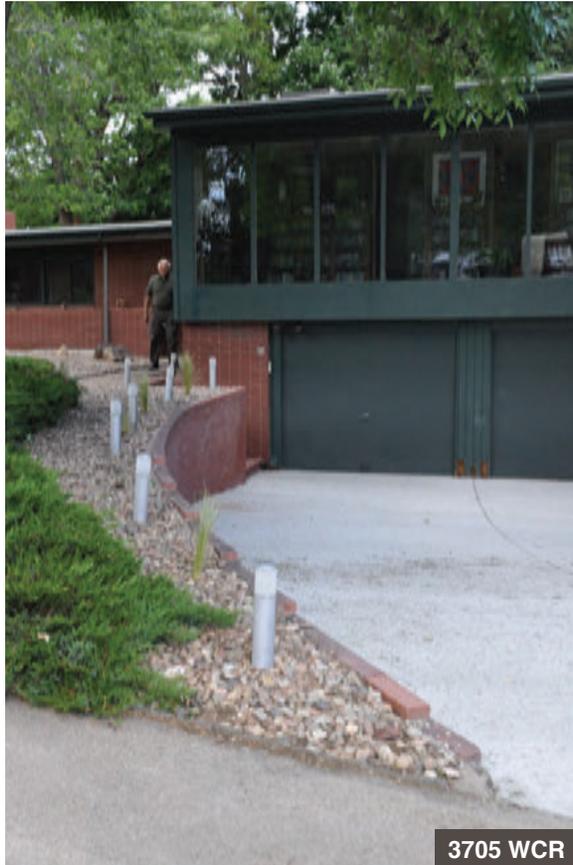
This curvilinear retaining wall follows the driveway as it drops to a garage located below street grade.

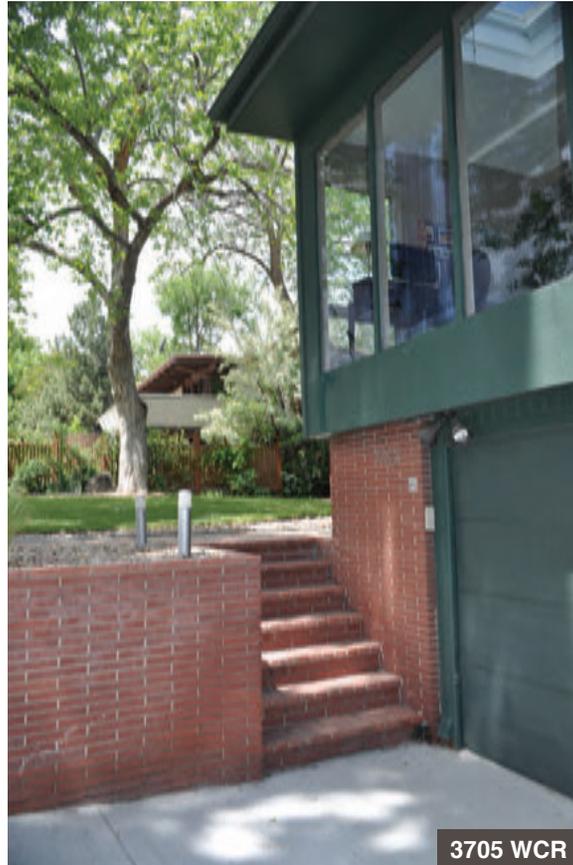
A formal staircase rises from the foot of the drive to join an upper walkway to the main entrance.

The wall and staircase are both constructed of the same red brick as the house.

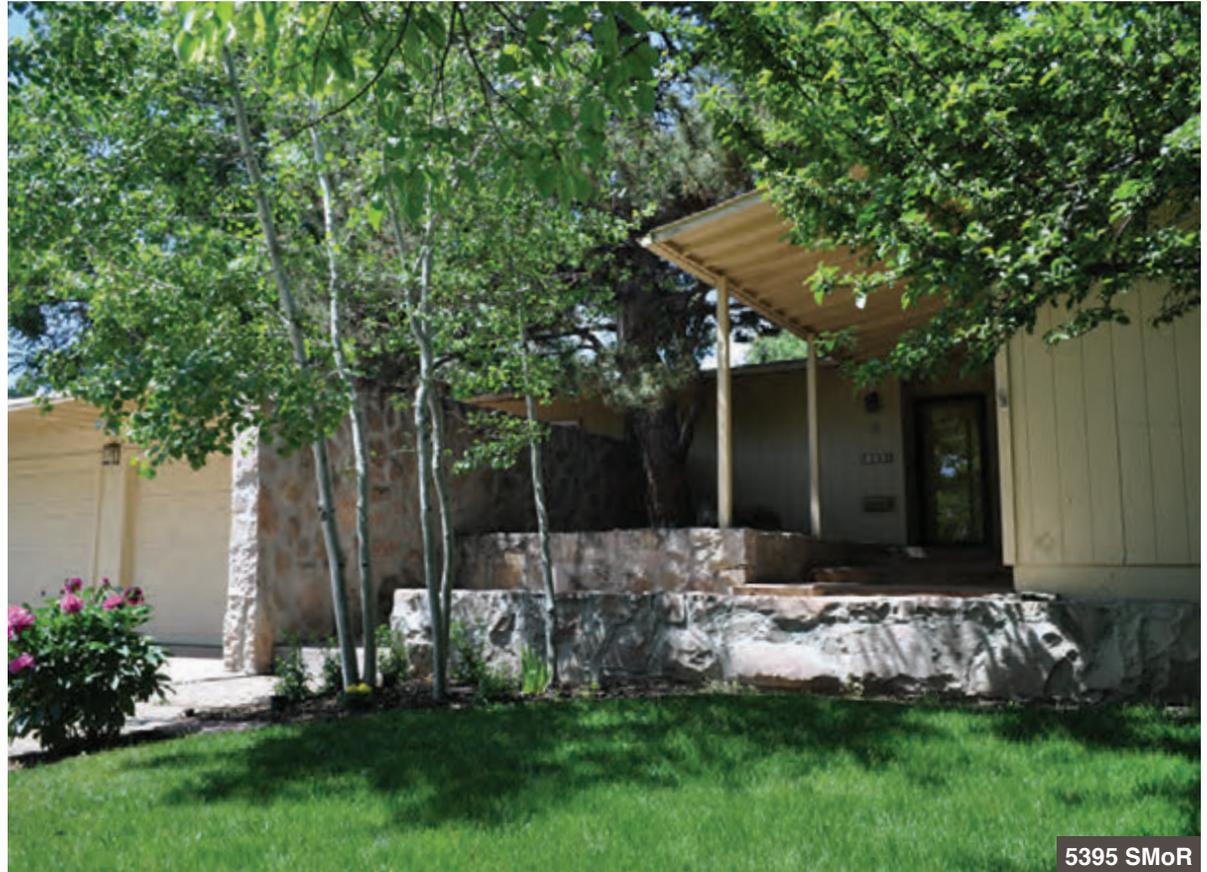
Surrounded on three sides by the house, this recessed courtyard includes a staircase with a series of landings that rise from the front walkway to the entrance.

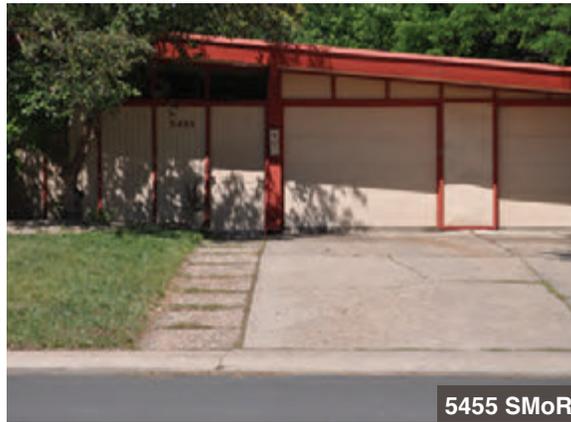
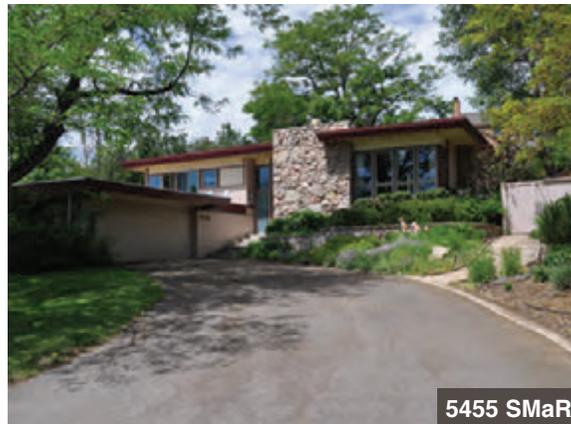
Walk and driveways are rectilinear and curvilinear. Here, a short, straight walk and concrete driveway are set perpendicular to the street.

This long, wide asphalt walk and driveway forms a broad curve from the street to the garage. A walkway to the back yard branches off at right. A staircase rises to the entrance.

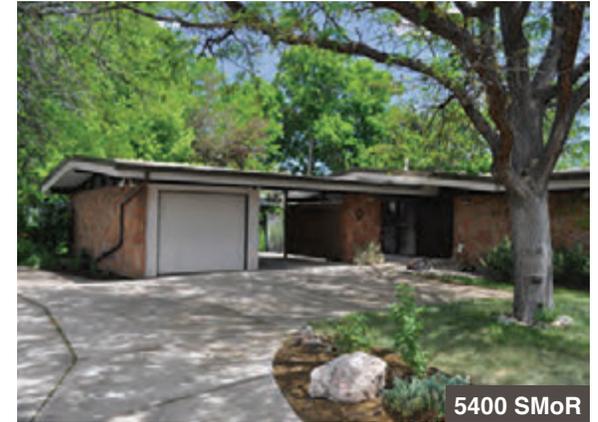
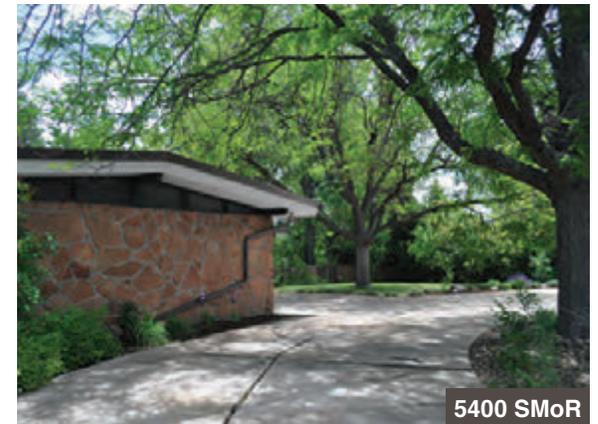
This semi-circular concrete driveway curves through the lot, branching off to the garage, carport and formal entrance to the house.

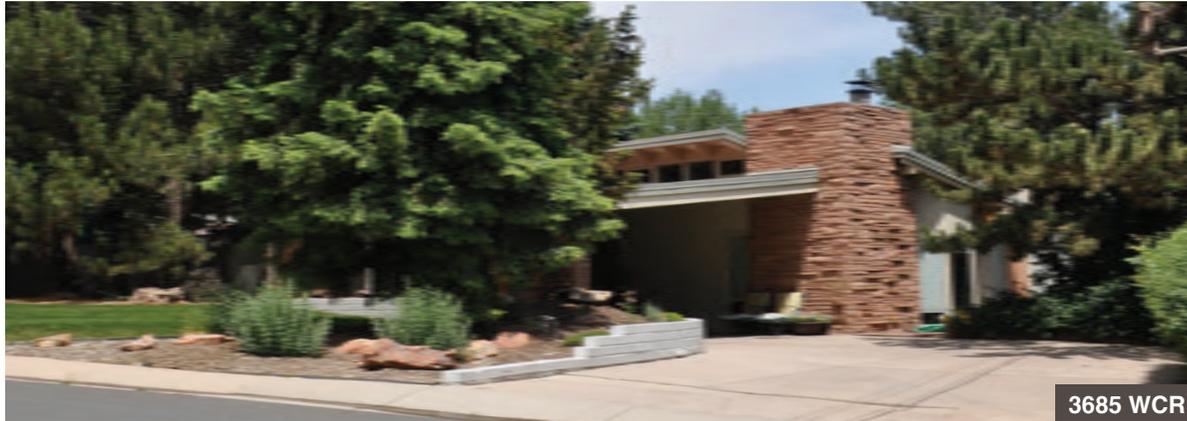
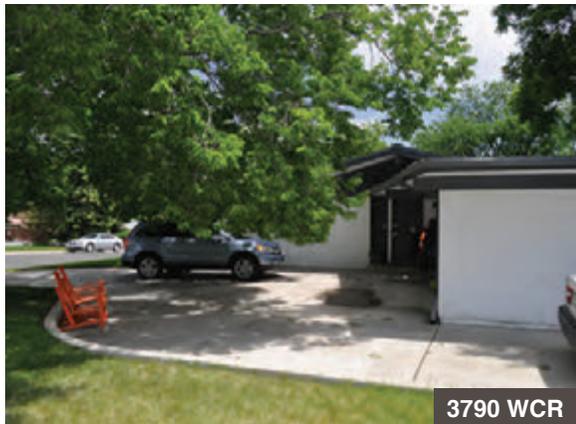
Another curvilinear driveway turns beneath a two-car carport positioned across the face of this house. At right, the driveway expands to form a parking pad.

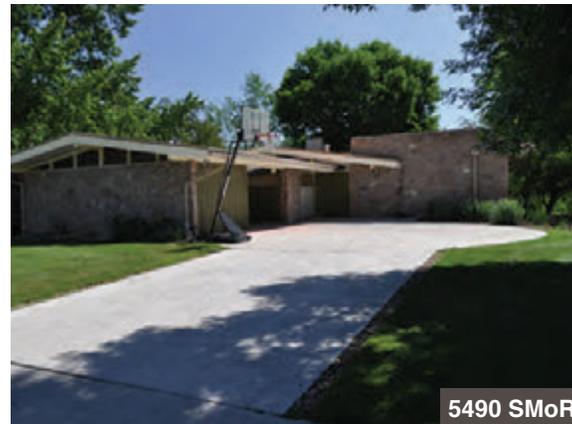
In the two lower photos, both these walk and driveways begin perpendicular to the street and form curvilinear pads for parking and access to garages and carports.

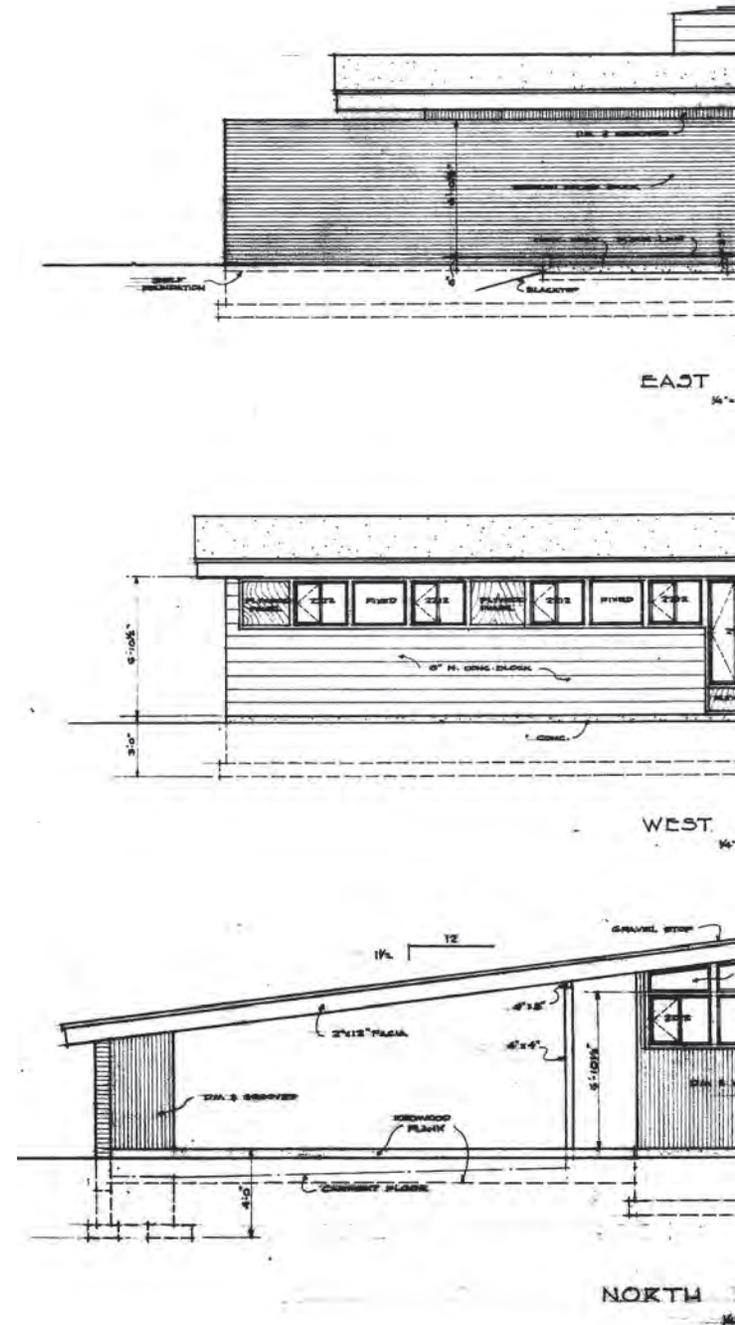
On the foundation plan, the open and closed nature of the two volumes and the relationship between them is clearly visible.

Bruce Sutherland's architectural design for 5375 South Lowell Boulevard dated March 9, 1957. Drawings courtesy the Arapaho Hills Archive.

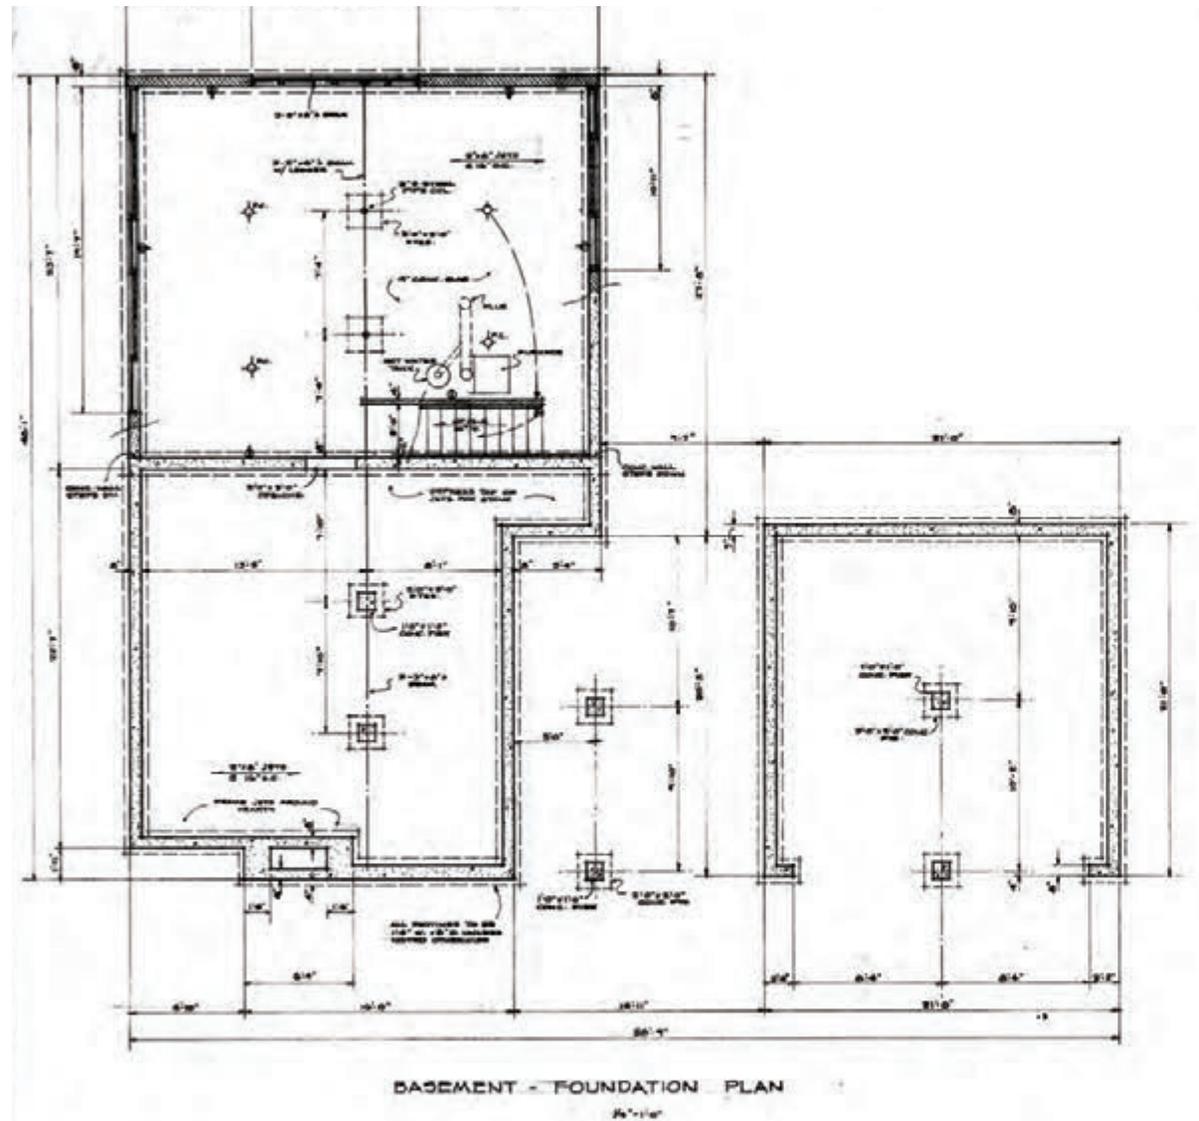
Between the house and garage is a breezeway. Open to the back yard and screened facing the street, it serves as a formal entrance court.

Bruce Sutherland's architectural design for 5460 South Manitou Road dated October 15, 1957. Drawings courtesy the Arapaho Hills Archive.

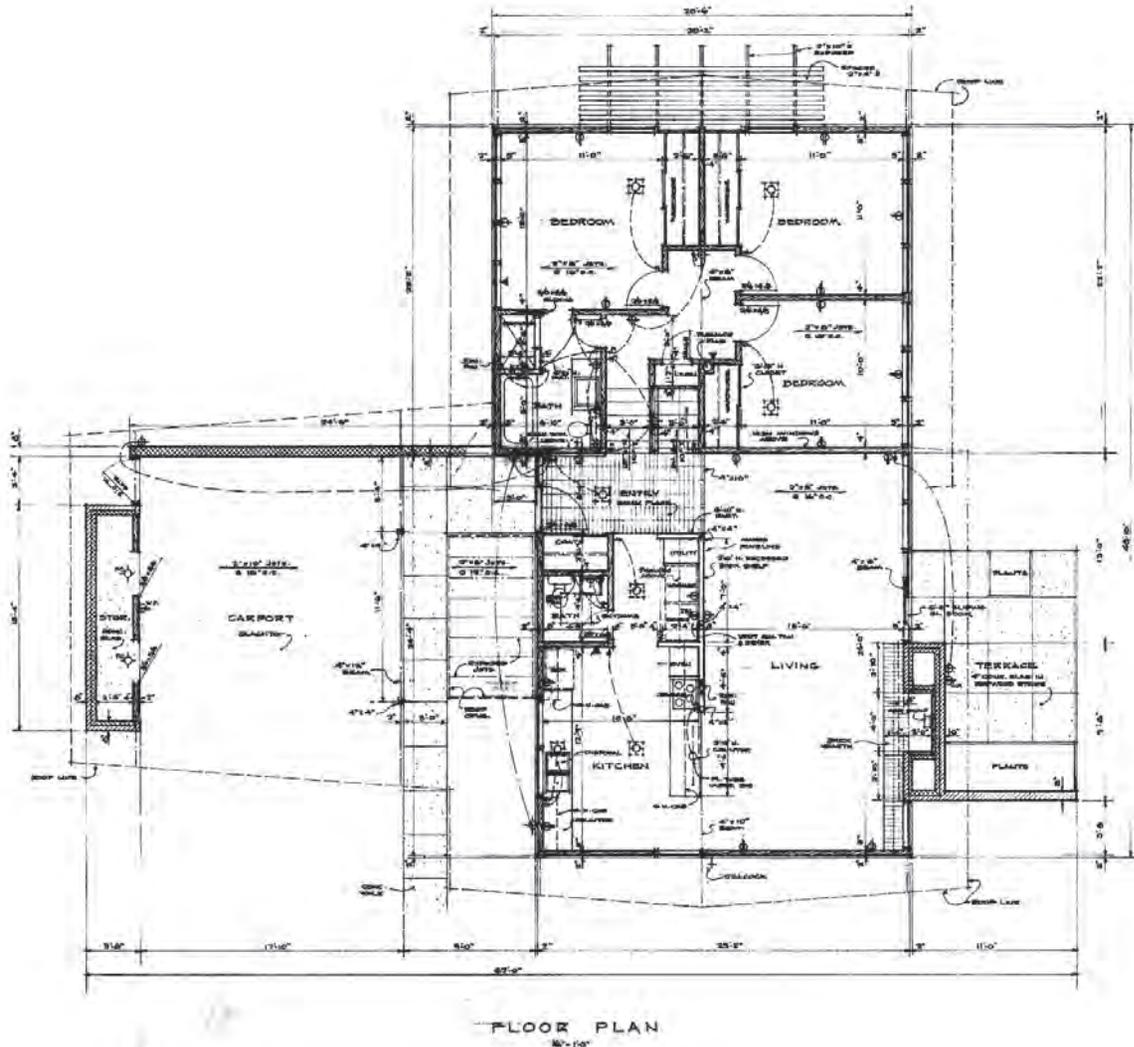
The Winter House is composed of four perpendicular primary volumes, three closed and one open.

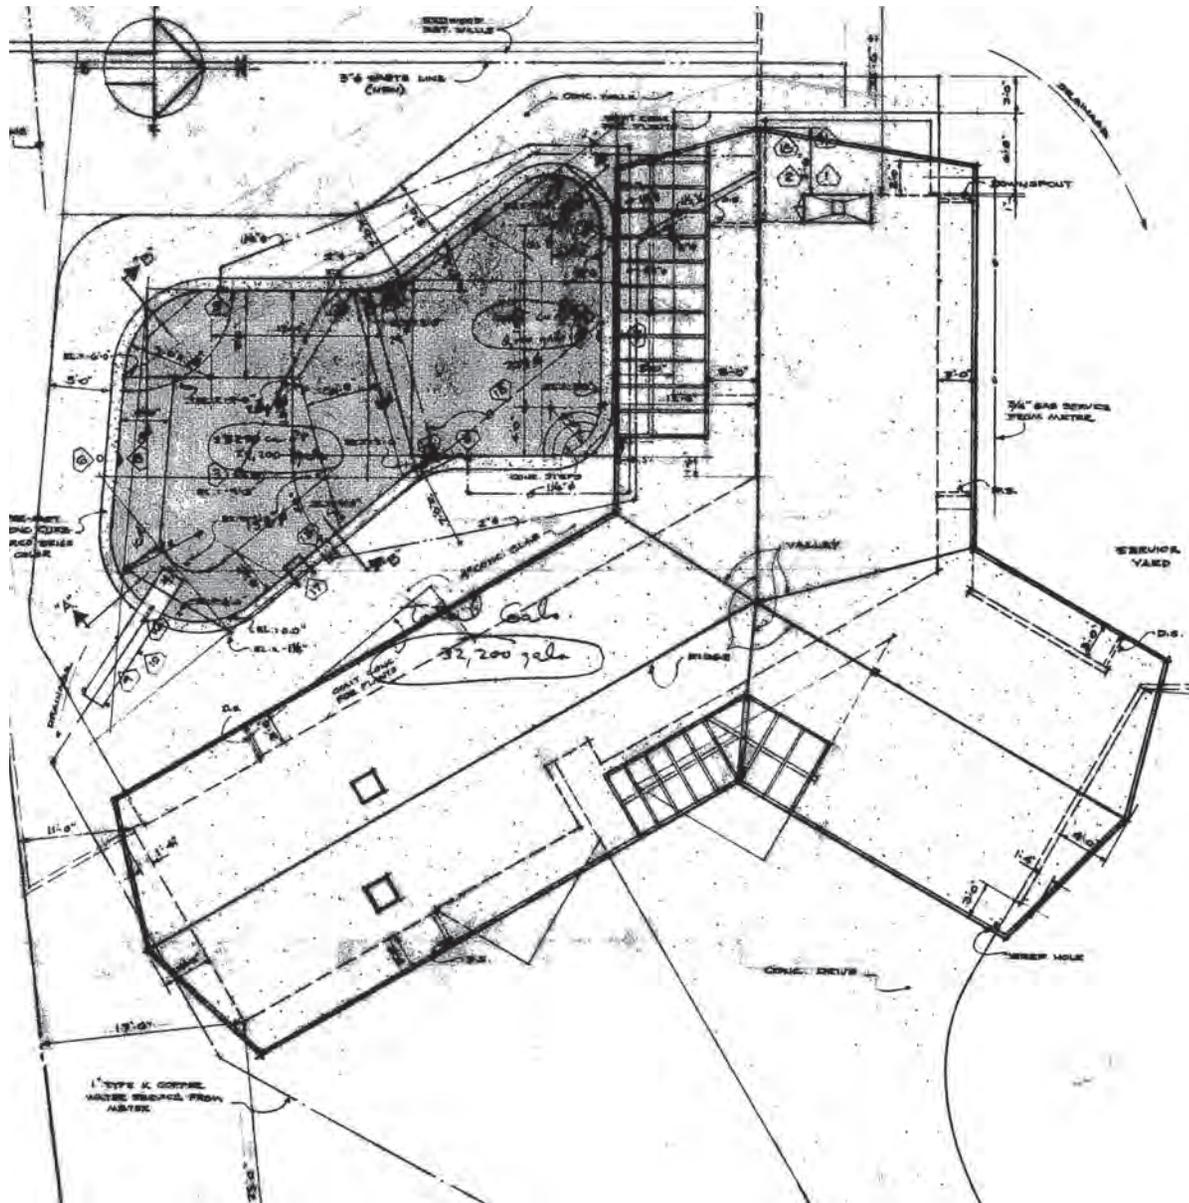
Bruce Sutherland's architectural design for 5420 South Mohawk Road dated March 12, 1960. Drawings courtesy the Arapaho Hills Archive.

The Nyman House is composed of three rectangular closed volumes joined at 45 degree angles.

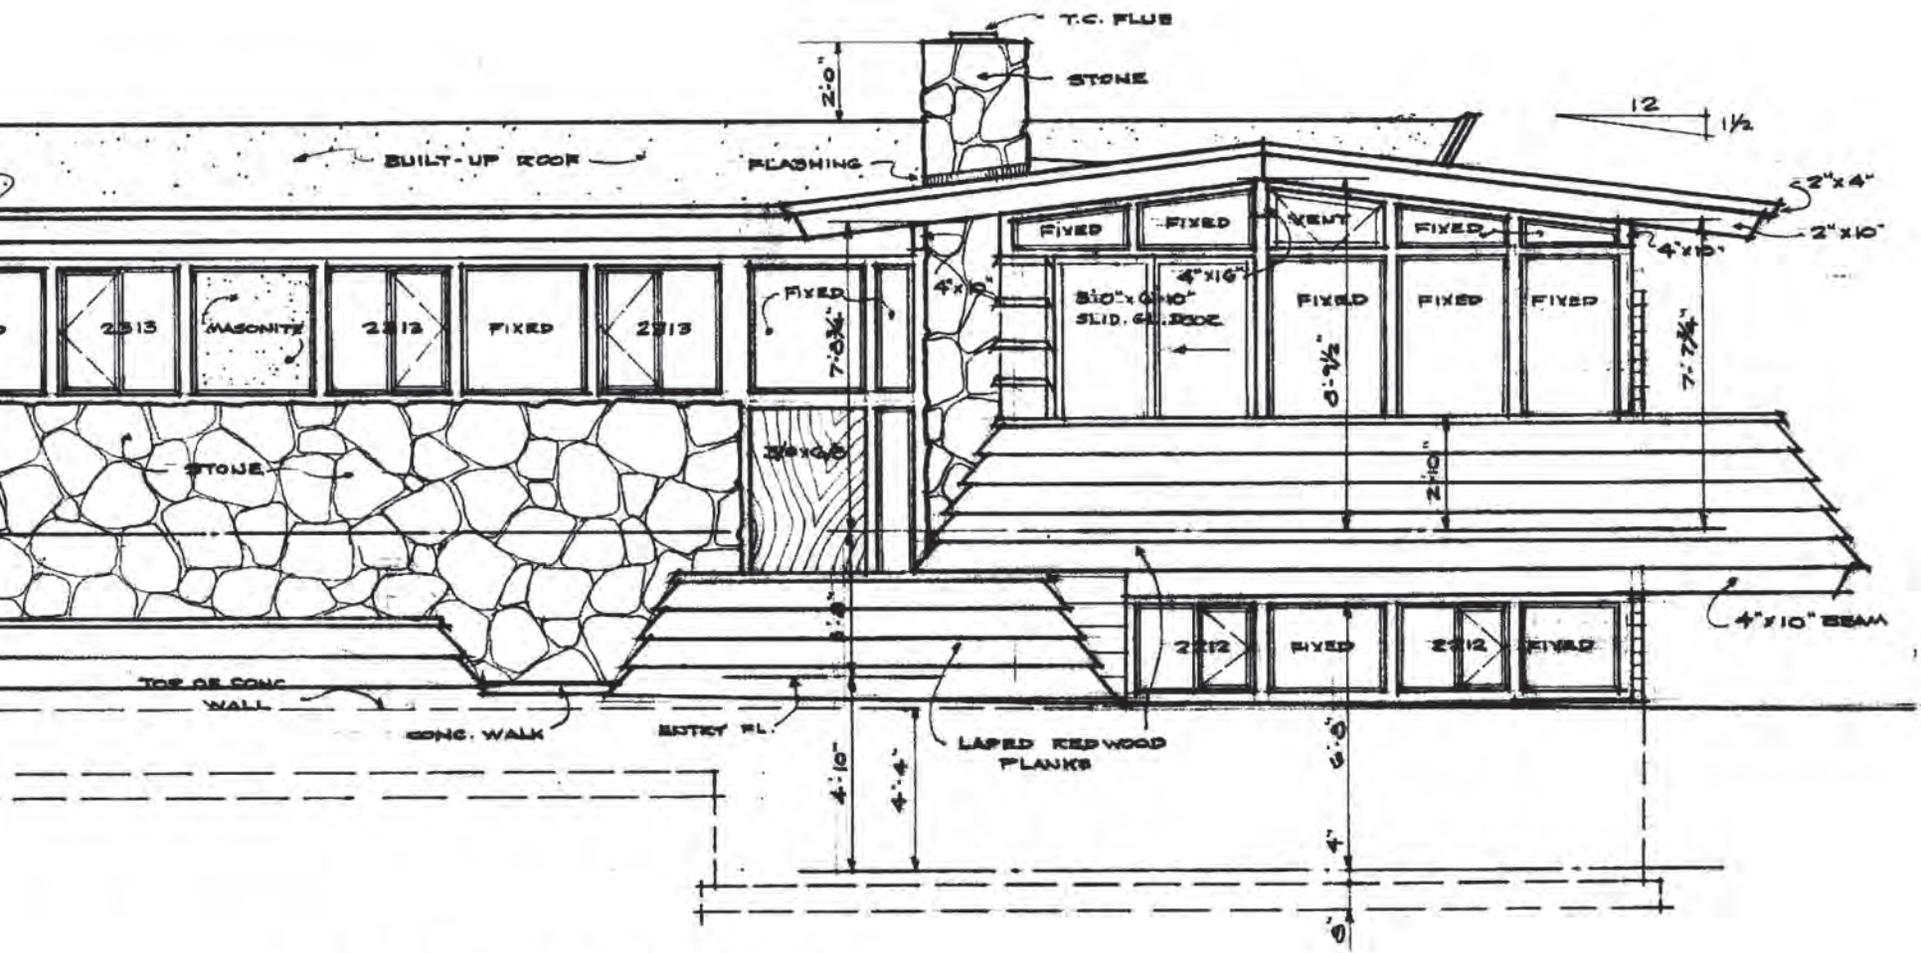
EAST ELEVATION
 1/4" = 1'-0"

Bruce Sutherland's architectural design for 5355 South Mohawk Road dated December 9, 1959. Drawing courtesy the Arapaho Hills Archive.

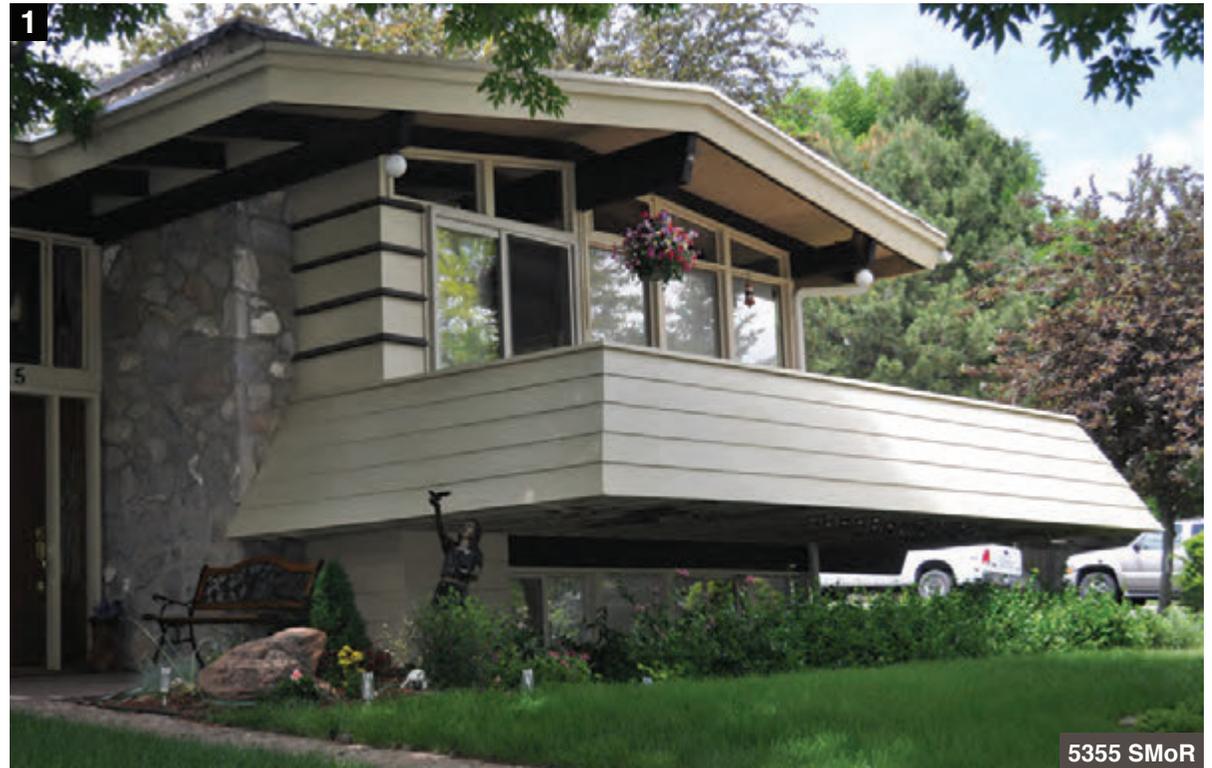
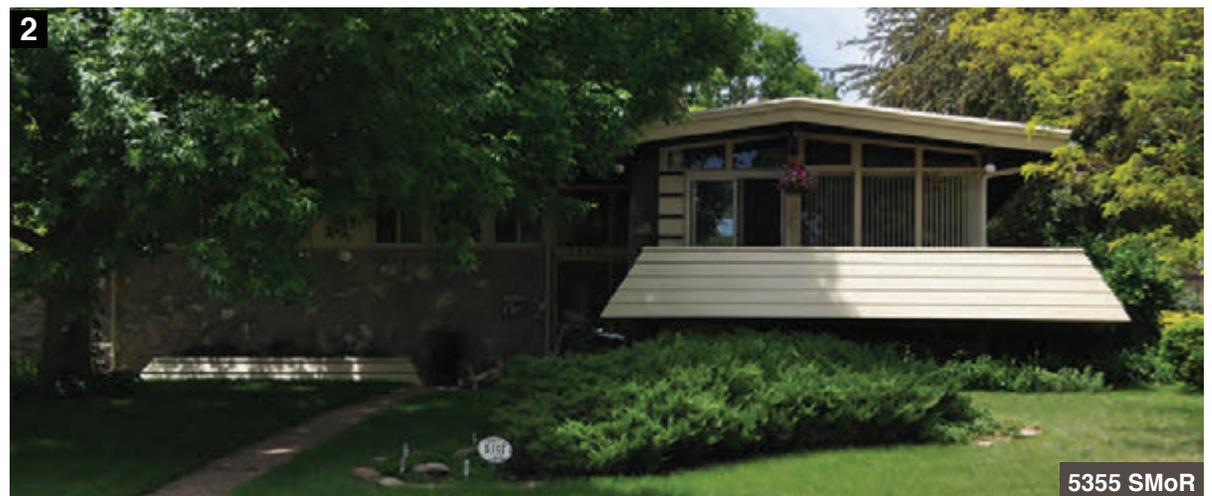
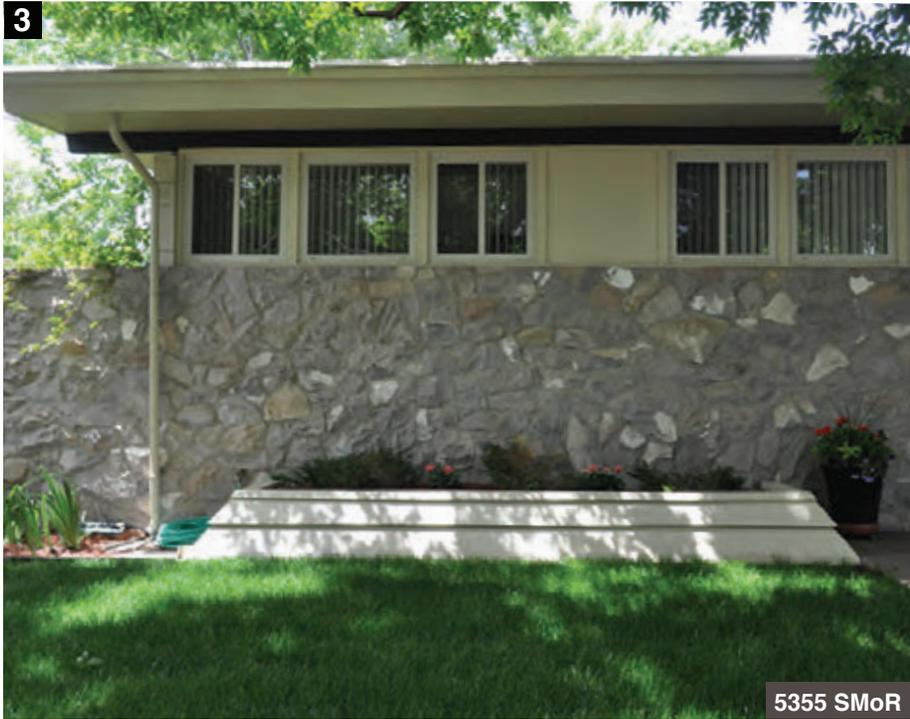
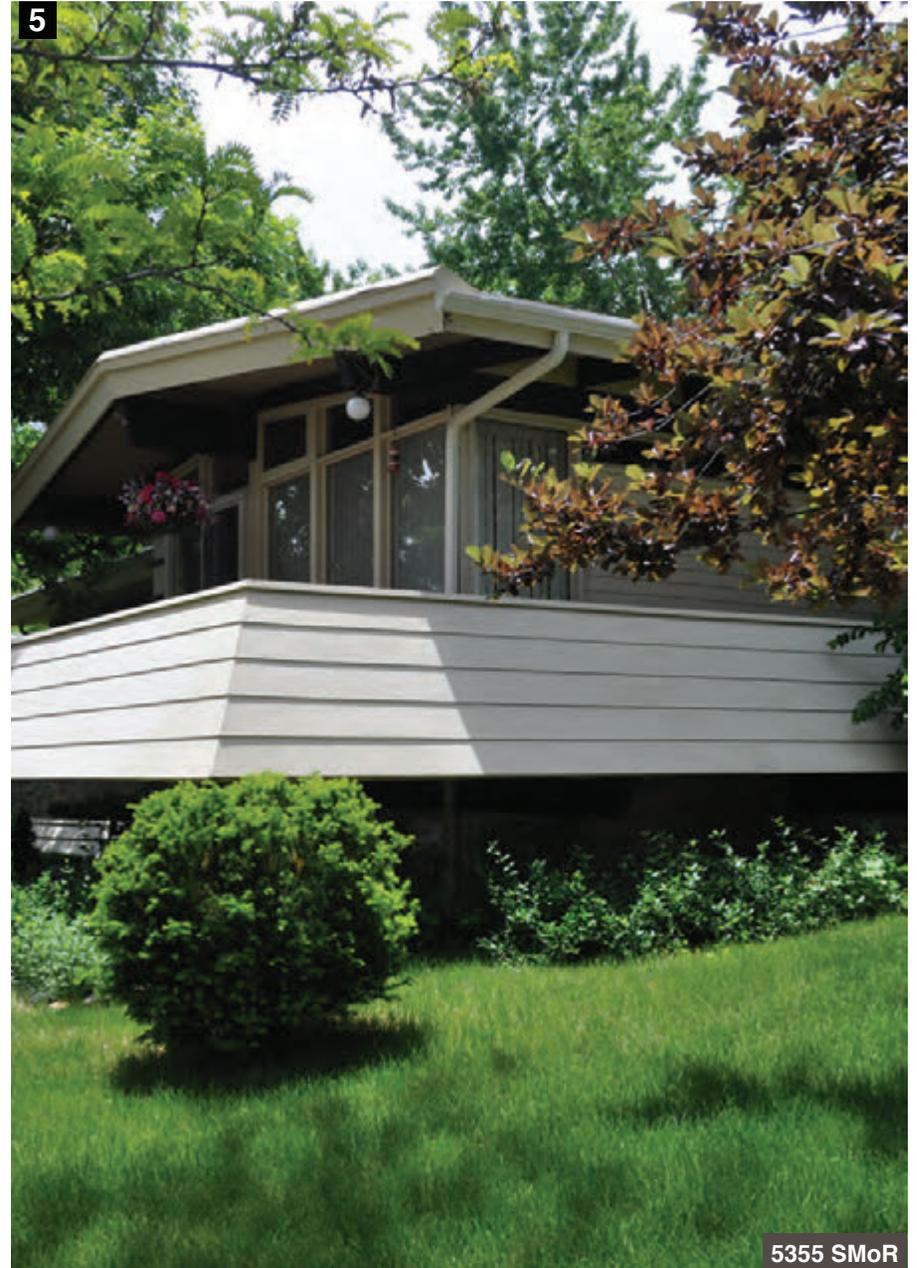
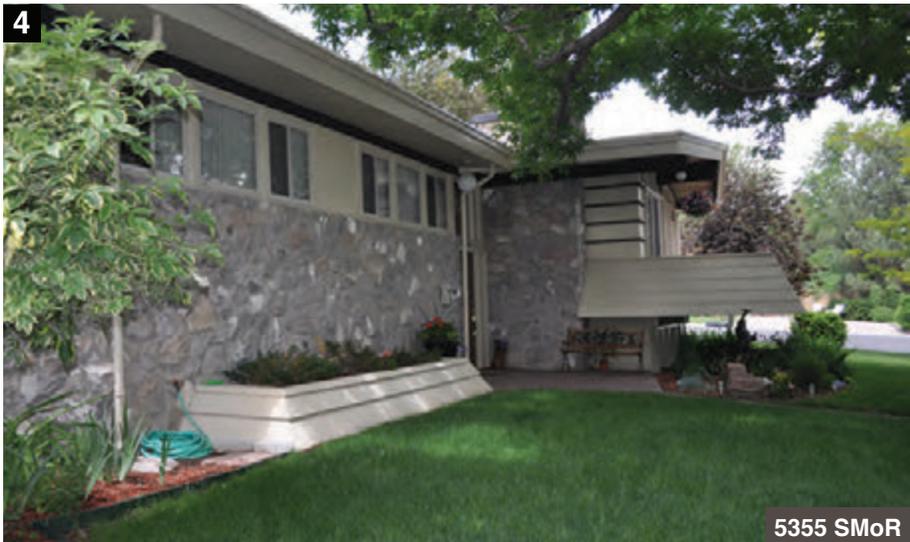
Secondary volumes add complexity and interest to the primary volumes that form the body of the Edds House.

- 1 A large slab chimney is positioned perpendicular to the front entrance of the house, its vertical form moderated by the overlapping horizontal roof fascia.
- 2 The massive balcony dominates most views of the house from the street.
- 3 The angled and faceted roof fascia also visually functions as a secondary volume.
- 4 Across the face of the house, a low redwood planter box is detailed to match the balcony fascia. A similar lost planter box once defined a front entry court.
- 5 The balcony projects out into the landscape surrounding the house.

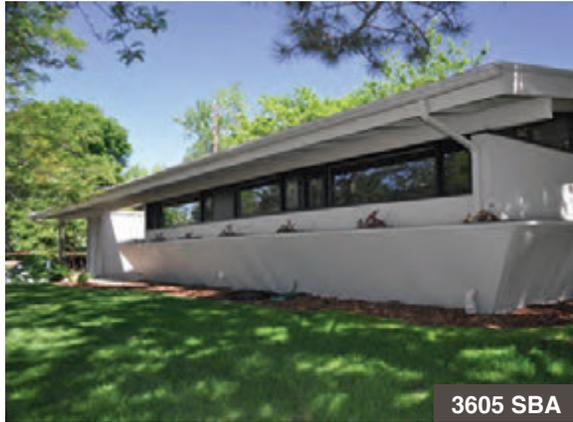
Planter boxes are an important secondary volume. This angled wood planter box wraps around two elevations of the house, terminating at the front entry court at left.
