MILE HIGH PHOTO - DENVER

**Prepared for the City of Littleton
Office of Community Development**

BRIEF HISTORY / ARAPAHO HILLS

PROPOSED NATIONAL REGISTER HISTORIC DISTRICT / ARAPAHO HILLS

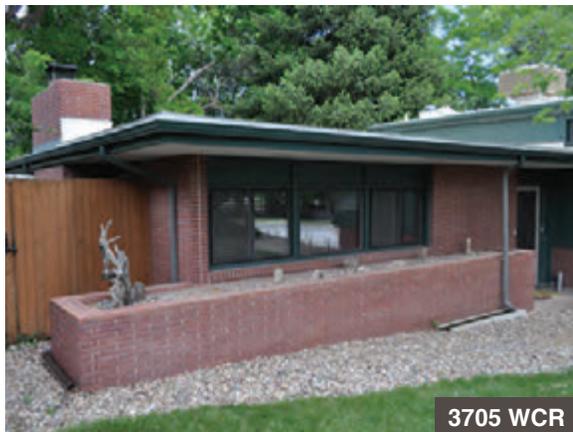
A simple rectangular planter box of red brick masonry extends beyond the face of the house into the landscape. Its placement emphasizes the location of the front entry door to the right.

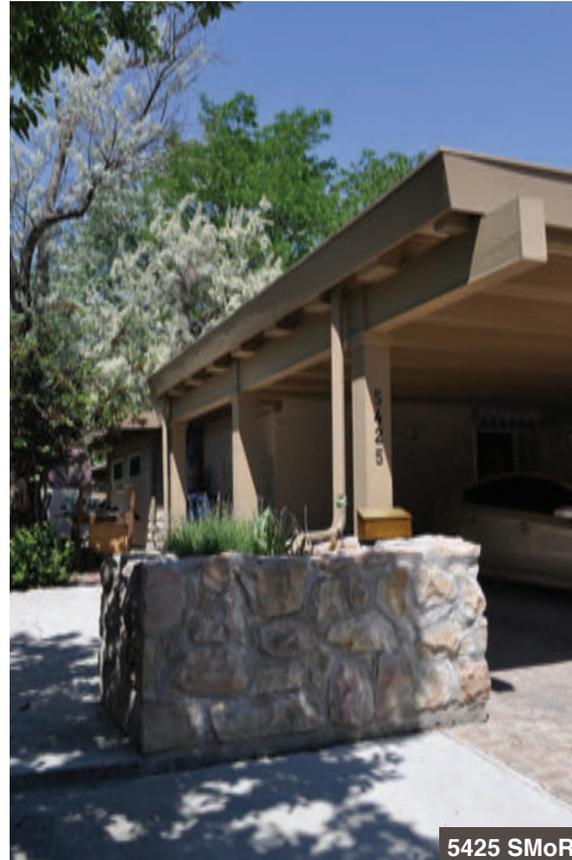
A rhyolite masonry planter carries the corner column of this carport roof.

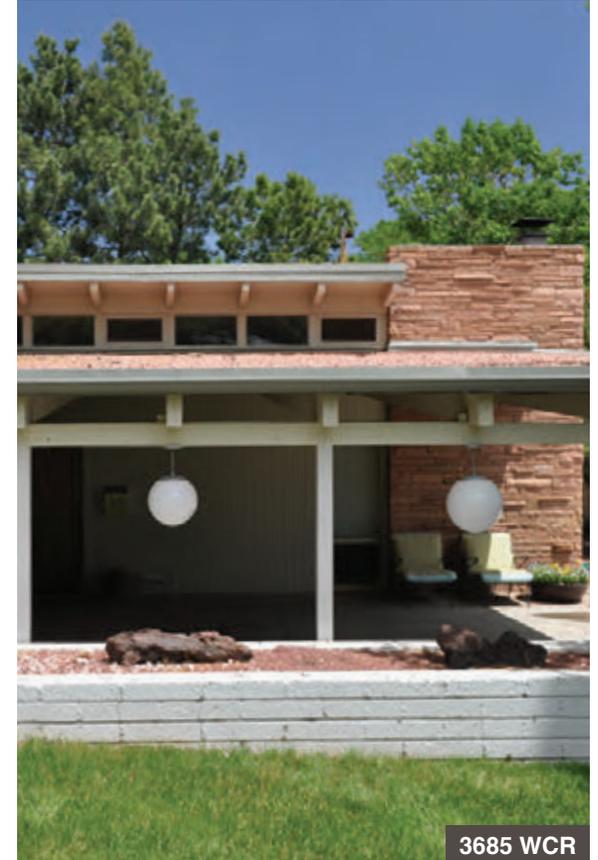
Concrete block forms a retaining wall and planter across the face of this open carport.

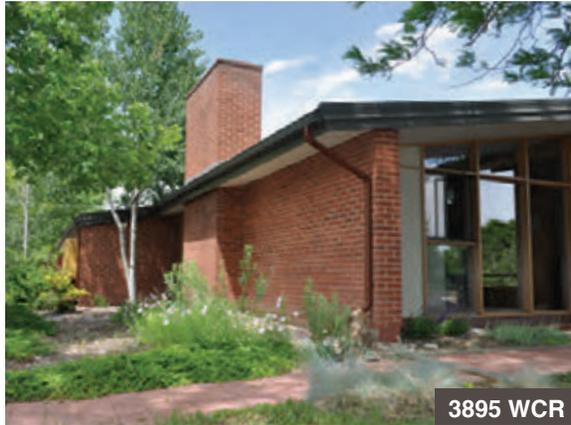
3895 WCR

Chimneys are another important secondary volume. These simple slab chimneys of red and gray brick rise adjacent to the wall.

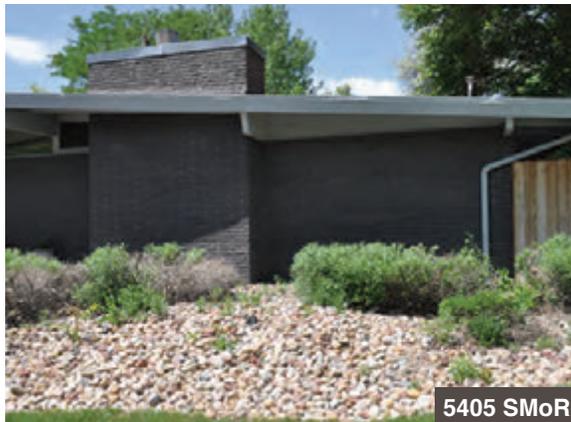
5405 SMoR

Chimneys interrelate with roof planes in a variety of ways. Here the overlapping fascia moderates the vertical thrust of the chimneys.

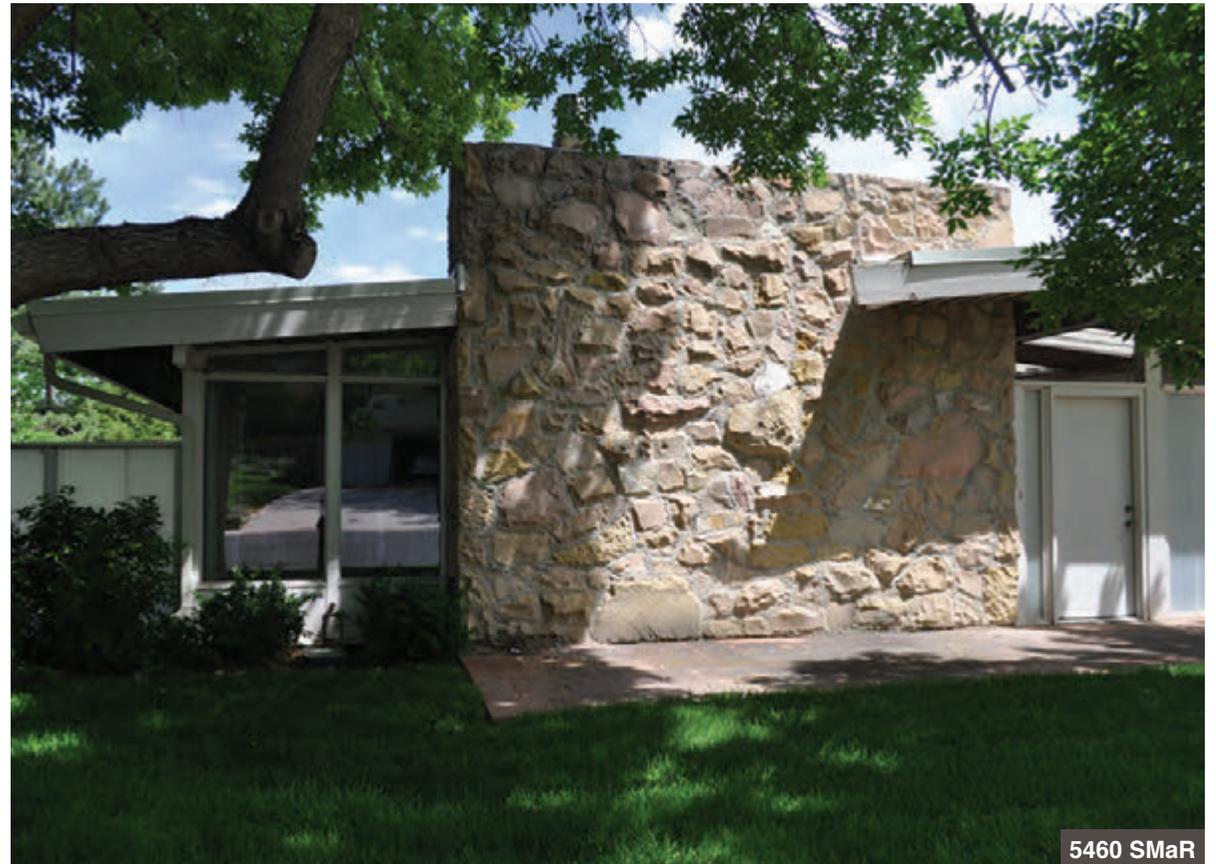
5460 SMaR

A massive rectangular stone masonry chimney is the focal point of this house.

At left, the roof plane terminates at the chimney. At right, it partially overlaps onto its face.

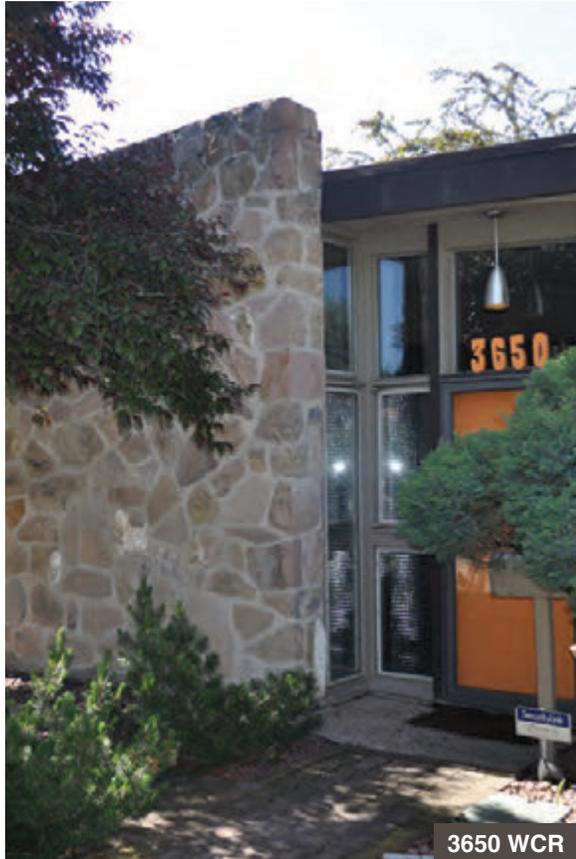
This rhyolite chimney wall sits entirely in front of the roof plane. Behind, perpendicular sidelights appear adjacent to the front entry.

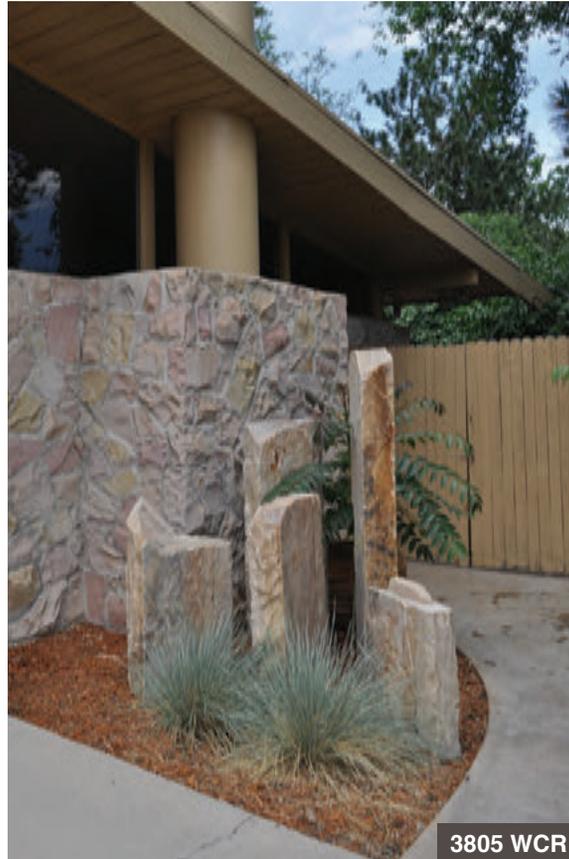
The rhyolite masonry of this chimney stops short of the roof line. A round concrete flue rises above it, in front of an inset window composition and behind the roof fascia.

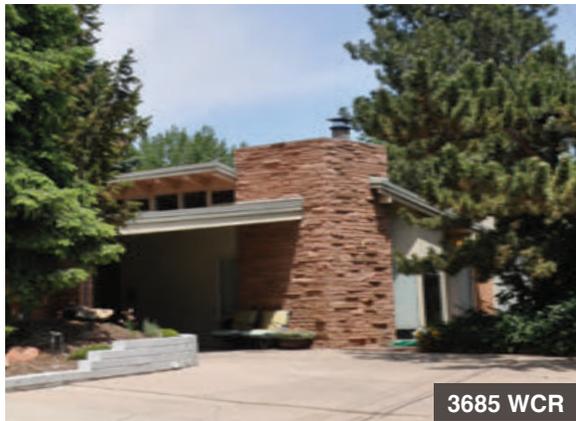
3685 WCR

A row of exposed aggregate panels are joined to form the chimney wall of this house. The angled roof line extends across it.

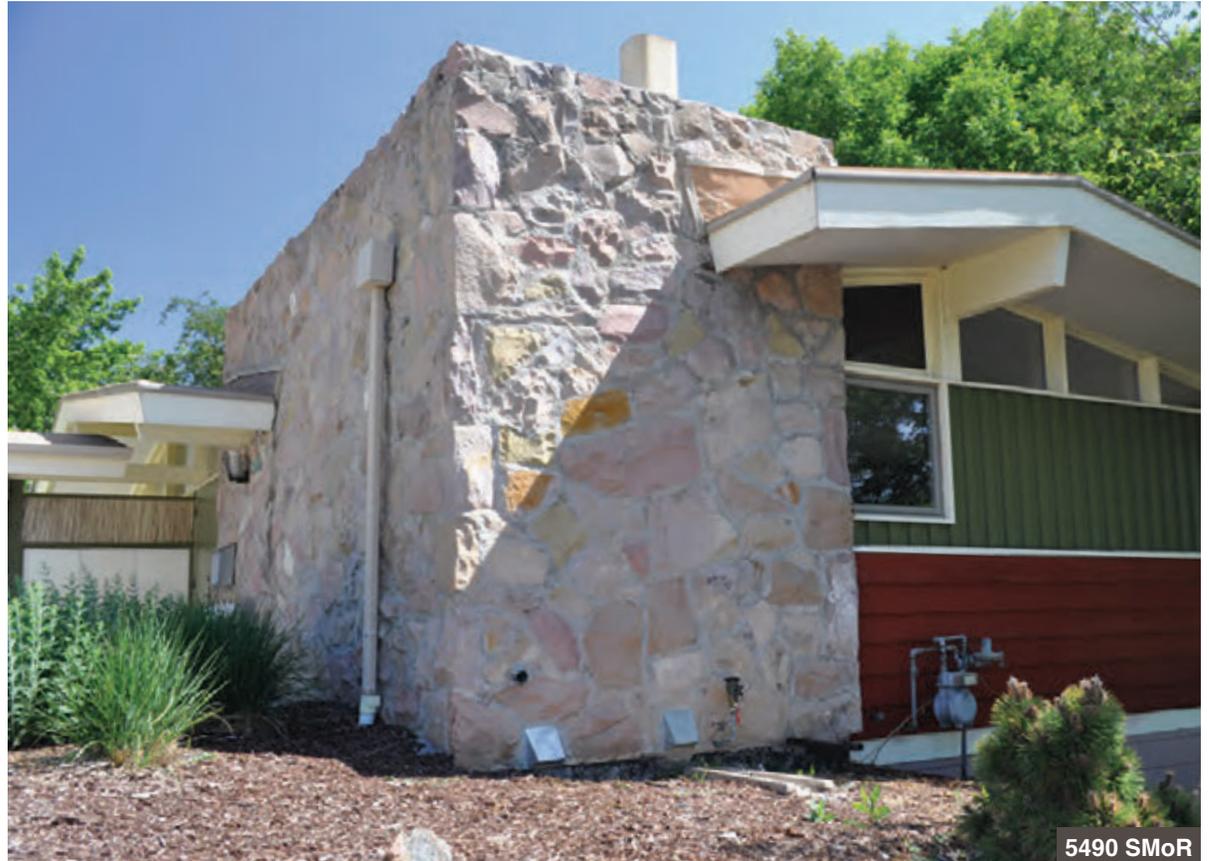
5490 SMoR

The roof line overlaps onto the face of both side of this massive chimney. At left, the roof forms a shallow porch over the front entrance. At right, it shelters a window composition.

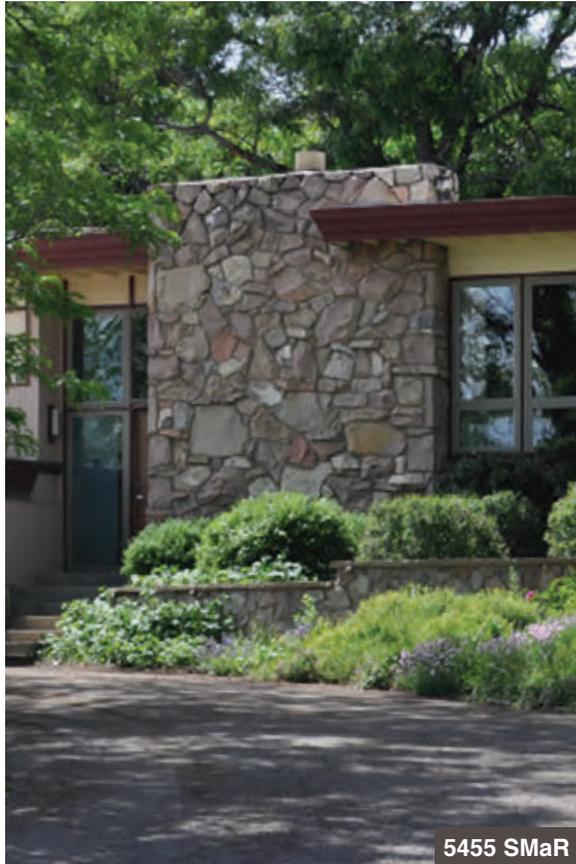
On houses of multiple levels, chimneys can rise to two stories in height.

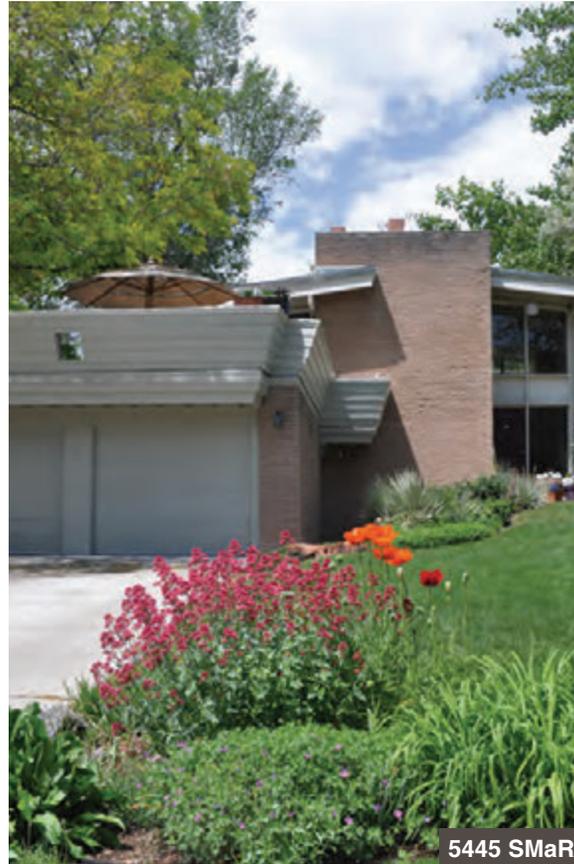
A balcony fascia atop the garage and a massive chimney define this home.

The roof and stepped balcony fascia both partially extend onto the face of the chimney.

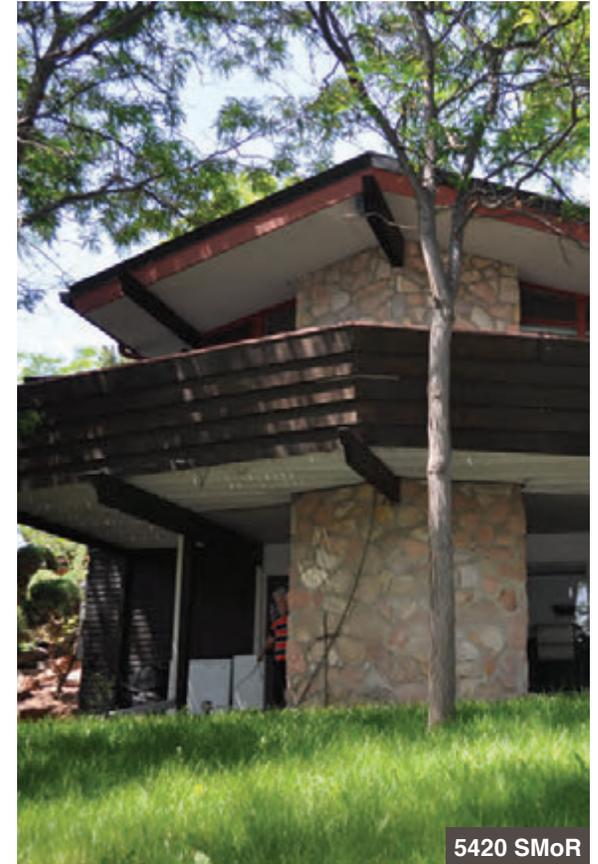
This projecting balcony wraps around three sides of this angled two-story chimney in an east-facing back yard.

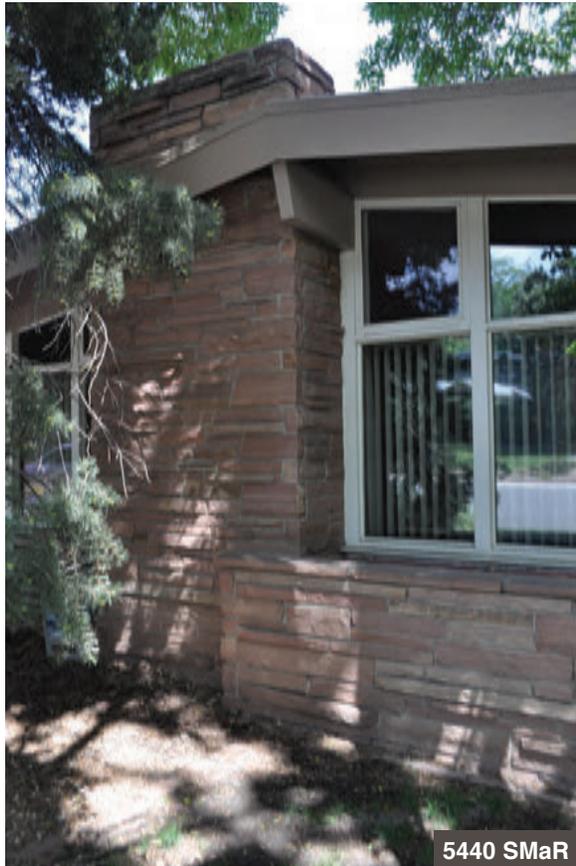
A chimney with overlapping roof fascia and planter box form defining features of this primary elevation.

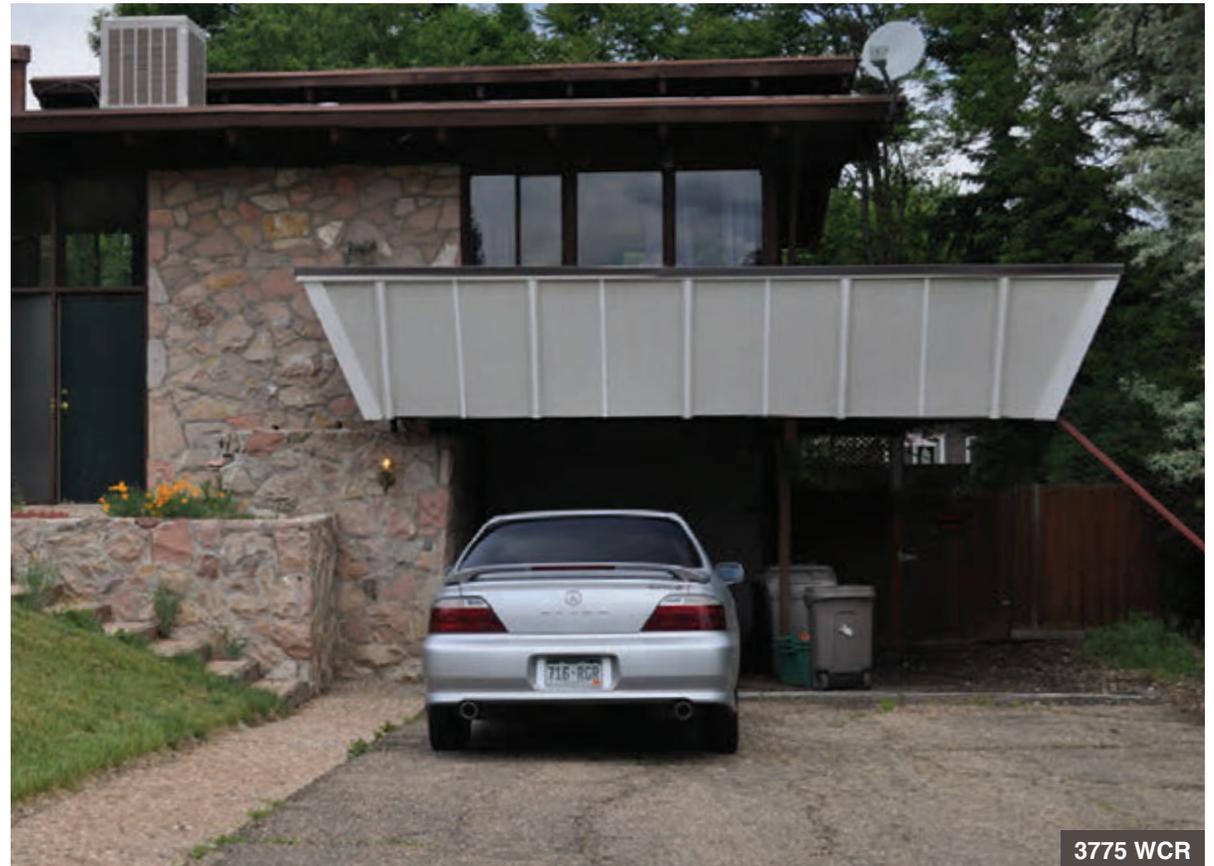
The cantilevered balcony extends around the corner of the house and terminates on the face of the chimney.

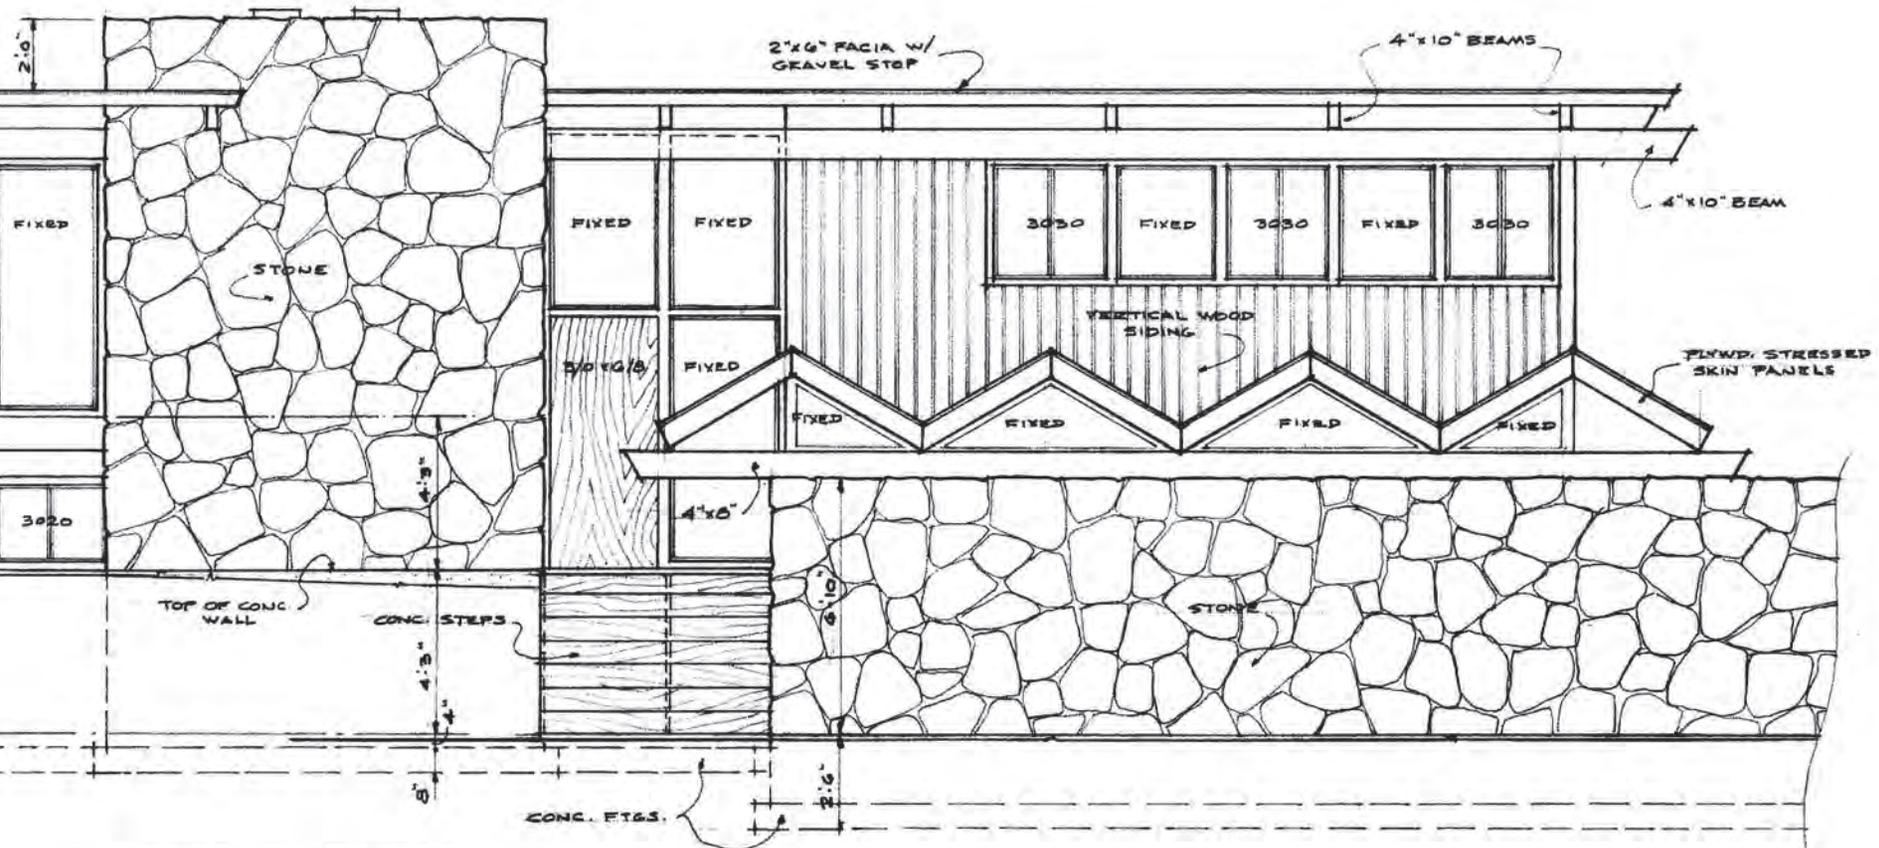
EAST ELEV.
1/4" = 1'-0"

Bruce Sutherland's architectural design for 5435 South Manitou Road dated February 14, 1963. Drawing courtesy the Arapaho Hills Archive.

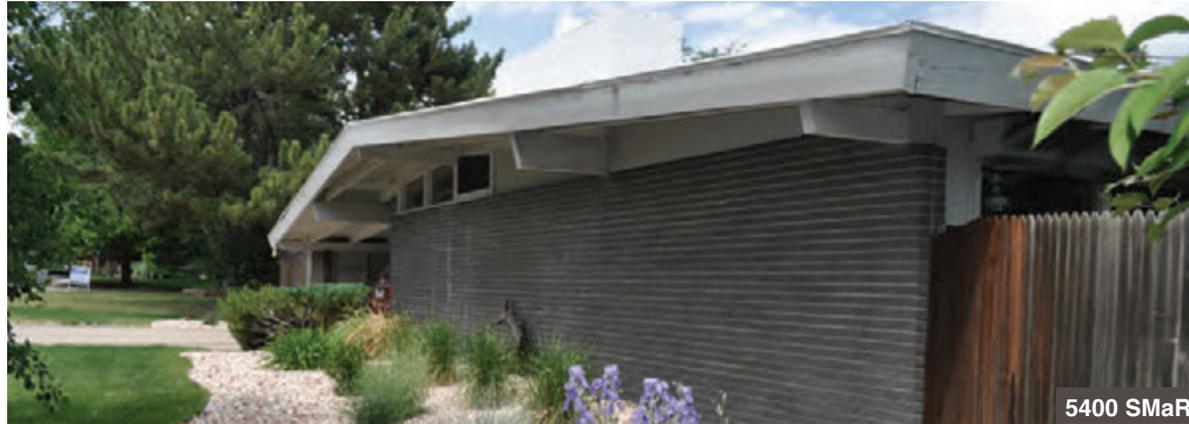
This front-gable roof has the peak of the roof facing the street.

It's asymmetrical, with two roof planes of differing lengths joined at the peak.

The roof accentuates the long horizontal form of the house.

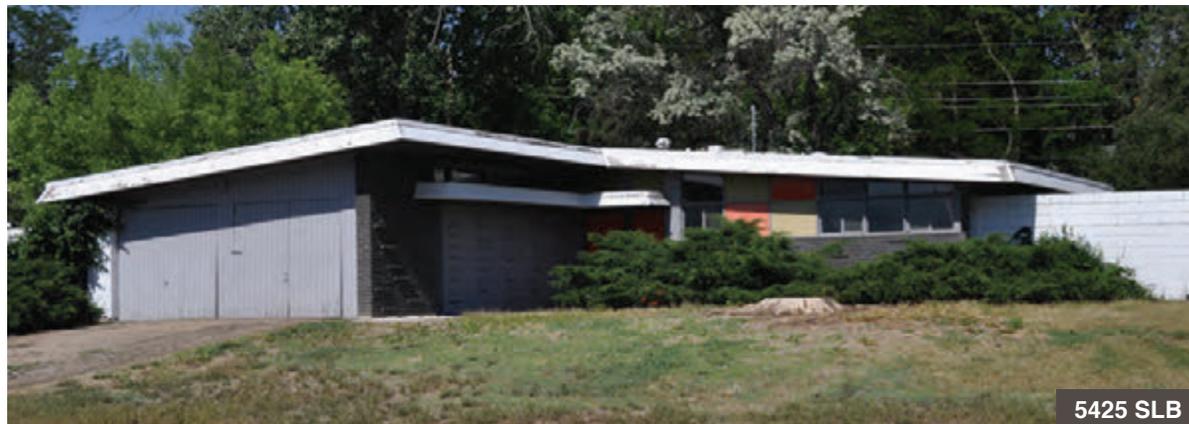
This house has a symmetrical front-gable roof. Both sides of the roof are equal in length. The peak appears at the center of the house.

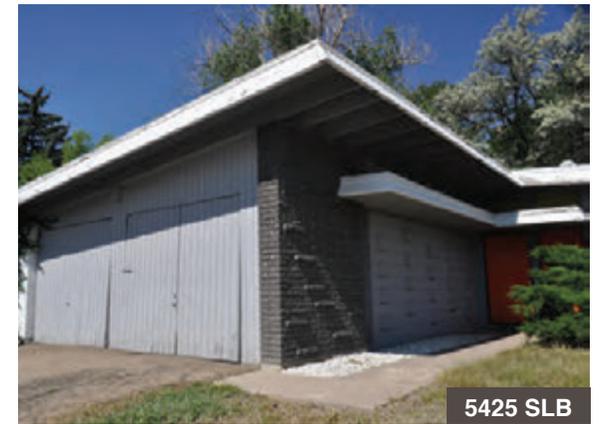
The garage has a shed roof, its highest point aligned with the peak of the gable roof behind. Both roofs are pitched at the same angle.

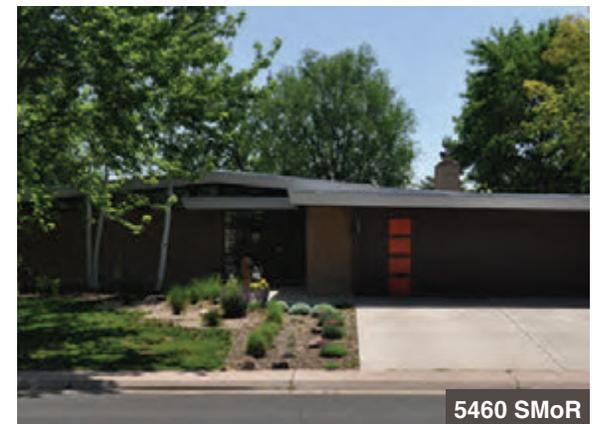
Here, with the shed roof pitched at a lower angle and set asymmetrically on the face of the house, the two roof forms are more distinct.

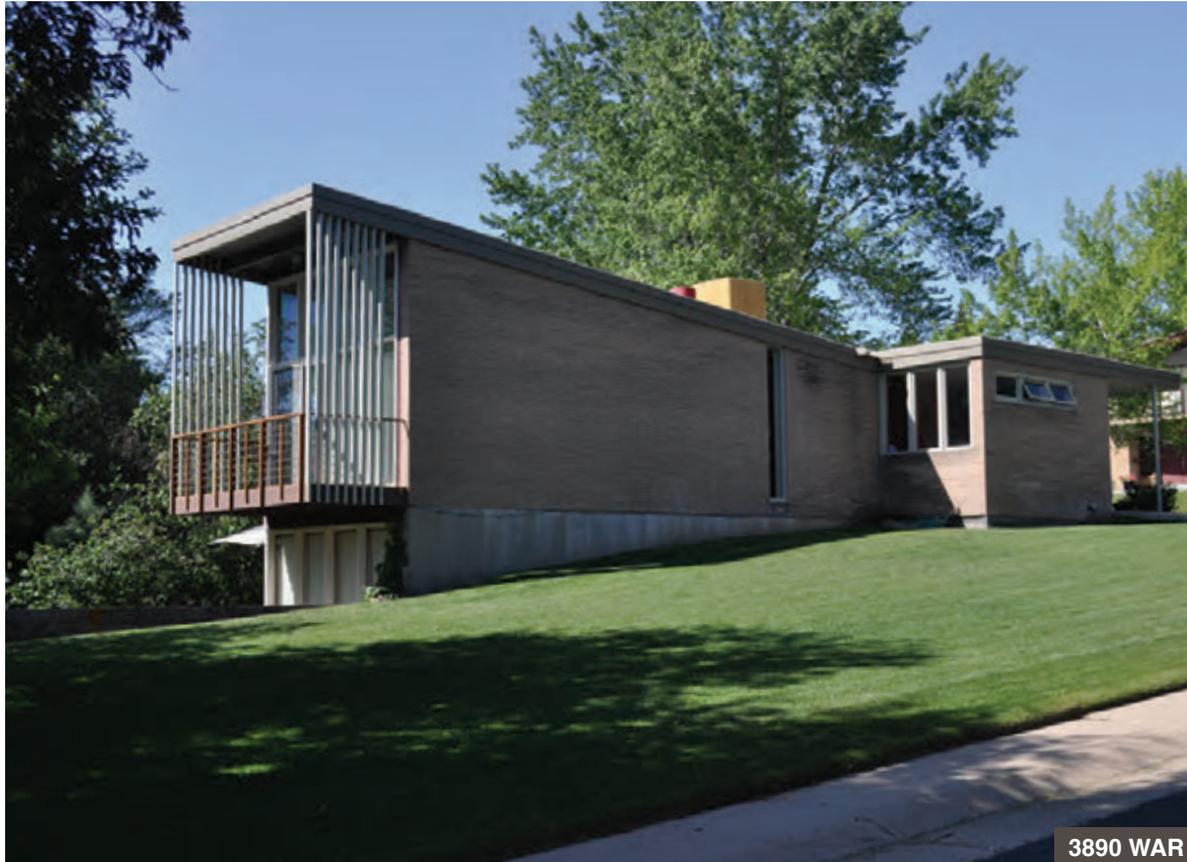
A long shed roof and flat roof are combined on these two, perpendicular volumes.

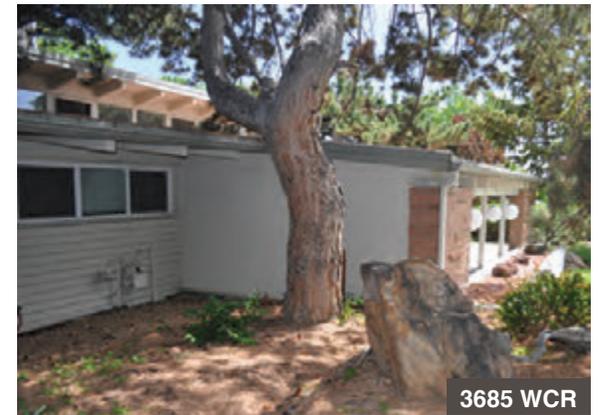
This house features two opposing shed roofs, the top roof extending to overlap the lower roof.

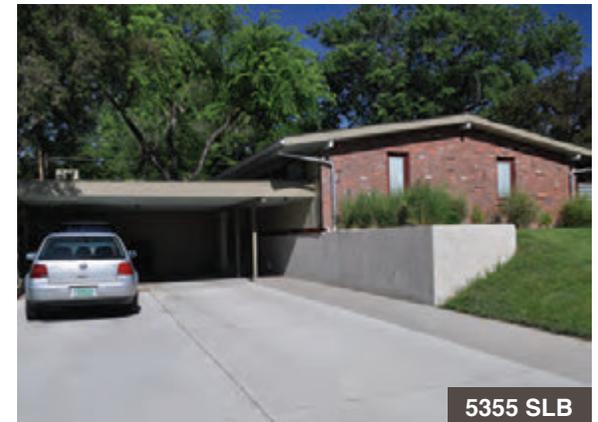
The symmetrical front-gable roof of the house sits above and beside the flat carport roof.

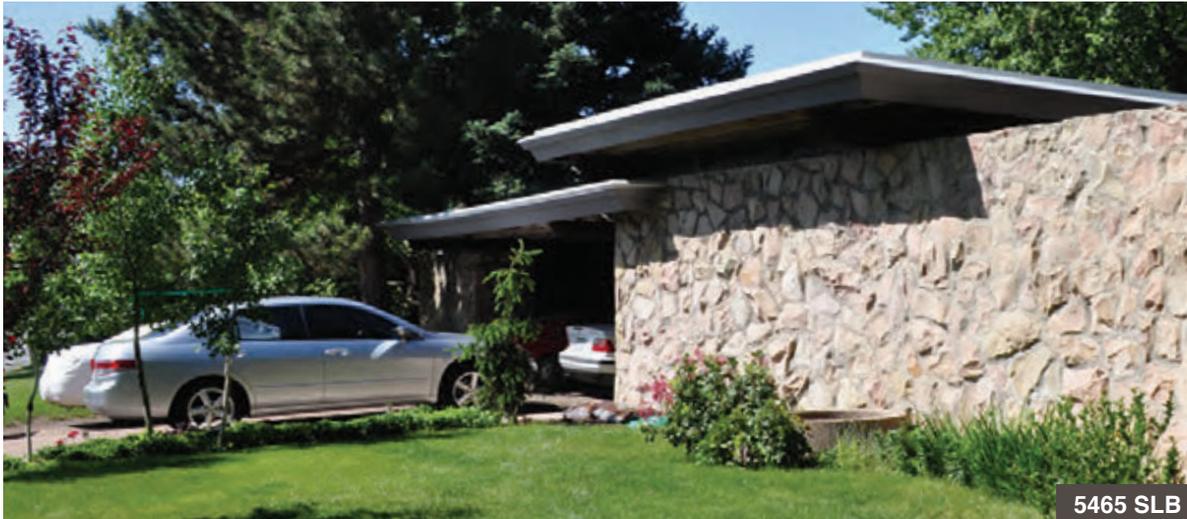
A single flat roof appears on this house.

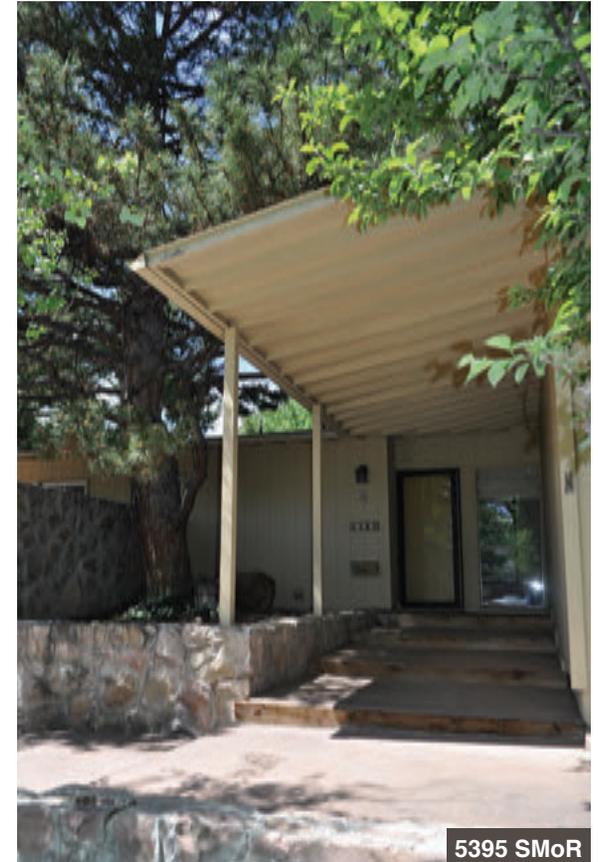
Two distinct roof forms overlap on this house and carport. The roof at right appears to hover over the body of the house.

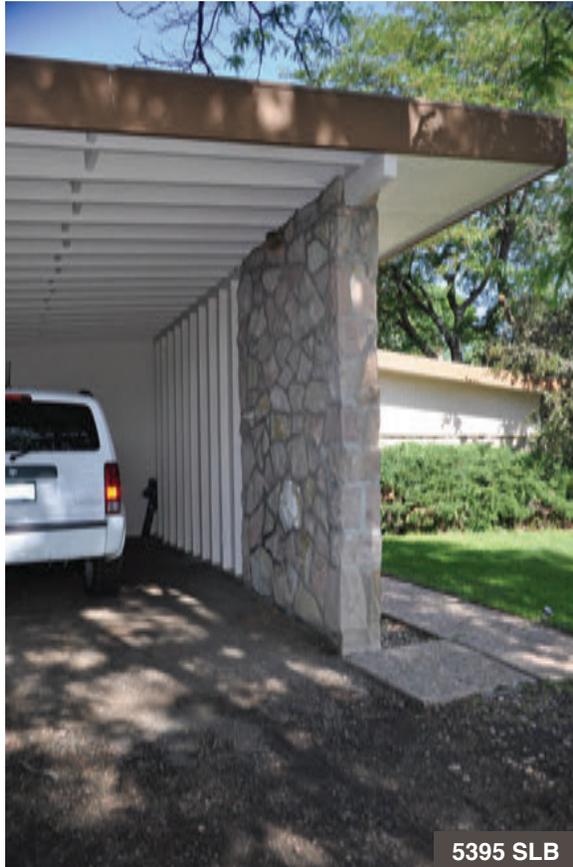
This shed roof extends over the side wall of the carport to shelter the walkway to the front entrance.

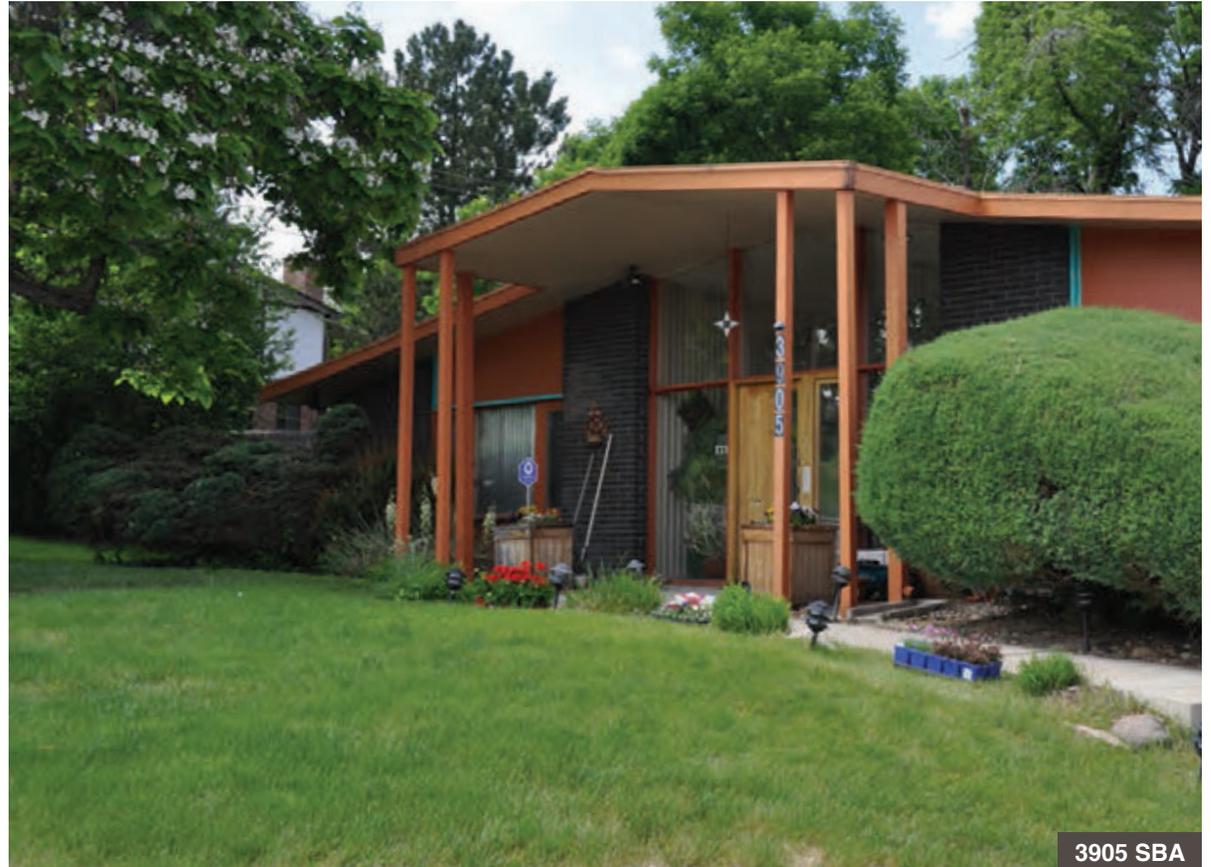
The peak of this front-gable roof projects beyond the body of the house to form a porch cover for the entrance.

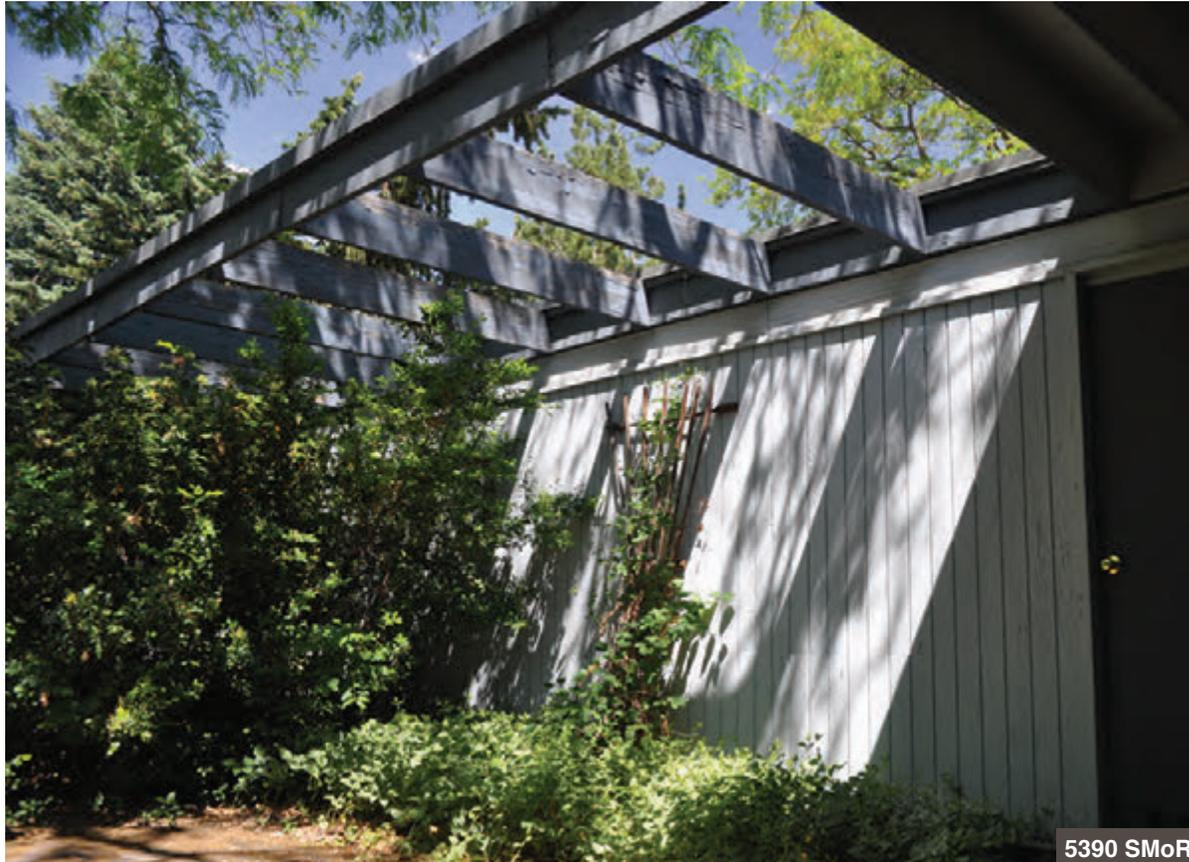
Open roof planes also appear. This arbor is designed as an extension of the garage roof. It serves as a sunscreen for the patio below.

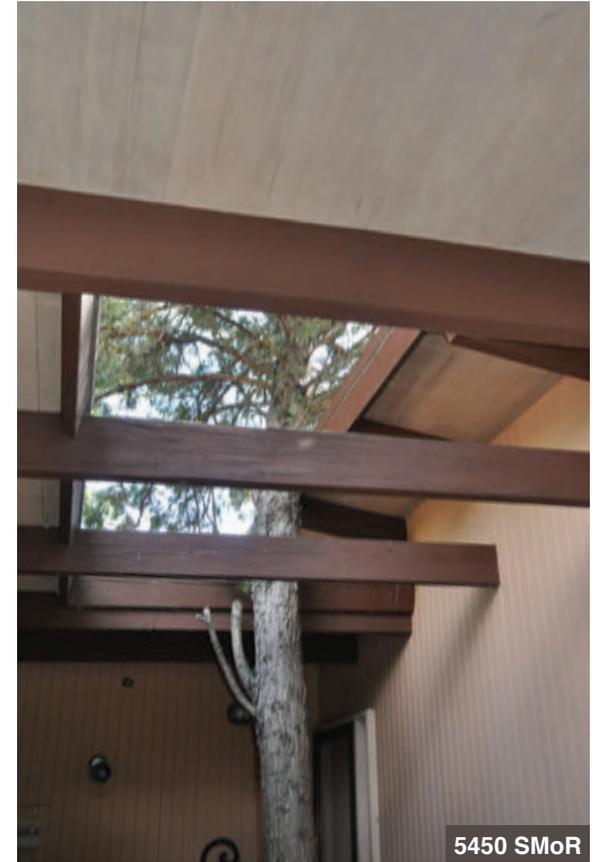
Where additional natural light is desired, like this deeply recessed entrance courtyard, the roof deck is removed. A pine has been trained through the opening.

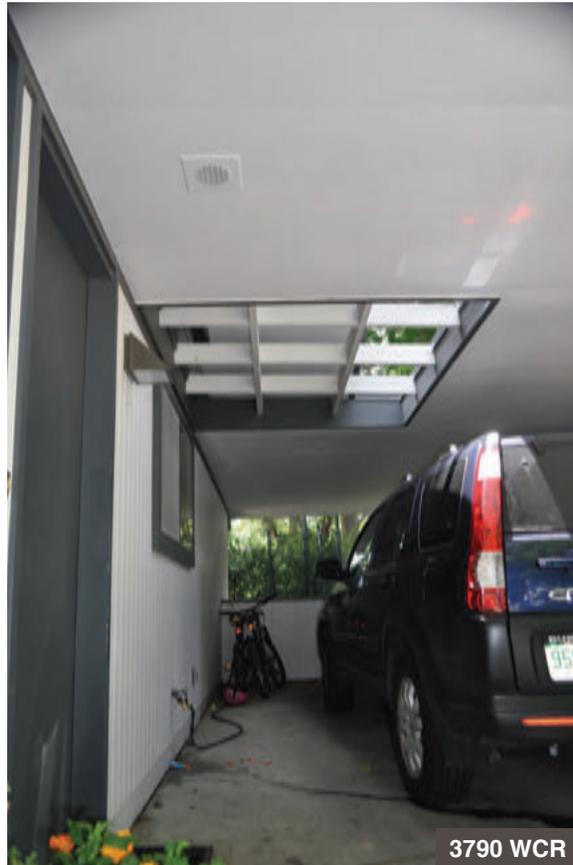
3790 WCR

A portion of this roof deck was removed to allow light to the window composition on the wall below.

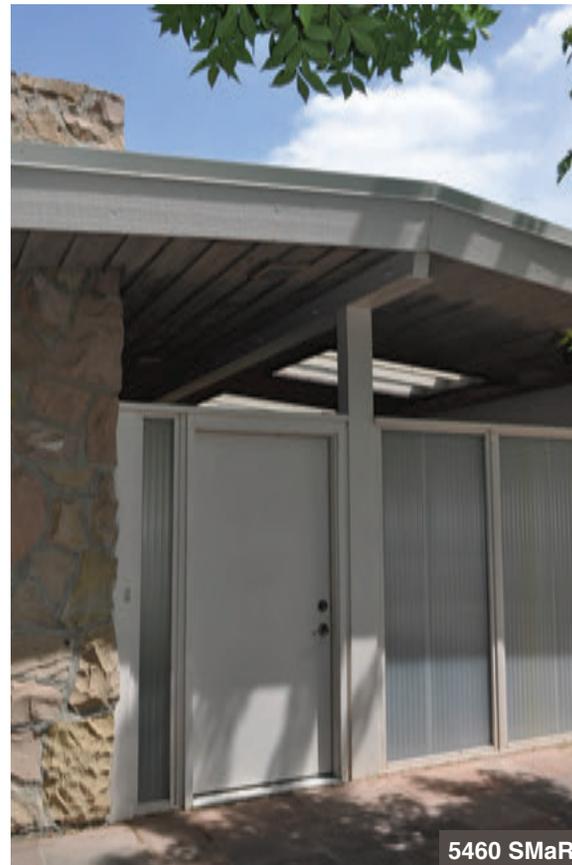
5460 SMaR

Roof openings appear over this partially enclosed entry courtyard.

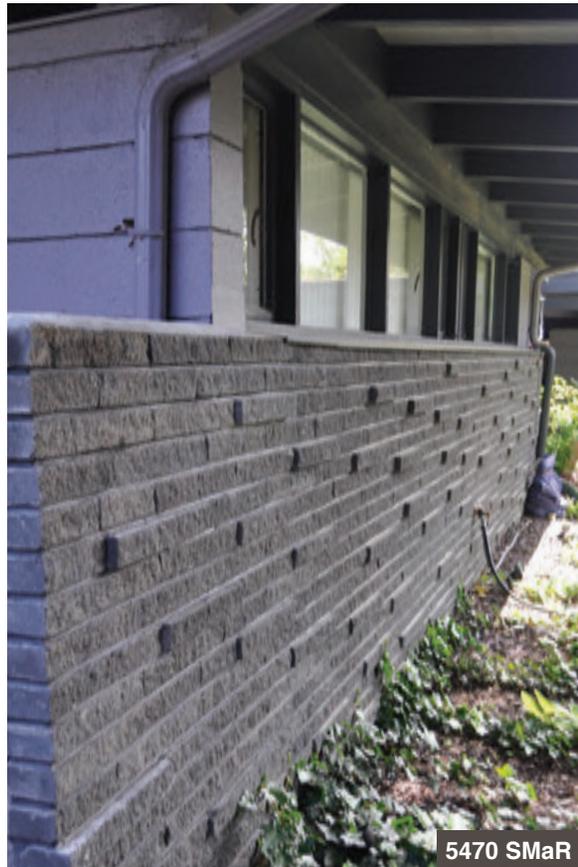
This brick masonry wall extends beyond the house to shelter a patio behind.

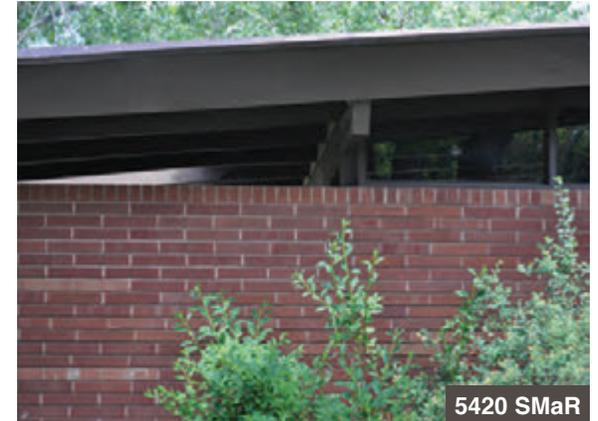
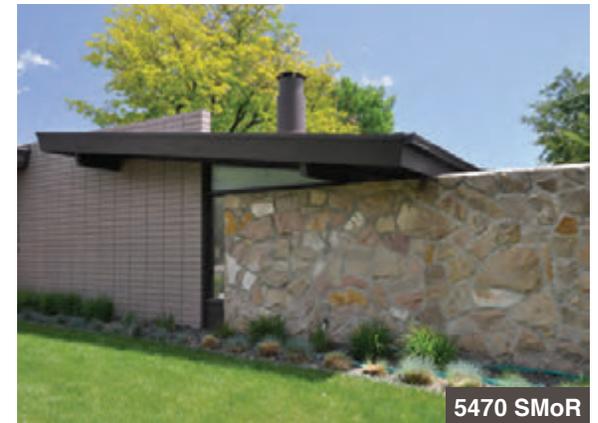
Such walls amplify the scale of the houses. Careful examination is required to see that the house does not extend the full length of the wall, but stops short at the exposed beam above.

Here a stone masonry fireplace wall extends into the garden.

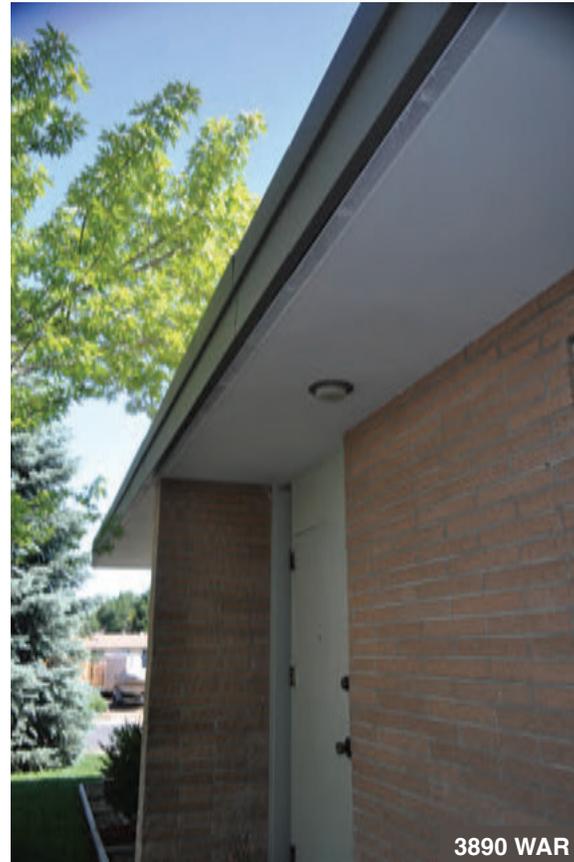
Here a projecting wall separates and screens a service entrance from the main entrance to the house. The roof acts as a porch cover for entrance.

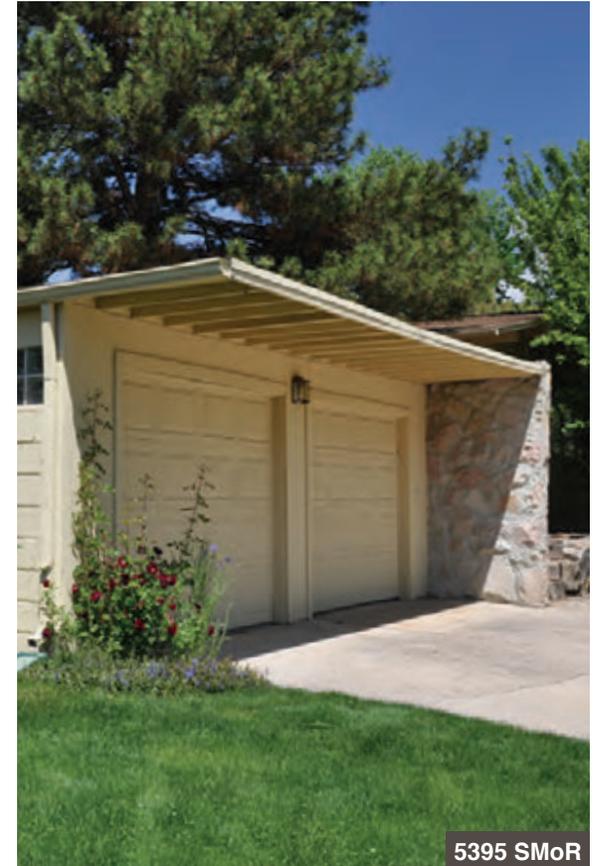
The roof and stone masonry wall extend to shelter a pair of garage doors.

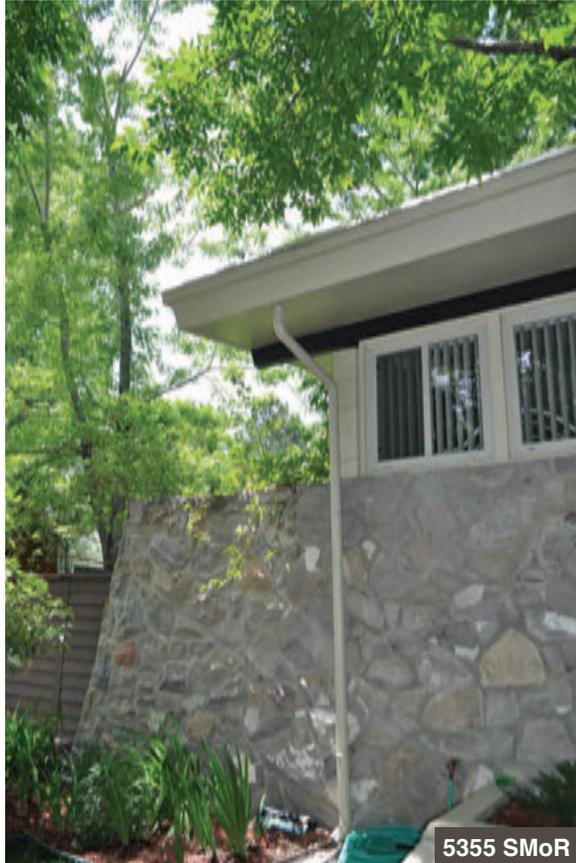
This wall and roof both extend beyond the body of the house. The end of the wall and the fascia of the roof are angled in opposition to each other, enlivening the overall horizontality of the house.

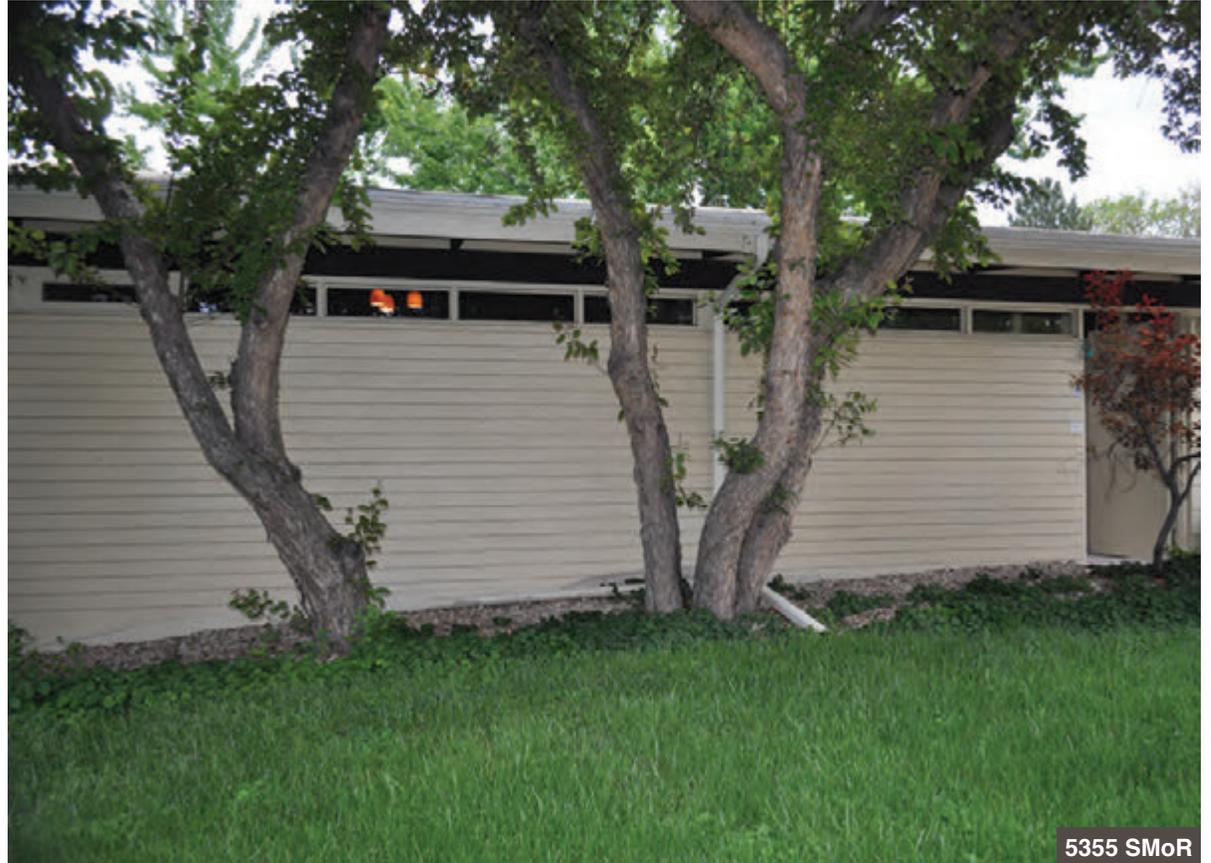
A single exterior wall extends the length of the house, across an open breezeway, and onto the face of the garage, creating the illusion of a much larger dwelling.
