MILE HIGH PHOTO - DENVER

**Prepared for the City of Littleton
Office of Community Development**

BRIEF HISTORY / ARAPAHO HILLS

PROPOSED NATIONAL REGISTER HISTORIC DISTRICT / ARAPAHO HILLS

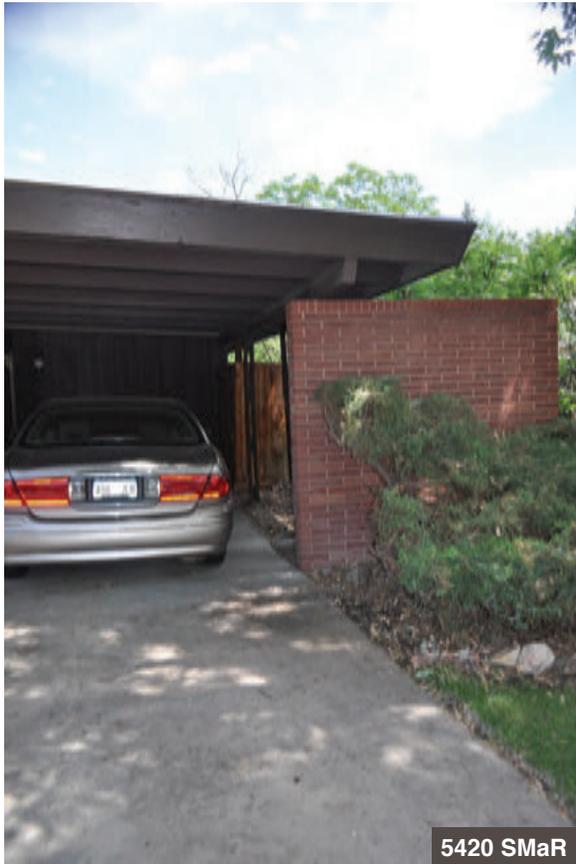
5420 SMaR

A free-standing brick masonry wall acts as a supporting column for the roof plane above and the open carport wall behind.

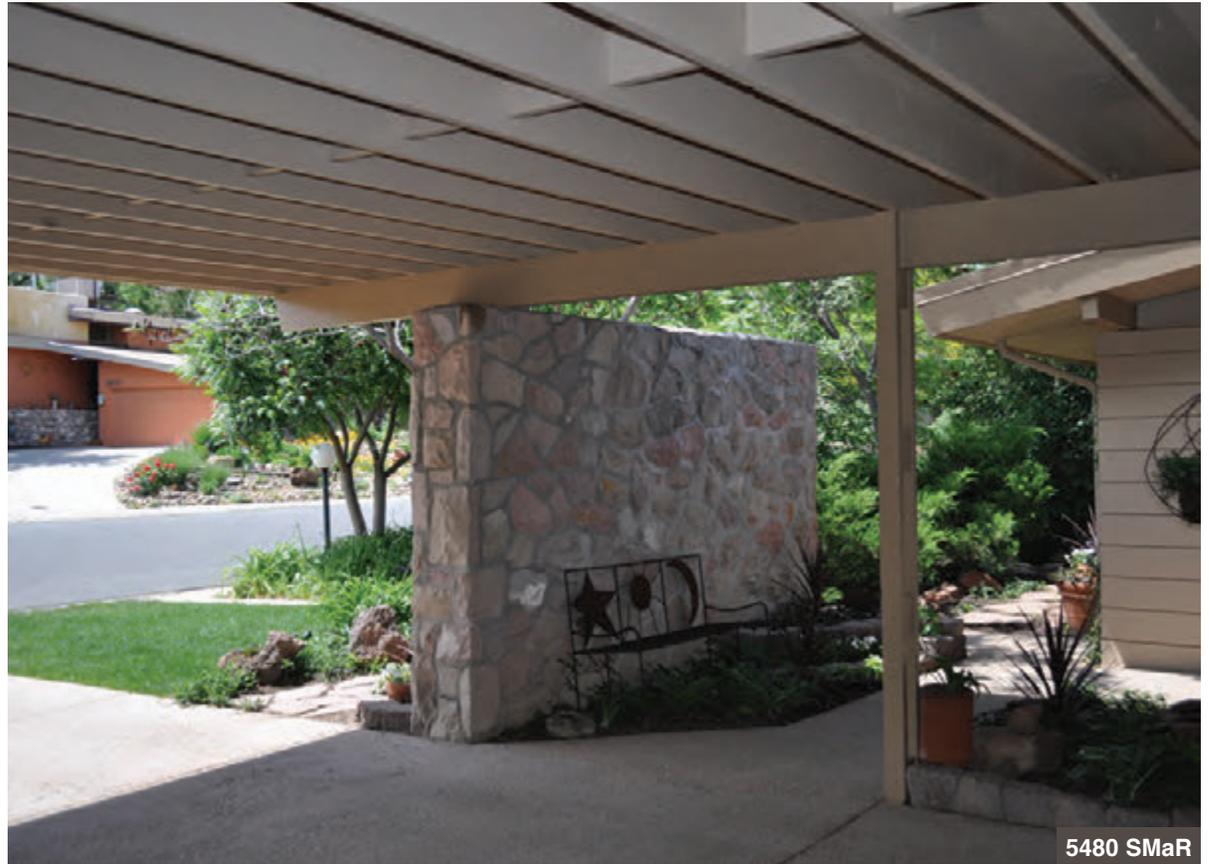
5480 SMaR

A similar wall plane of rhyolite carries the front corner of this carport roof while creating a private front entrance courtyard.

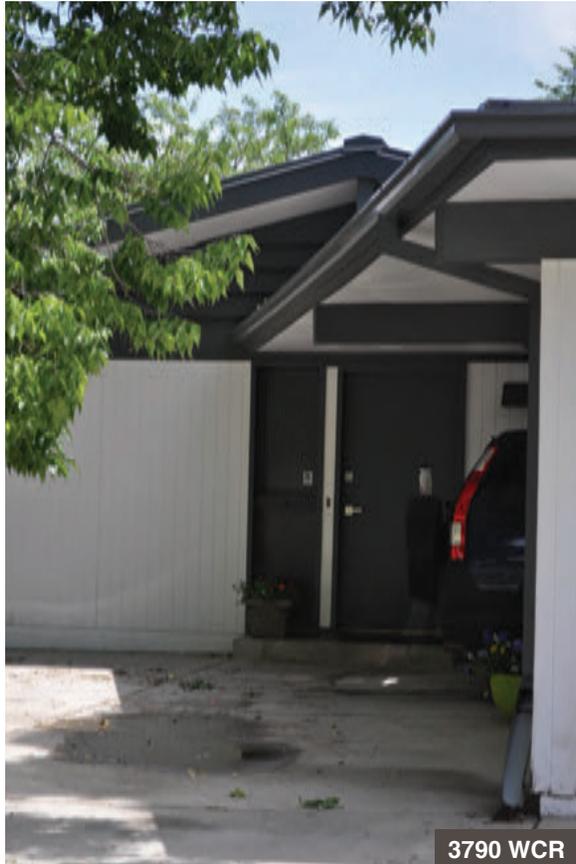
3790 WCR

Projecting and overlapping roof and wall planes create complex compositions on many Arapaho Hills Houses.

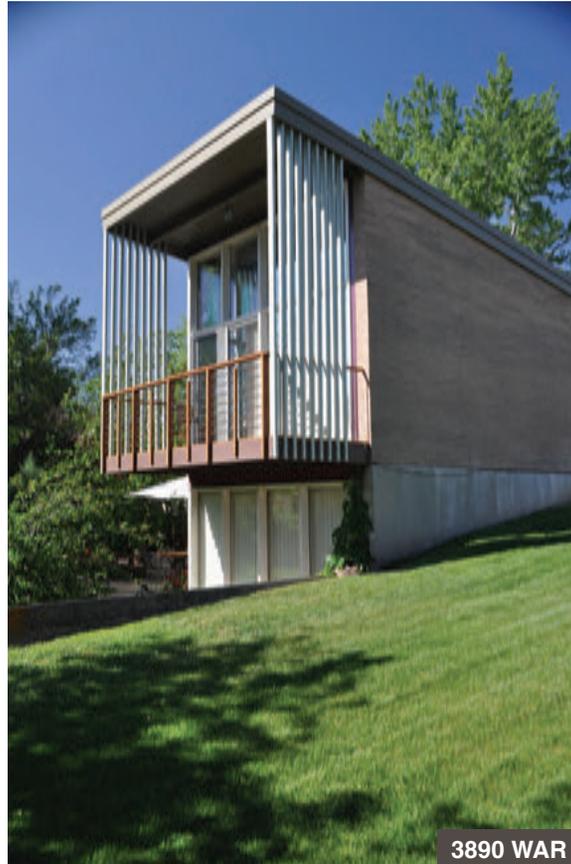
3890 WAR

Here the roof, wall and floor planes all project beyond the body of the house to form a semi-enclosed balcony with an eastern view.

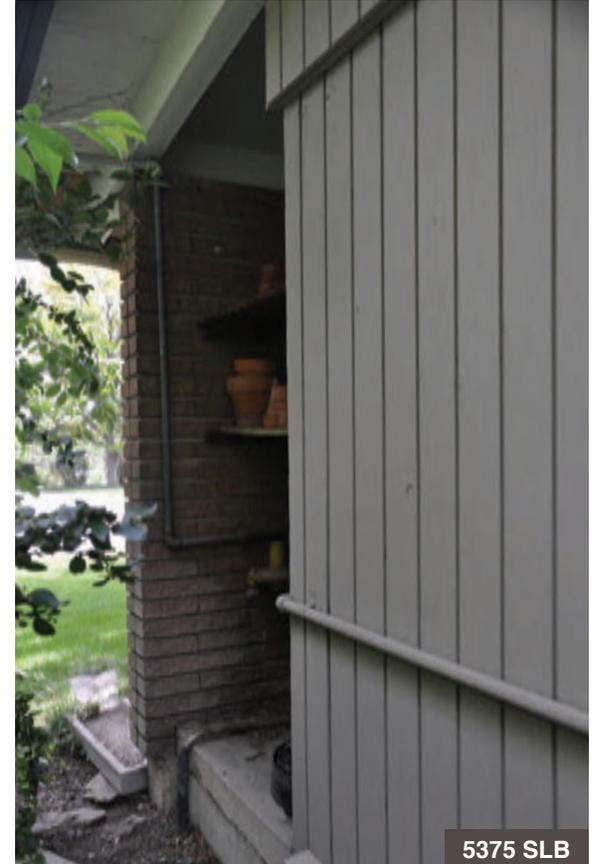
5375 SLB

Projecting walls sometimes serve utility purposes as well. This front wall extends beyond a recessed alcove that shelters the water meter.

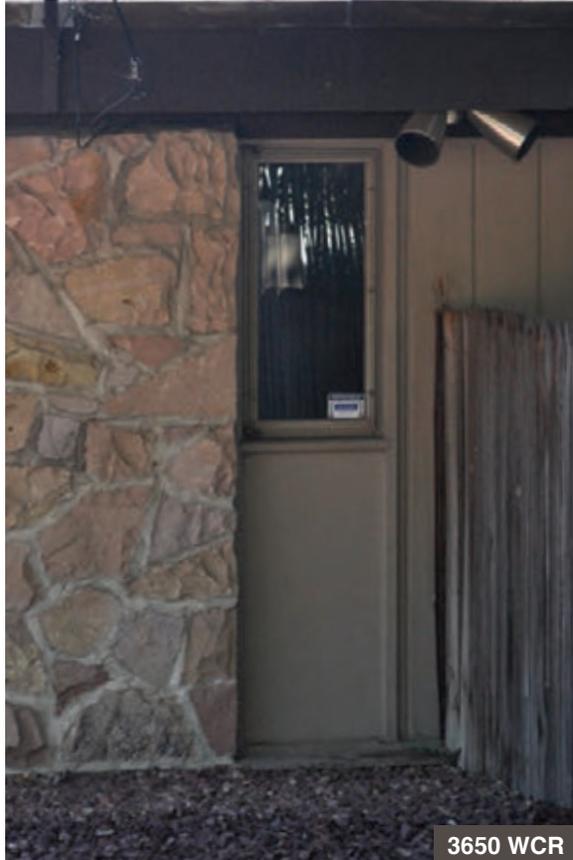
This simple vertical composition is an operable casement above a spandrel panel.

Casement sash are hinged on the left or right and swing outward. They are opened and closed by cranking a metal handle located on the interior frame. A metal latch operates the window lock. They have detachable window screens that install on the inside of the frame.

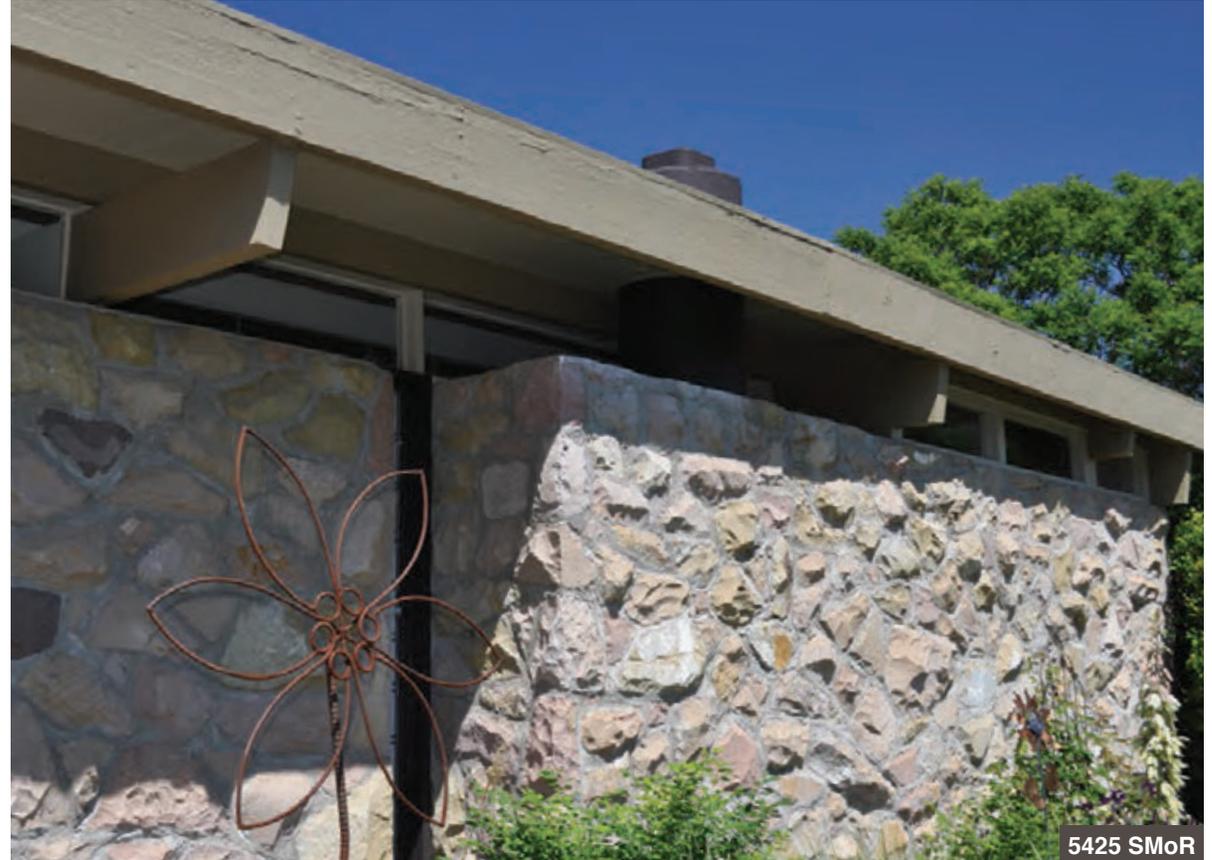
Horizontal and vertical window compositions appear on houses with flat roofs and the secondary elevations of those with front- or side-gable roofs.

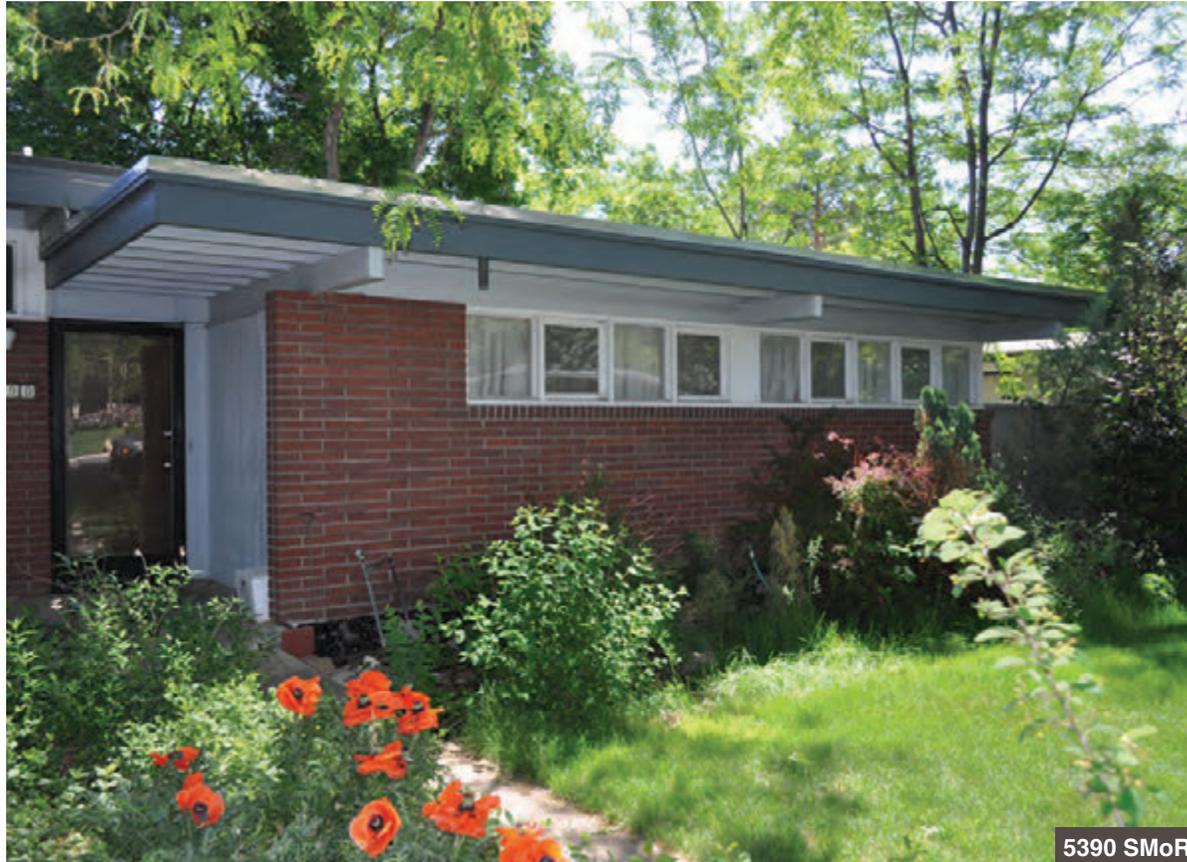
A horizontal window composition appears above a high sill, providing privacy to the rooms facing the street.

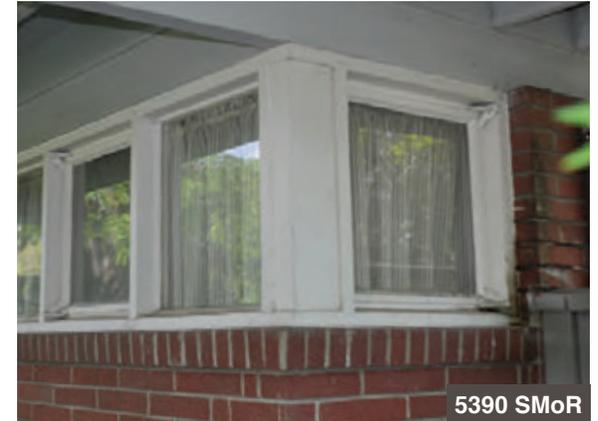
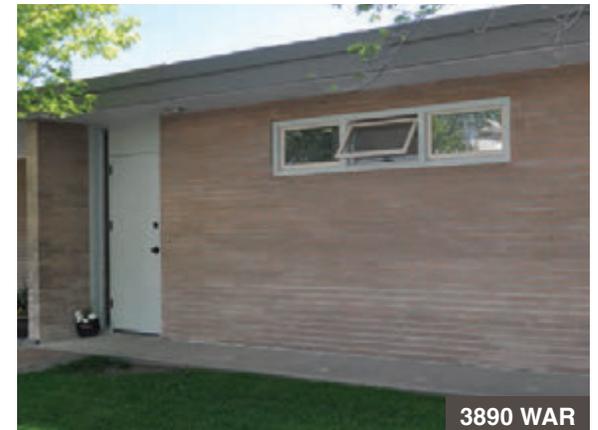
The same window composition extends around the corner of the house.

A row of operable awning windows is positioned within a masonry wall just below the roof line. Awning sash are hinged at the top and swing outward. Their hardware and interior screens resemble those of casements.

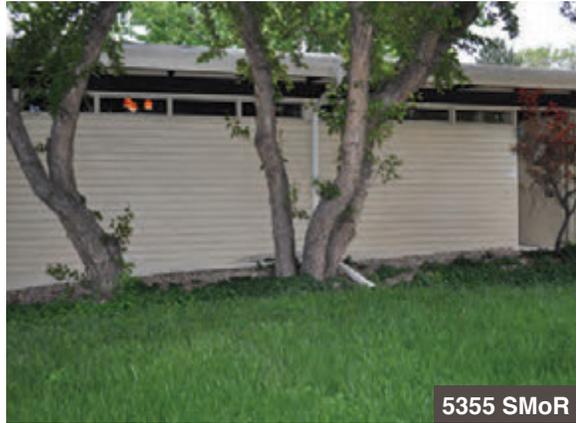
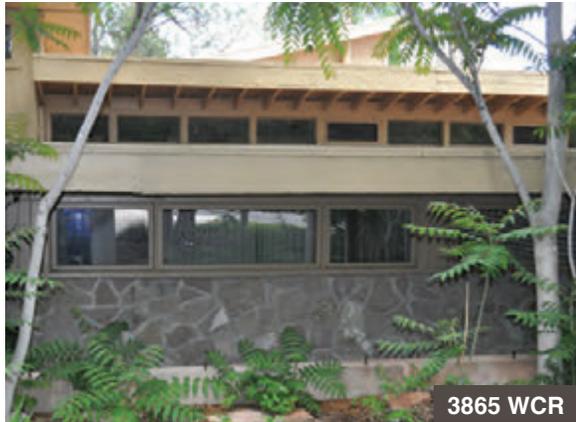
A long narrow window composition appears above a high masonry wall between exposed roof beams.

In the foreground of the photo below, a horizontal band of windows appears above a masonry wall. Above and behind, a narrow window composition appears beneath the overlapping opposing shed roof.

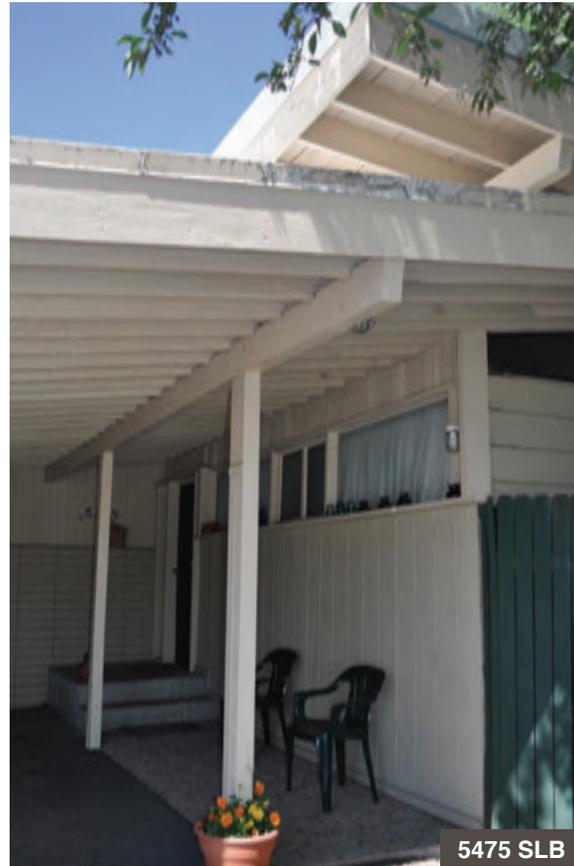
A horizontal band of fixed and operable windows appears on the interior wall of a carport.

Similar window compositions of varying heights appear in carports that shelter the main entrance to the house.

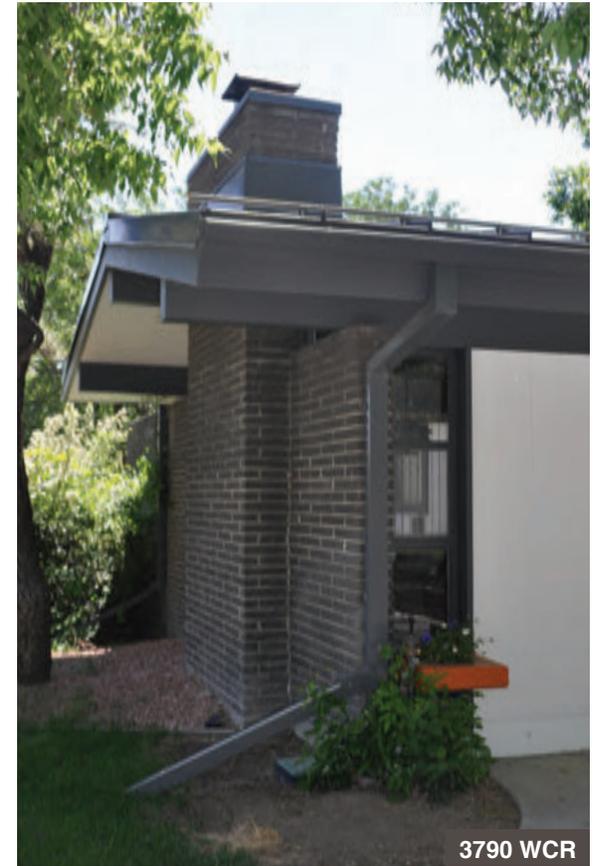
This corner window appears behind a projecting brick wall, flush with the adjacent wall of vertical wood siding.

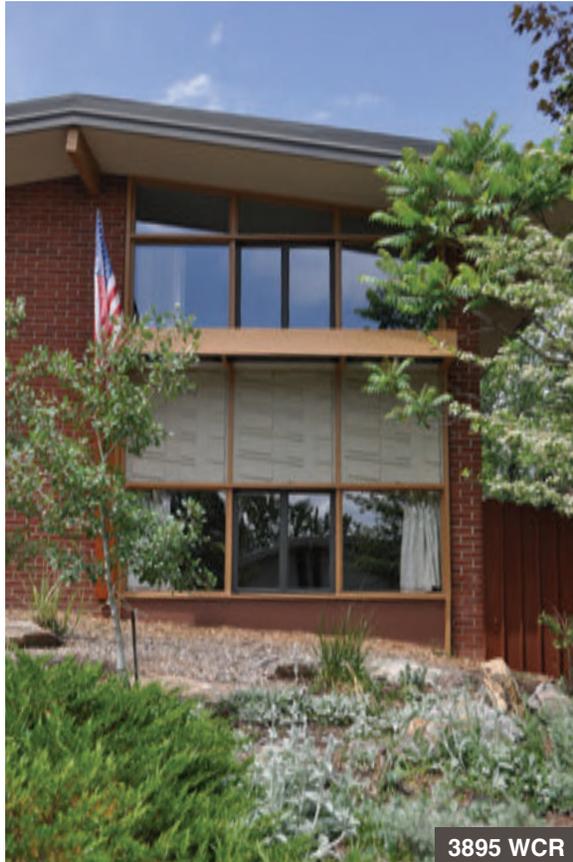
Spandrel panels are fixed solid panels of wood siding material that appear above, between or below vertically stacked windows.

These spandrel panels have a simple decorative geometric pattern.

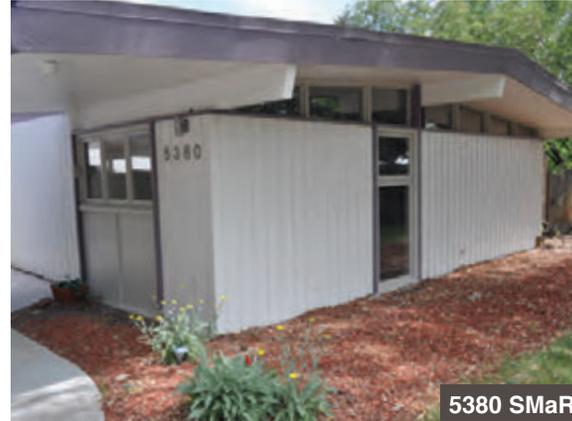
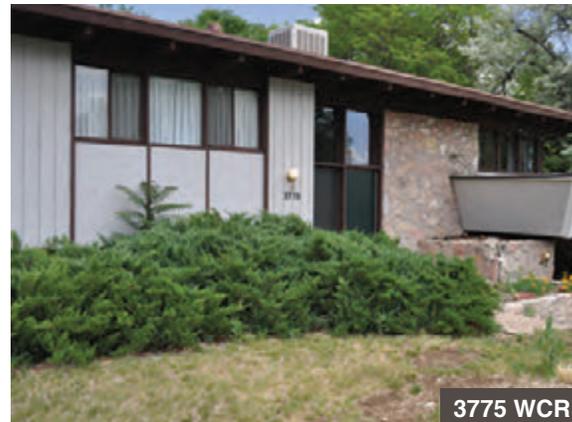
Spandrel panels appear below a row of windows within an open carport.

Here they appear between an upper band of windows and one just above grade, hidden behind the shrubbery.

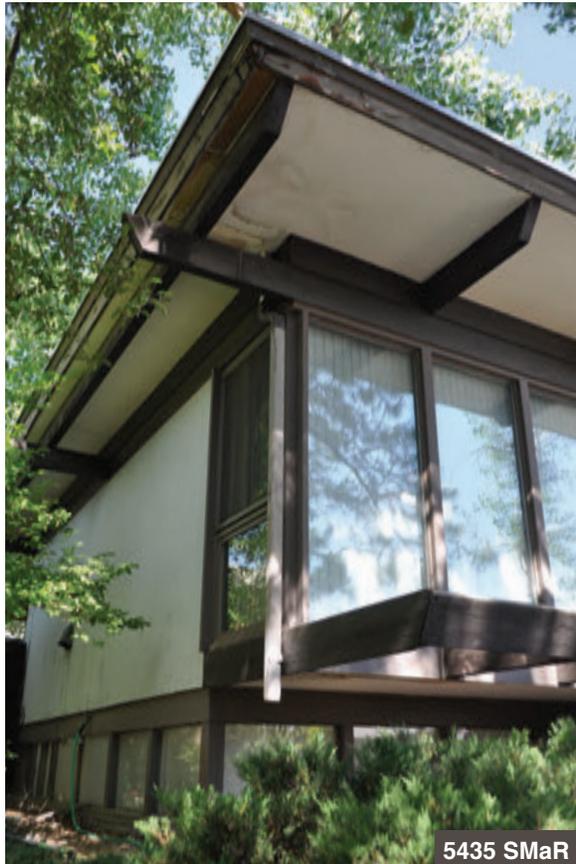
A full-height window composition appears at the upper level, wrapping around to the side elevation.

At the lower level, just above grade, a long horizontal window composition completely wraps the southwest corner of the house.

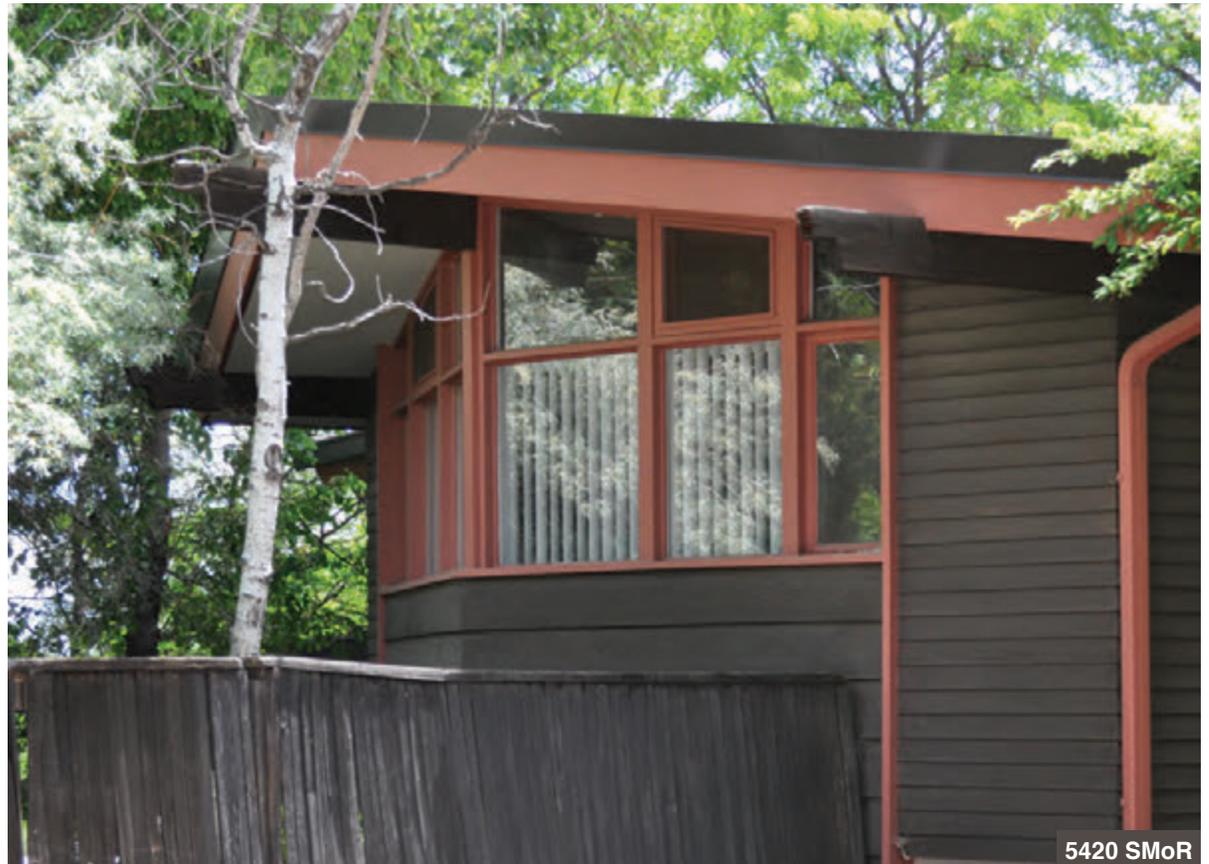
This window composition follows the angle of the polygonal primary volume that forms the body of the house. Above, the side-gable roof extends to shelter the window.

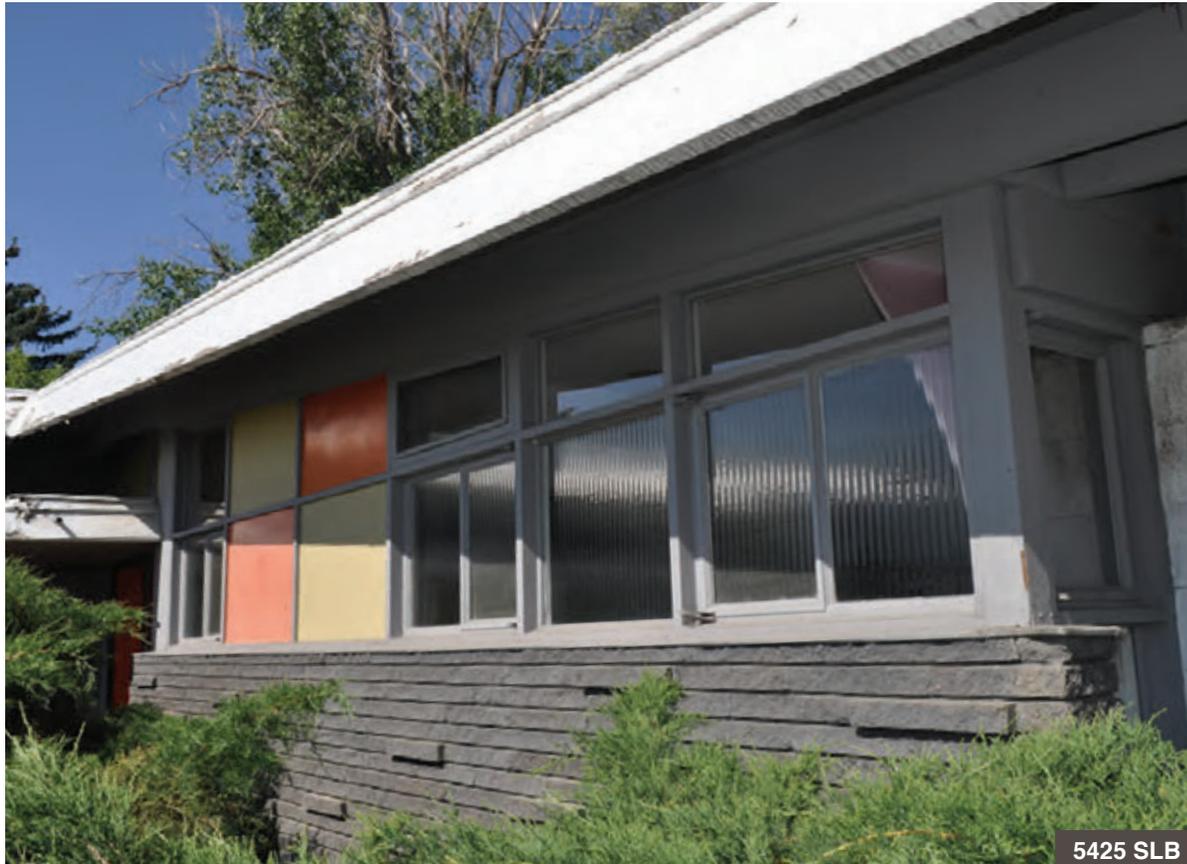
Blind windows are fixed solid panels of wood siding material that appear within horizontal window compositions.

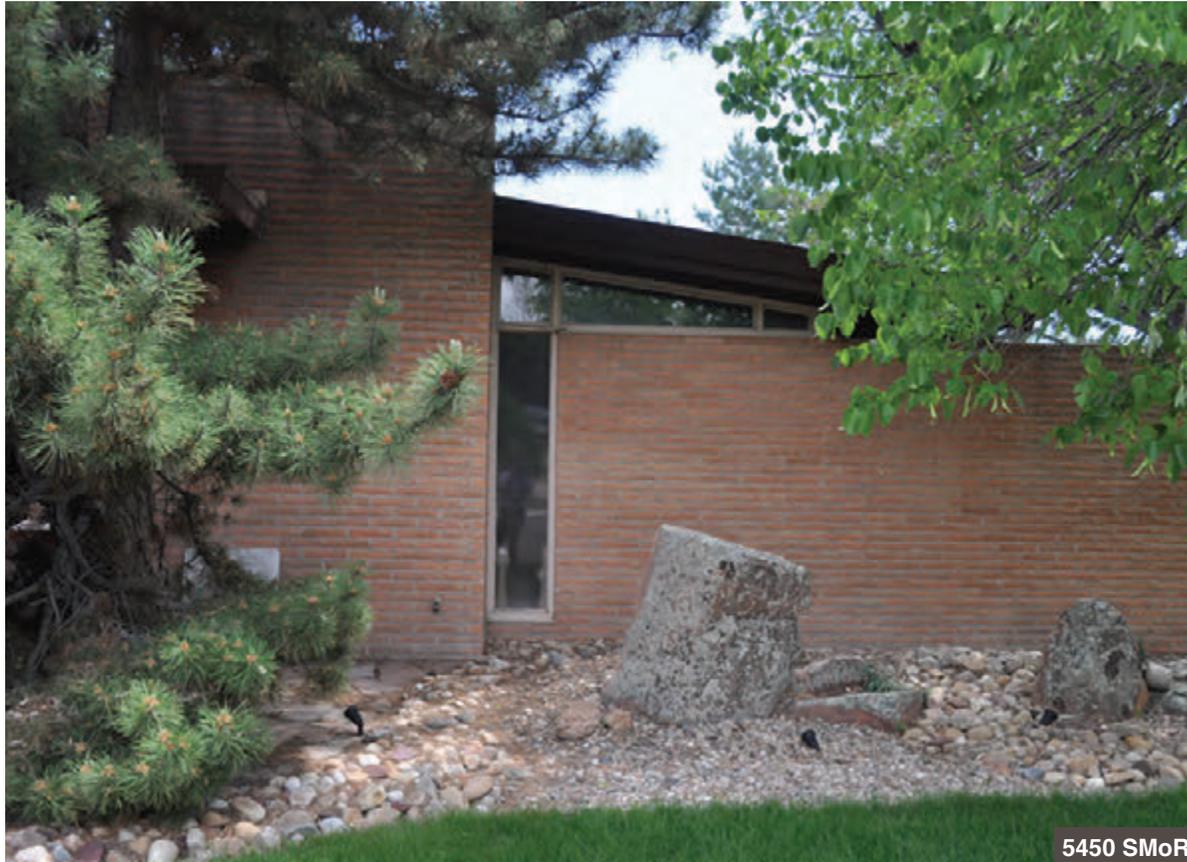
This composition includes a full-height fixed vertical pane that rises to a row of windows below the low-pitch front-gable roof.

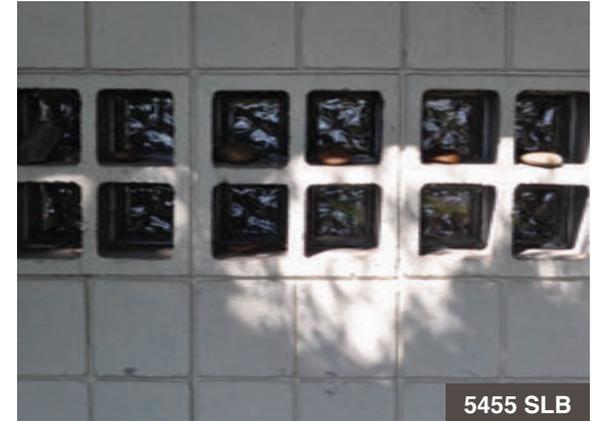
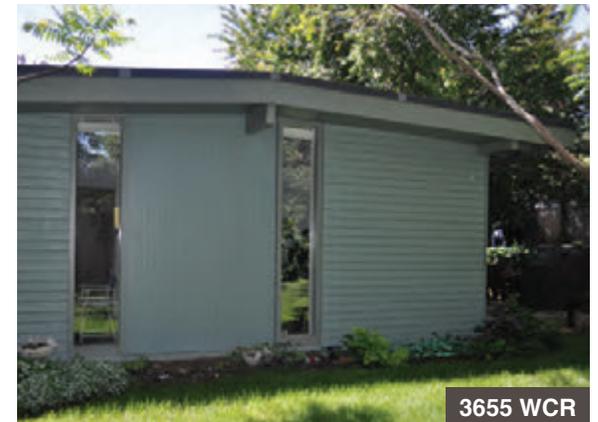
Glass block appears occasionally. Here it's inserted in the openings of a patterned concrete block.

Two full height windows flank a large panel of vertical siding. On either side, concrete block appears.

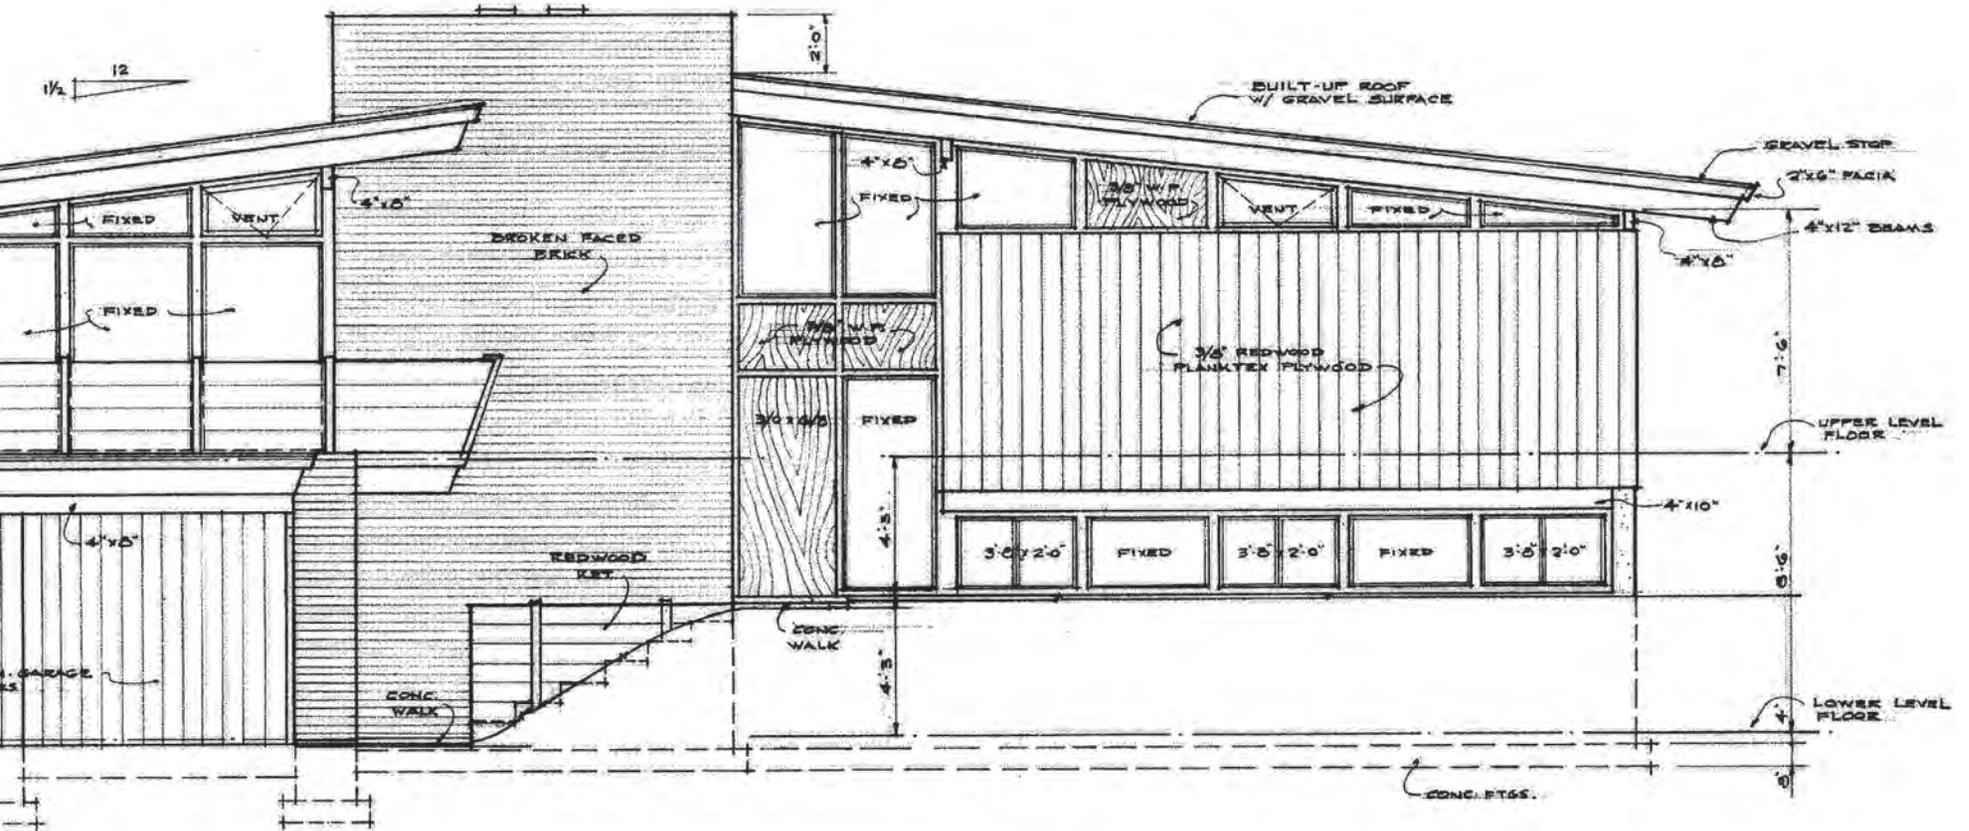
EAST ELEVATION

Bruce Sutherland's architectural design for 5445 South Manitou Road c1963 (drawings undated). Drawings courtesy the Arapaho Hills Archive.

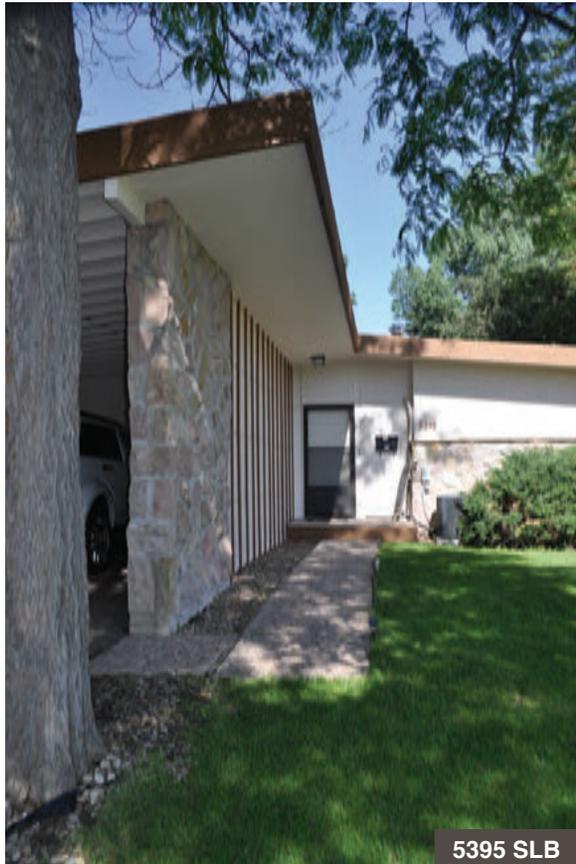
This entrance is located at the juncture of the projecting carport and the body of the house. The vertical wood siding detail beside the walkway creates a sense of entry.

The primary entrance door appears at left, with a service or utility door of equal size to the right. Above both doors are transom panels of pegboard.

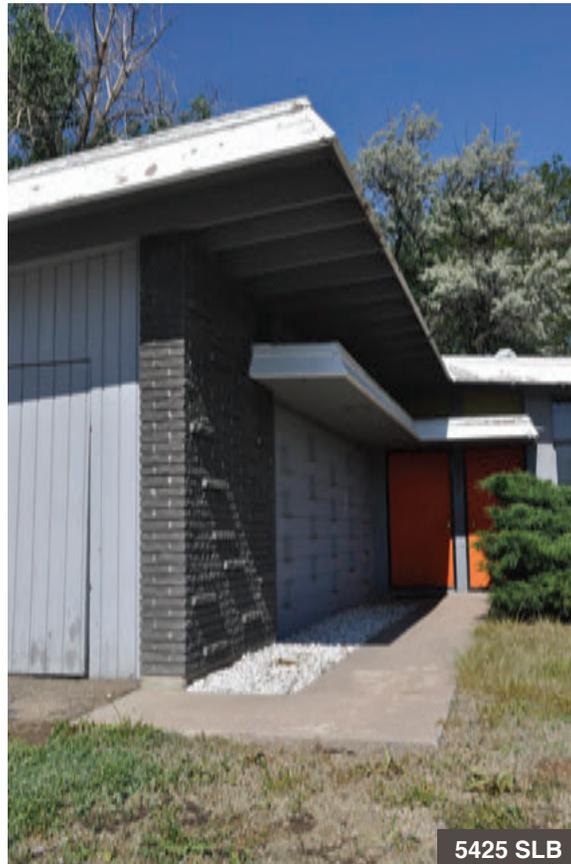
A narrow roof-form shelters this entry walk. The fascia is detailed to match the roof above except the soffit, which is closed and incorporates recessed lighting.

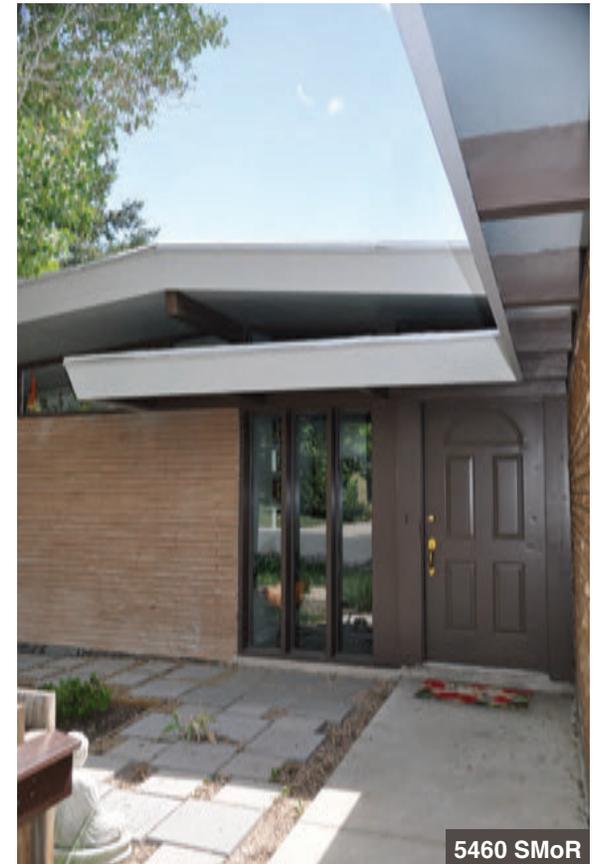
A similar detail appears on this home.

The roof-form extends further onto the face of the house, where the entrance includes three vertical sidelights.

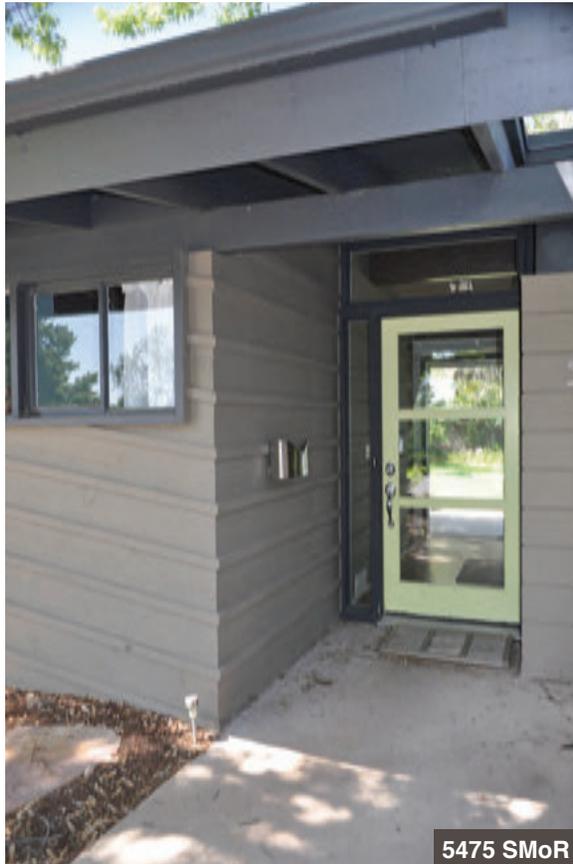
5475 S MoR

This entrance has a door with a narrow side-light and transom window above. The roof plane shelters the entry, then opens to light the adjoining entrance courtyard.

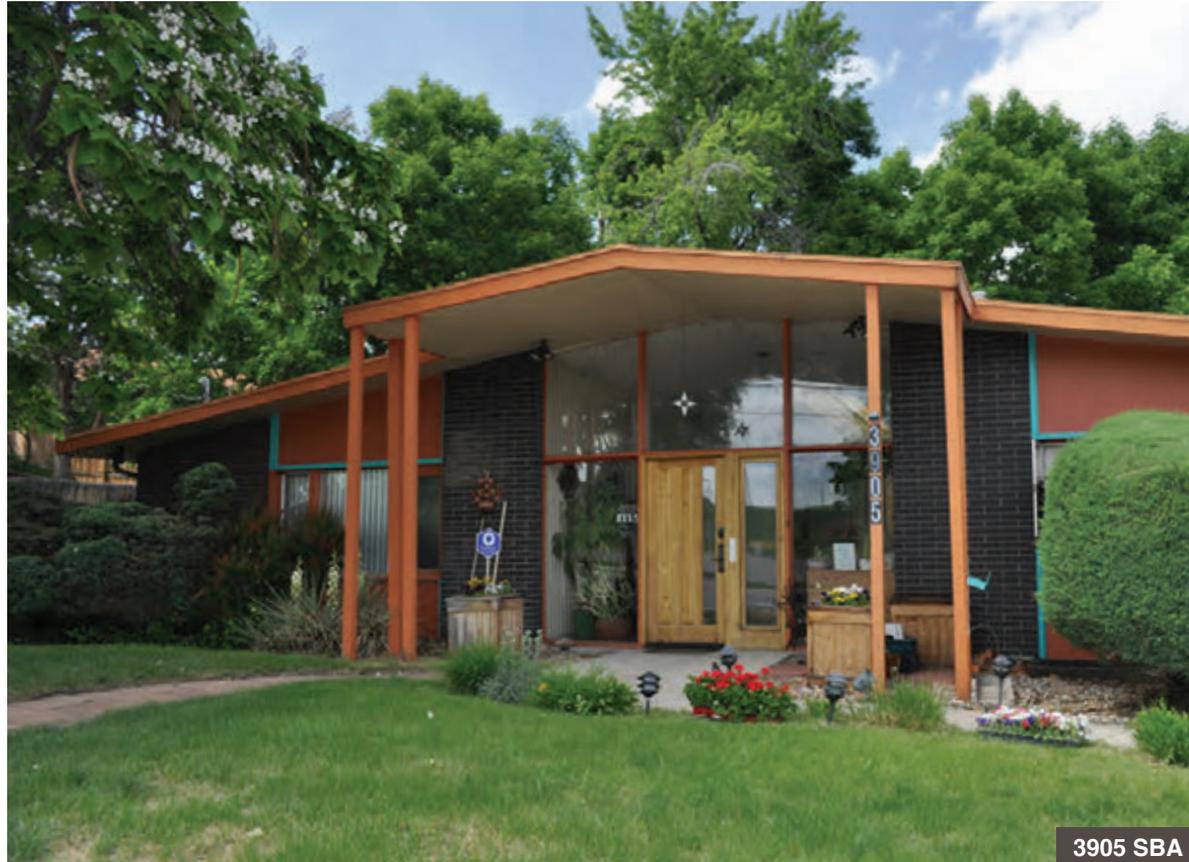
3905 SBA

This roof plane extends beyond the body of the house to shelter a large entry with a full-height entrance composition.

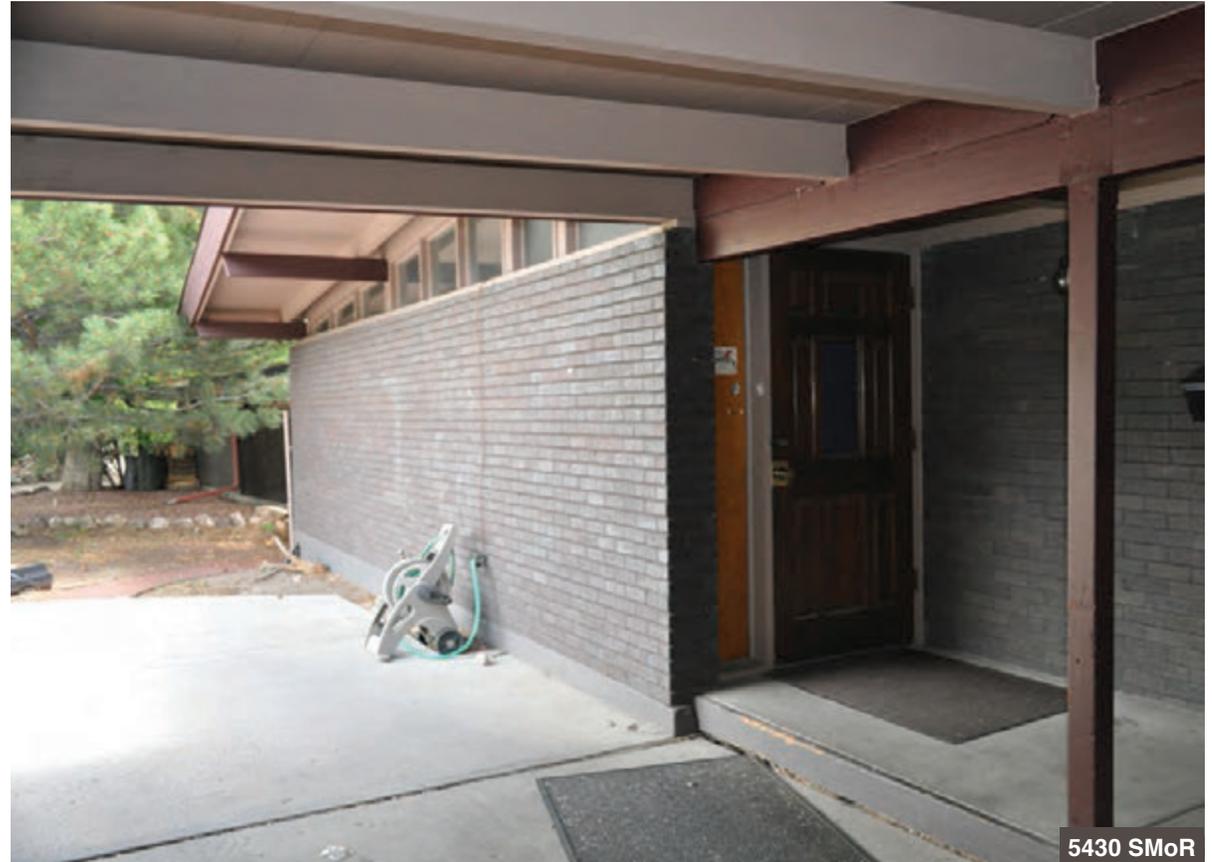
This simple entrance is positioned perpendicular to the front wall of the house, just inside the entrance of a two-car carport.

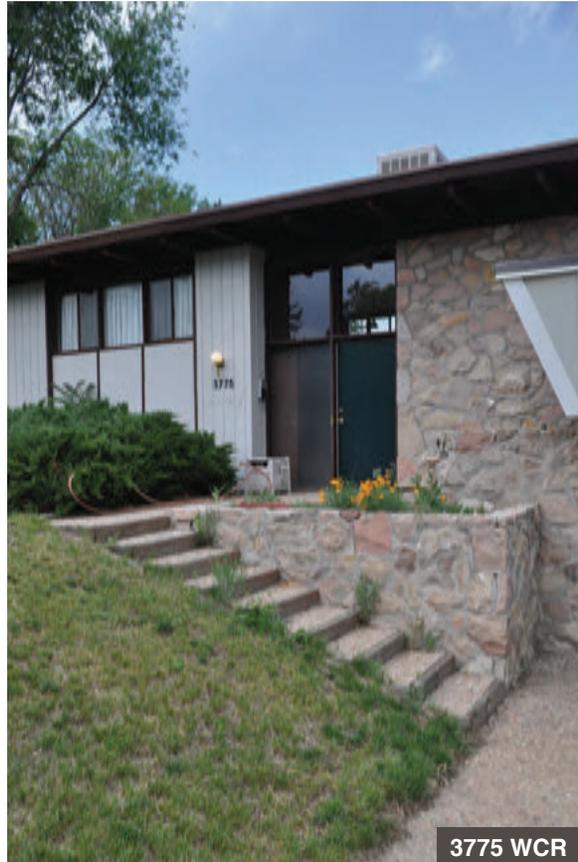
Entrance compositions are often related to secondary volumes. Here, an entry stair rises beside a prominent masonry planter box, positioned asymmetrically on the face of the chimney. The entry is positioned flush with the chimney.

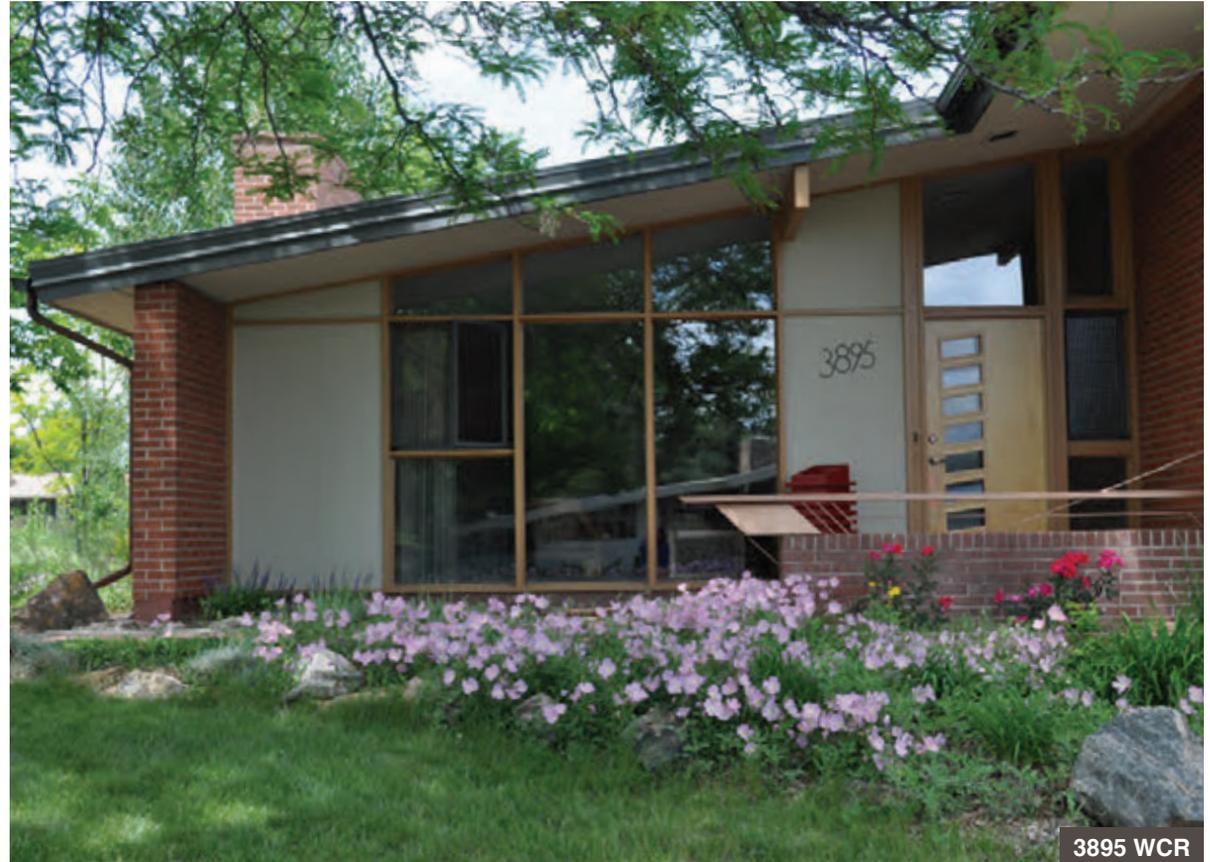
This large entrance and window composition merge to form an entire wall sheltered by projecting roof and wall planes.

Blind and transparent windows match the height of the door, an upper row rising into the front-gable roof. The door is reached by a walkway across the face of the house. Two stacked translucent windows form the sidelight of the door, with transom windows above.

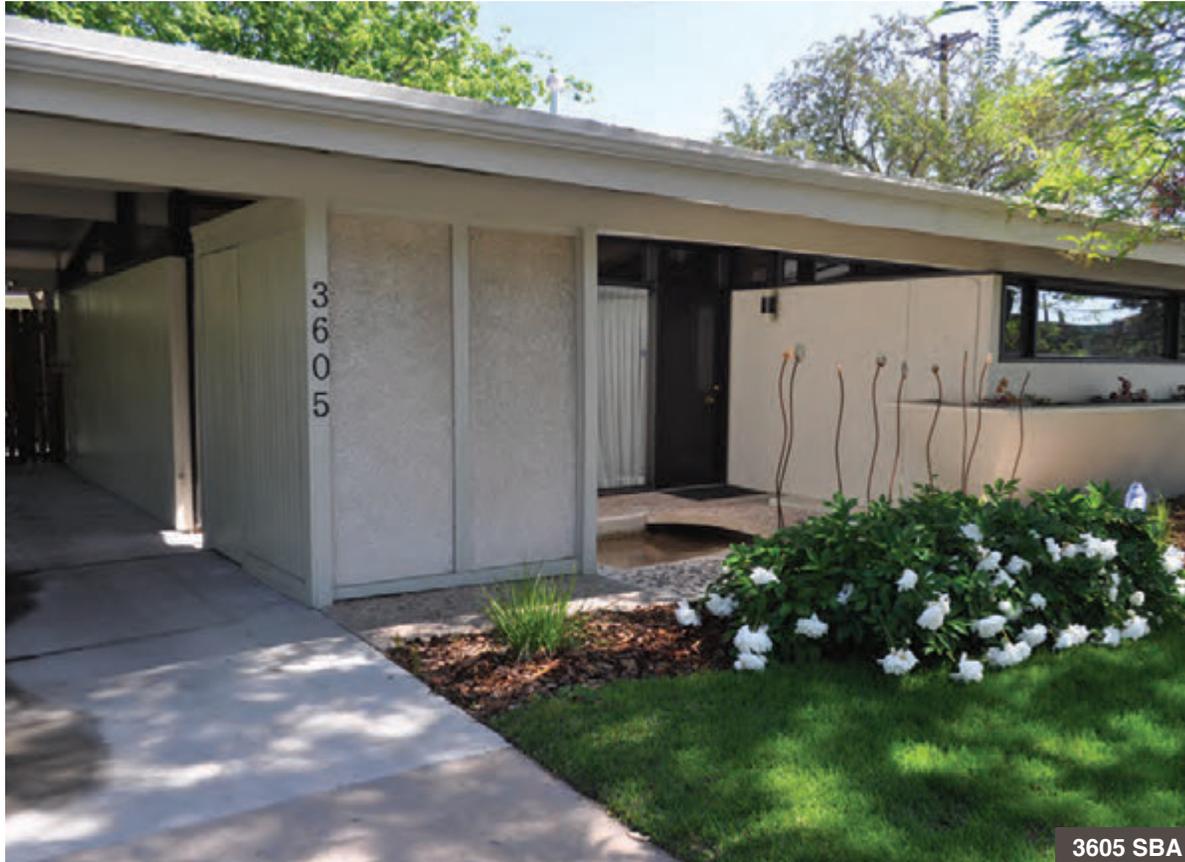
3605 SBA

This open entry court is recessed between the carport storage unit and the main body of the house, to the right.

From the carport, a service sidewalk leads behind the storage unit to the front door.

From the driveway, the formal entry walk leads in front of the storage unit to a small arched bridge over a shallow pool.

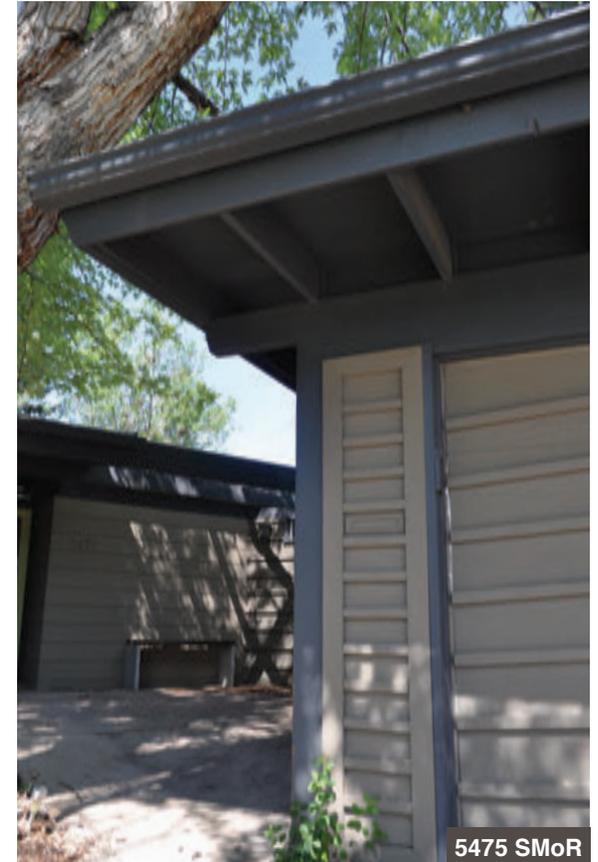
5475 SMoR

Located in a small open courtyard at the juncture of the house and garage, this entrance is partially concealed from the street.
