MILE HIGH PHOTO - DENVER

**Prepared for the City of Littleton
Office of Community Development**

BRIEF HISTORY / ARAPAHO HILLS

PROPOSED NATIONAL REGISTER HISTORIC DISTRICT / ARAPAHO HILLS

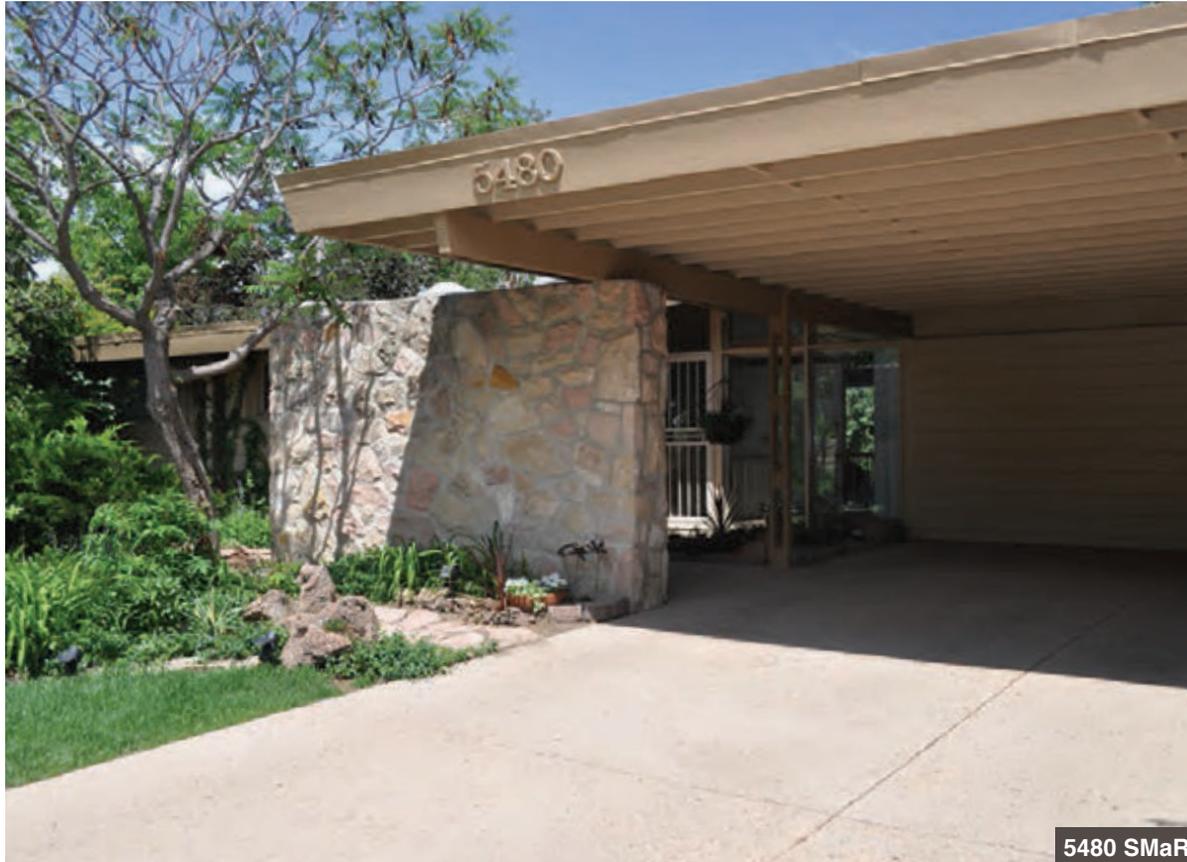
The masonry wall that carries this carport roof also defines an open courtyard behind, at the primary entrance to the house.

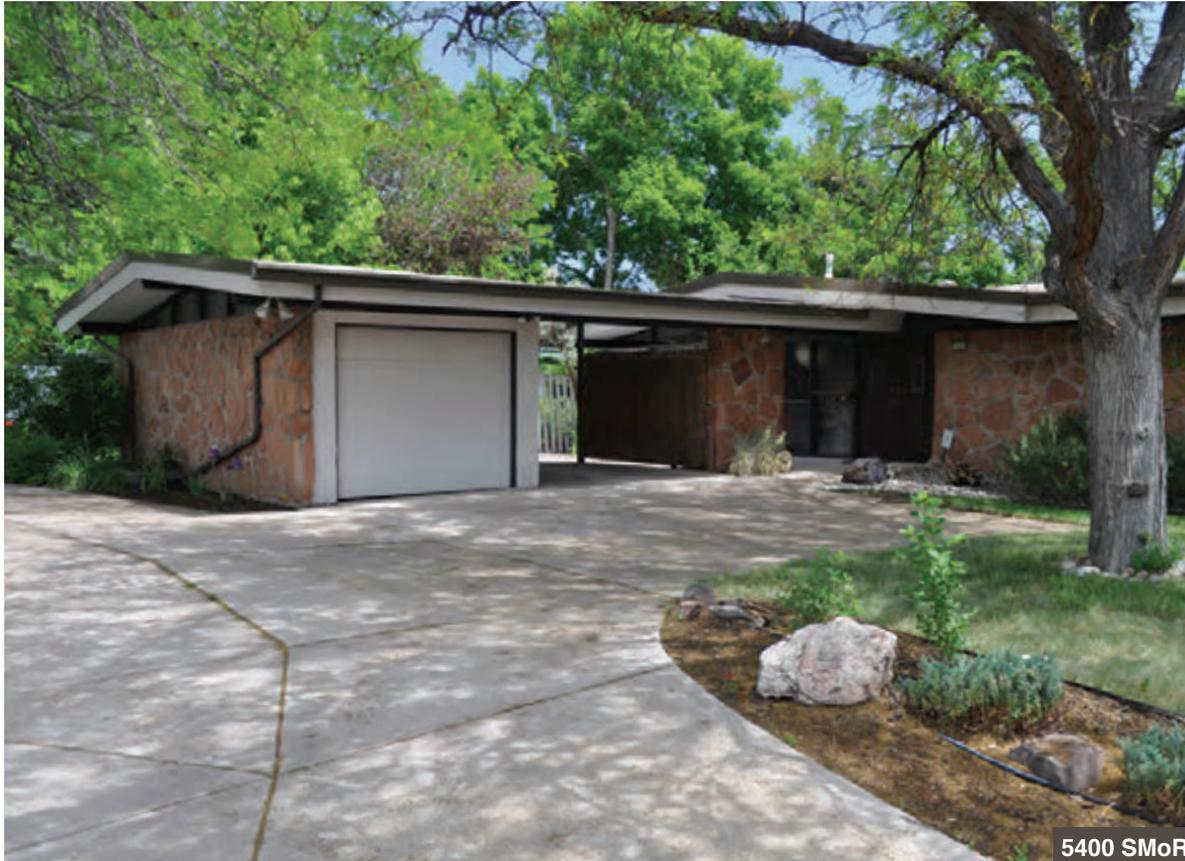
5400 SMoR

This entrance is located on the face of the house, sheltered below a roof plane that projects outward over a one-car carport and one-car garage.

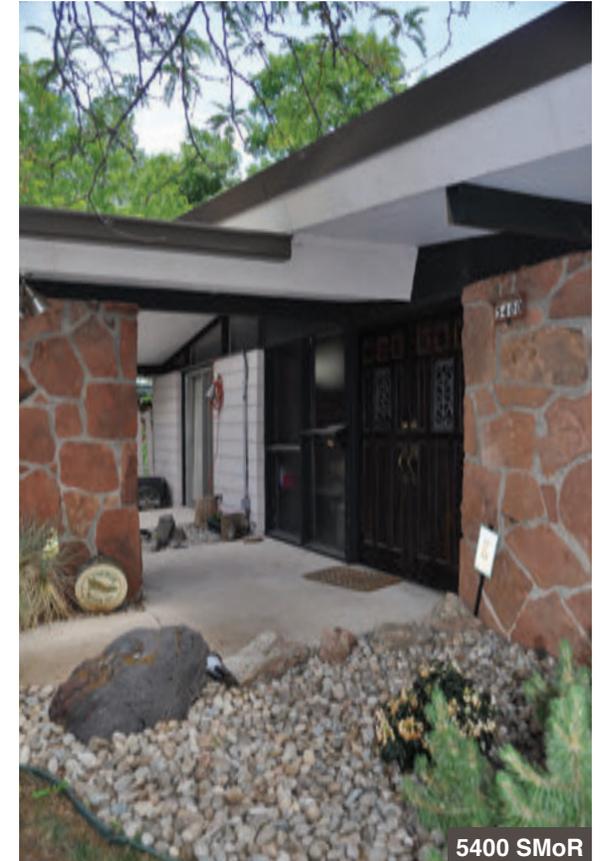
5400 SMoR

The main entrance includes a pair of double doors with two translucent sidelights.

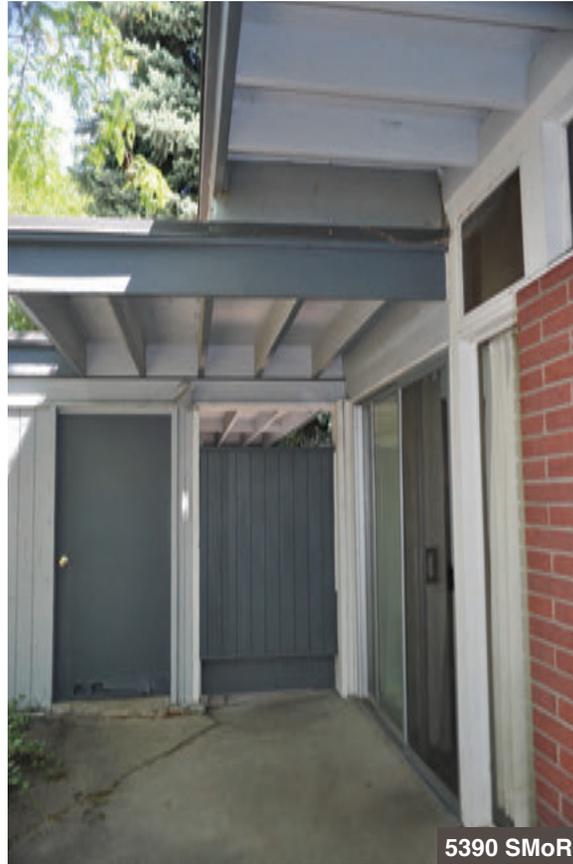
5390 SMoR

A secondary entrance to the garage and a formal gate to the side yard appear in this patio area in front of the house.

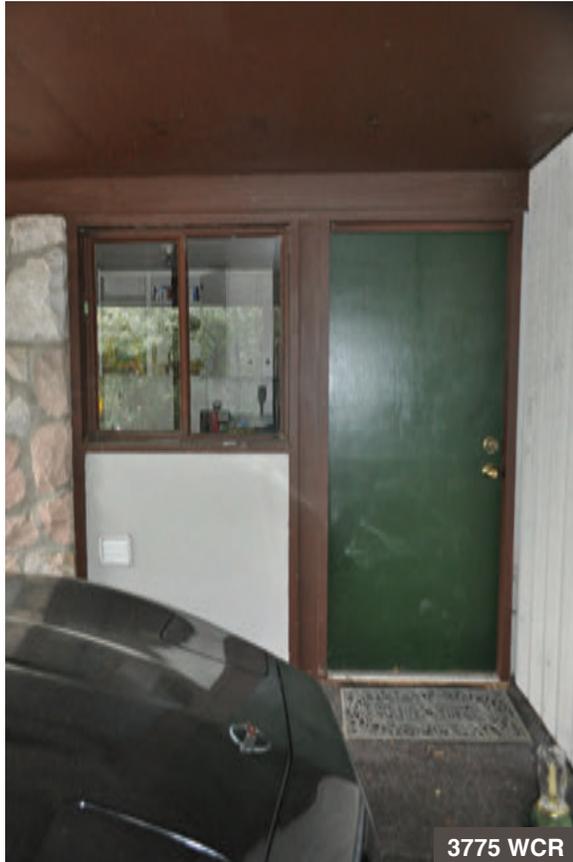
3775 WCR

The main living area of this house cantilevers over the carport. In the back corner of the carport, a secondary entrance appears beside a pair of windows above a spandrel panel.

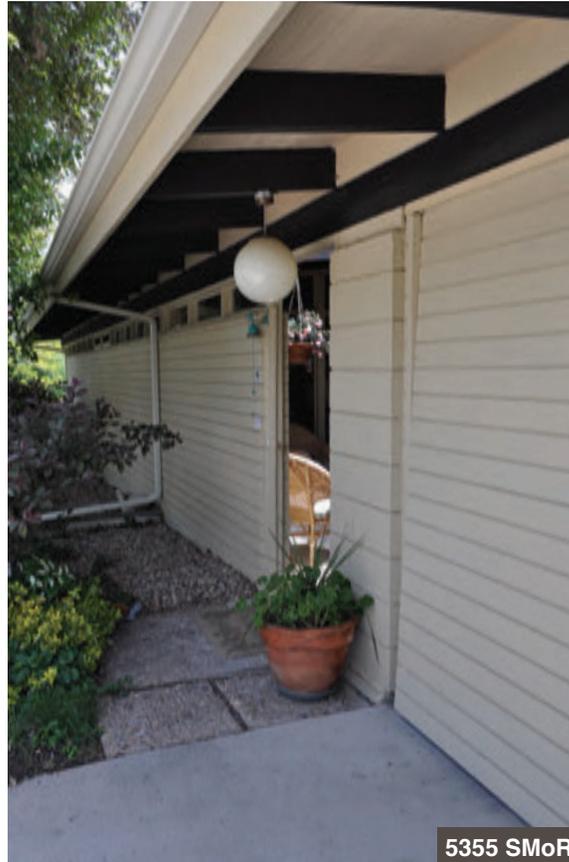
5355 SMoR

On the side elevation of the house, this secondary door provides egress to a breezeway between the house and garage. A pedestrian door into the garage appears inside the breezeway.

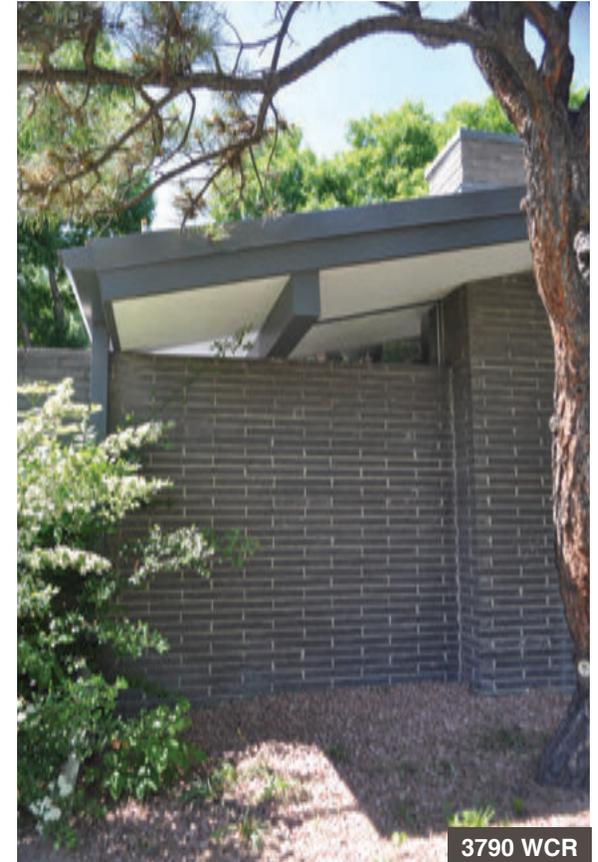
3790 WCR

Set back behind the chimney and a projecting wall plane, a secondary door from the house leads into a small concealed outdoor patio.

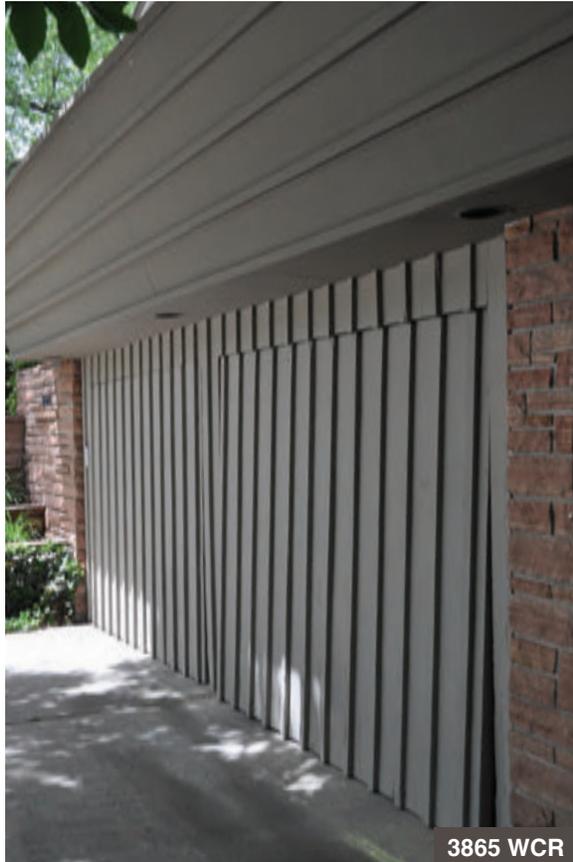
Garage doors were finished with the same siding materials as the surrounding wall. When closed, the garage wall and doors create a visually seamless surface.

Each door is a single panel, even on two-car garages. They pivot upward to open.

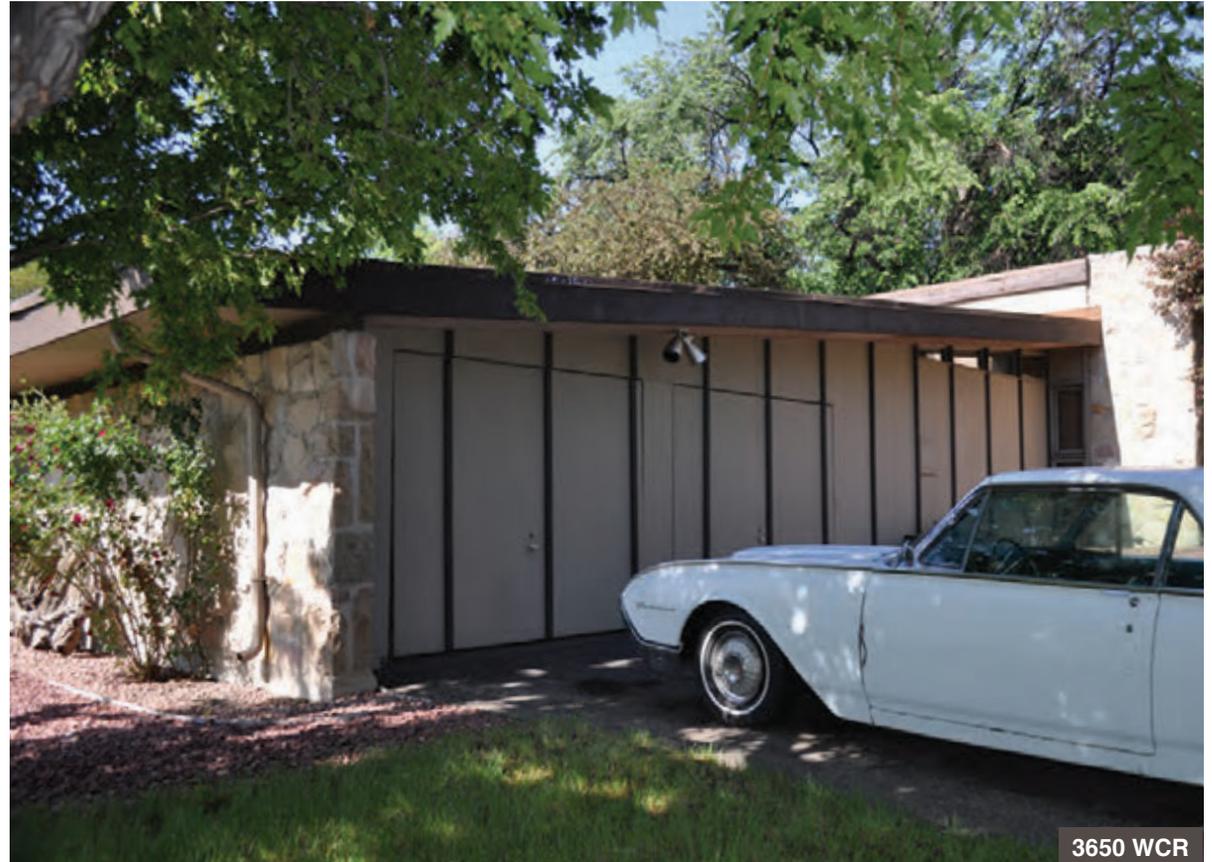
These garage doors are faced with the same board-and-batten siding as the wall.

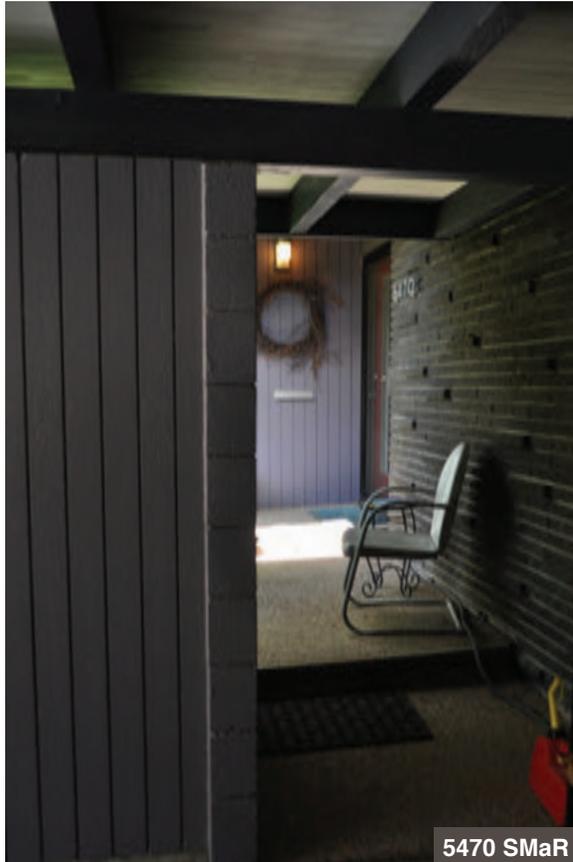
5470 SMaR

Open passageways also provide egress between carports, garages and the primary entrance to the house.

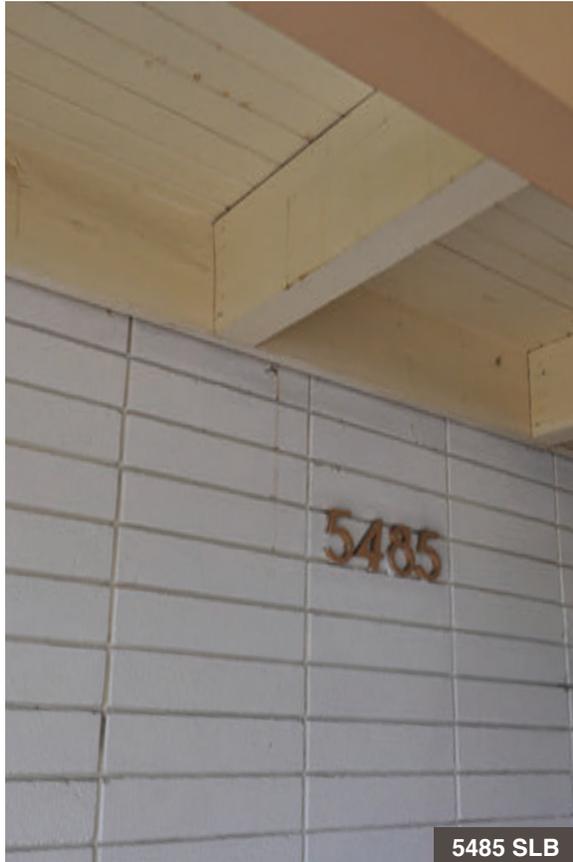
A variety of smaller original features appear in conjunction with entrances.

These original street numbers, routed from wood, are directly attached to a concrete block wall adjacent to a recessed carport entry.

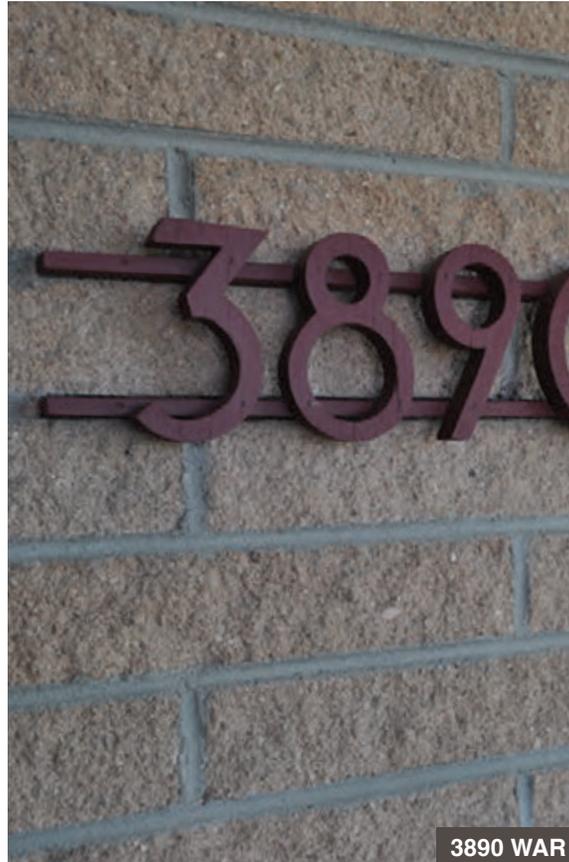
Similar wood numbers are secured to narrow strips of wood and fitted into deeply raked mortar joints.

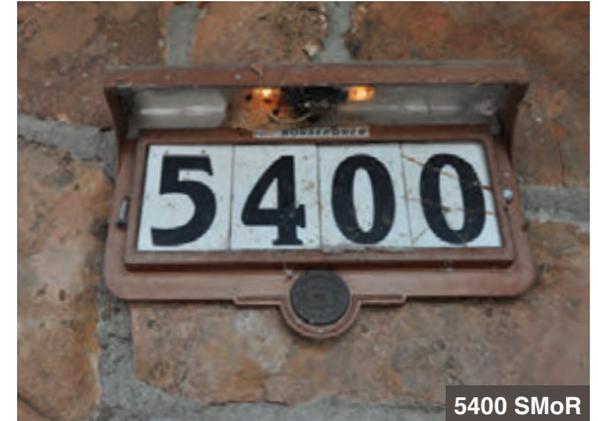
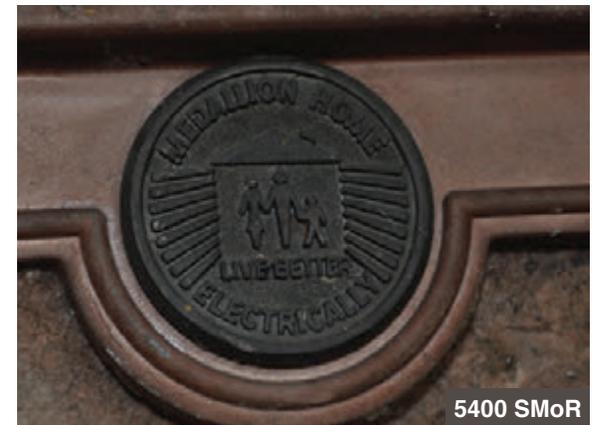
This porch light with street number was part of a Colorado Central Power Company promotion of new applications for electricity in post-war houses.

It reads "Medallion Home" and "Live Better Electrically," picturing a man, woman and child holding hands within radiating rays of electrical power.

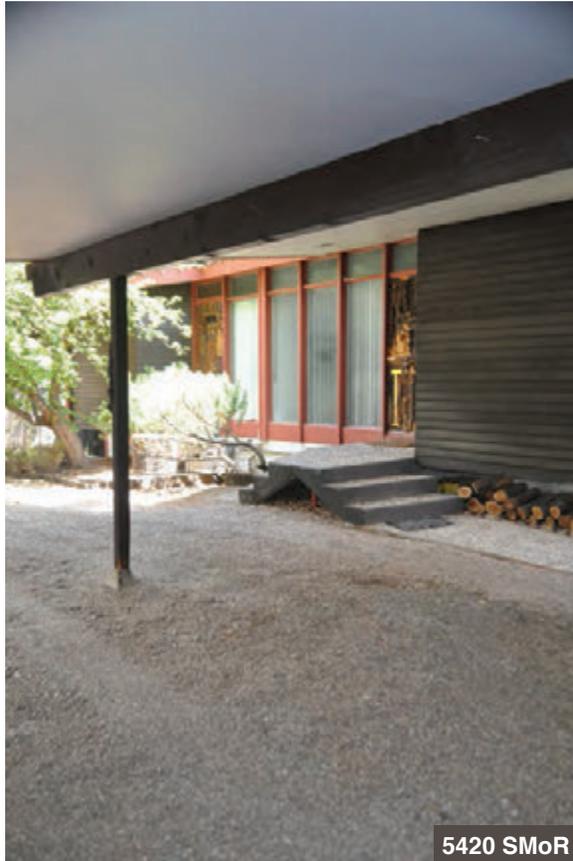
An entrance door adjacent to a carport opening features shallow collages of found objects that may have been salvaged from mountain ghost towns by the original owners.

A similar panel is applied to the blind window on the far side of the entrance composition at left.

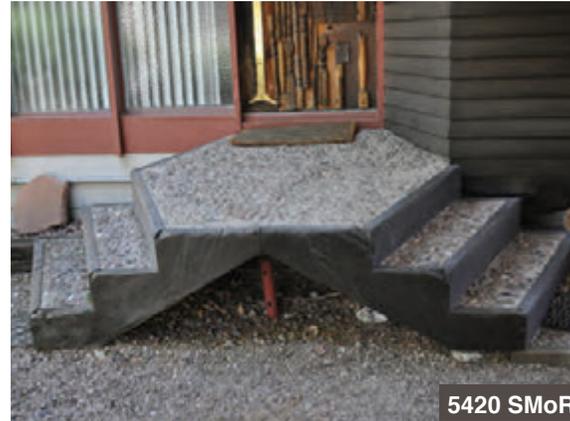
The same primary entrance features this unique two-sided step of exposed concrete aggregate. The open triangle on the face of the step echoes other triangular decorative motifs that appear on the house.

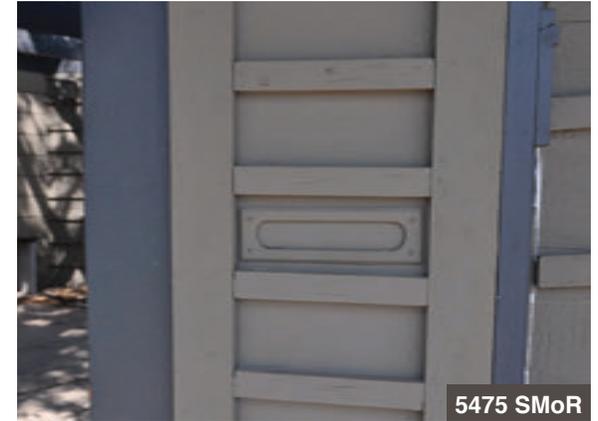
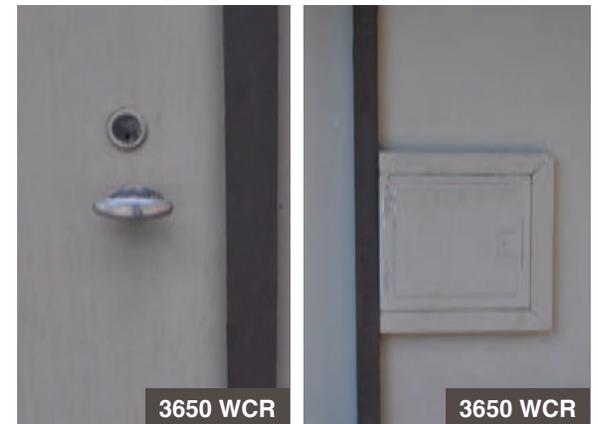
Mail slots are often integrated into walls near entrances.

Original door handles and locks, like this garage hardware, can be identified.

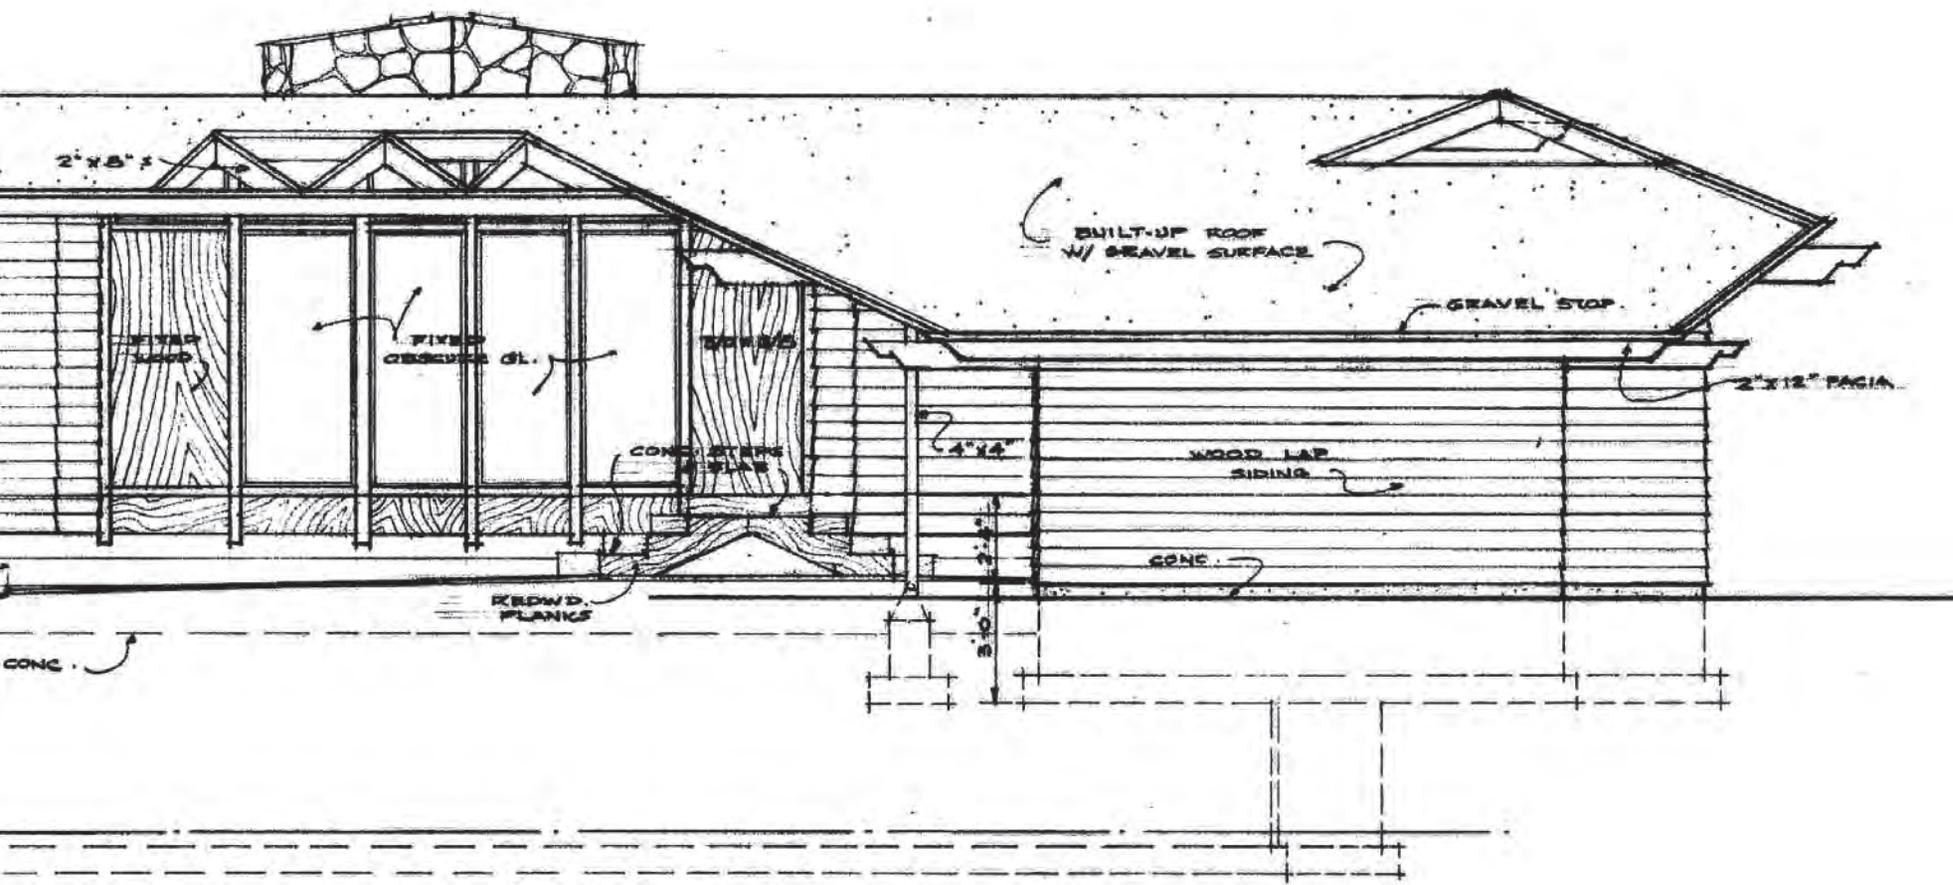
WEST ELEVATION

Bruce Sutherland's architectural design for 5420 South Mohawk Road dated March 12, 1960. Drawings courtesy the Arapaho Hills Archive.

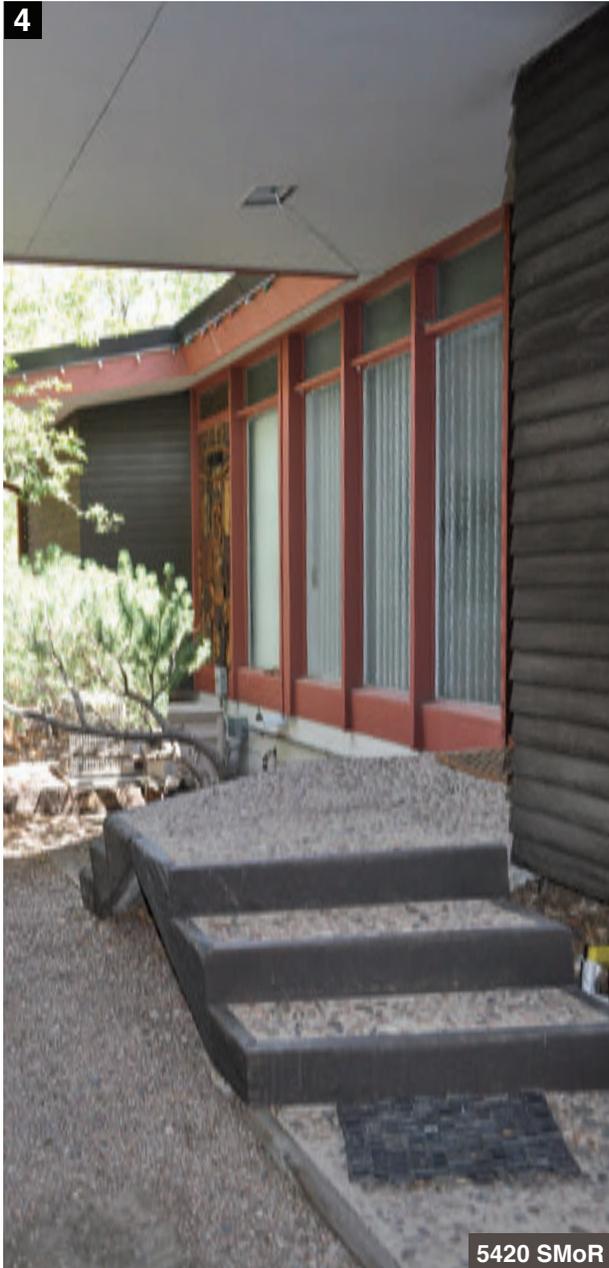
4 The original plans show an open roof plane above this front window composition, forming a sunscreen of three triangular openings

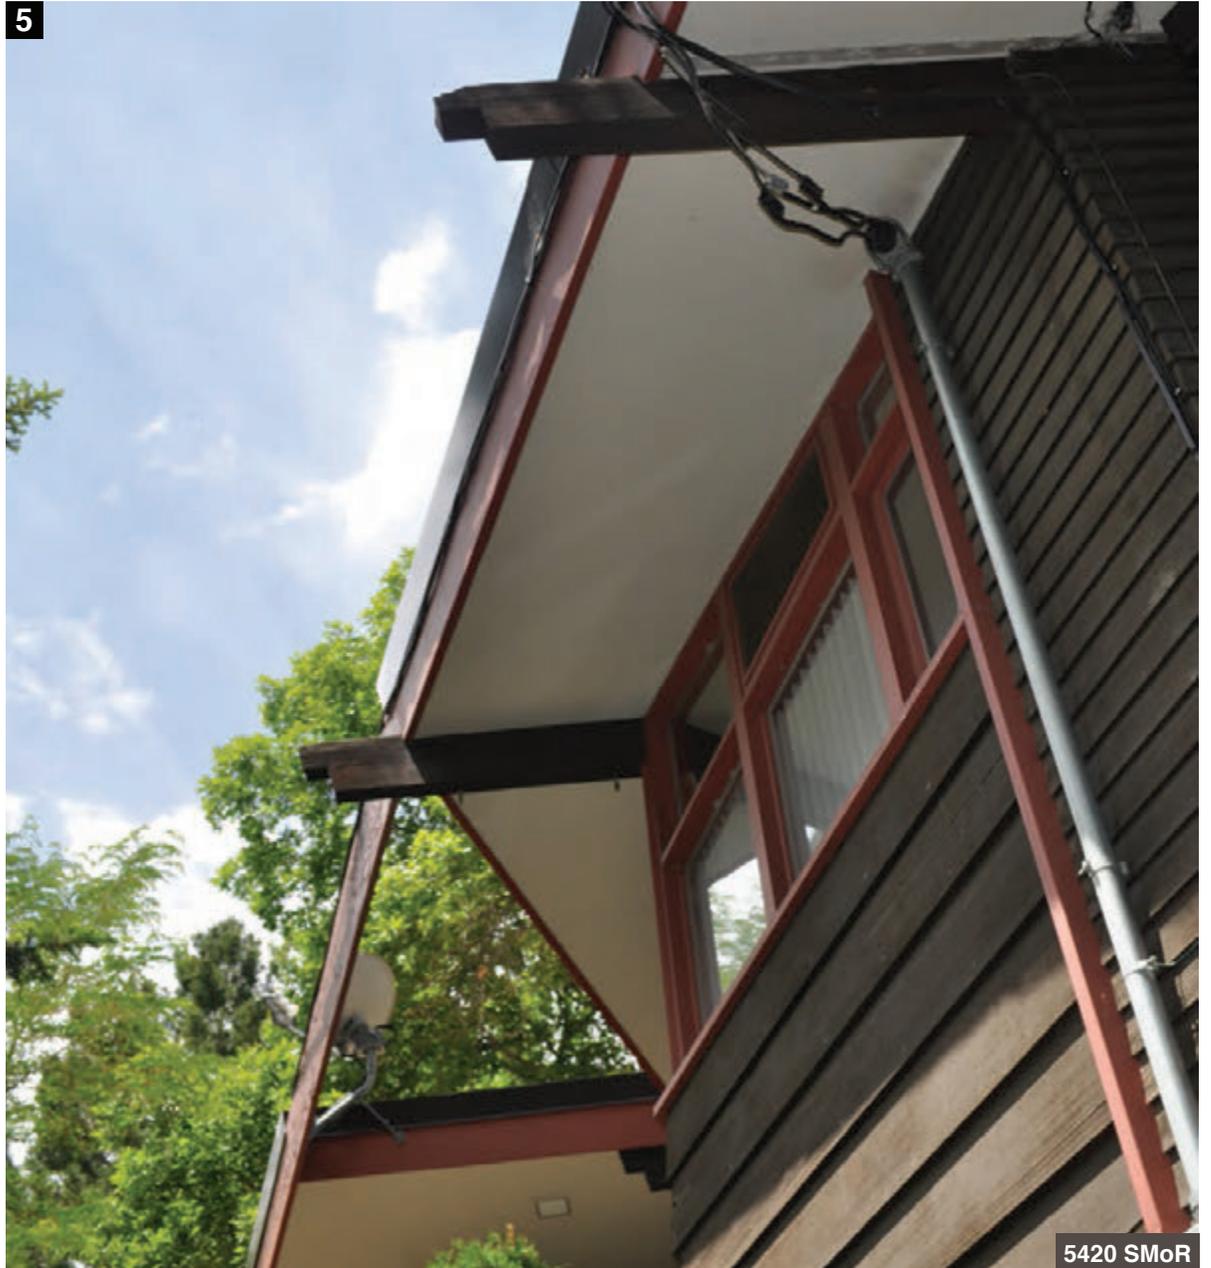
5 The fascia of the house extends to join the carport roof at the southwest corner of the house, creating a triangular opening to the sky.

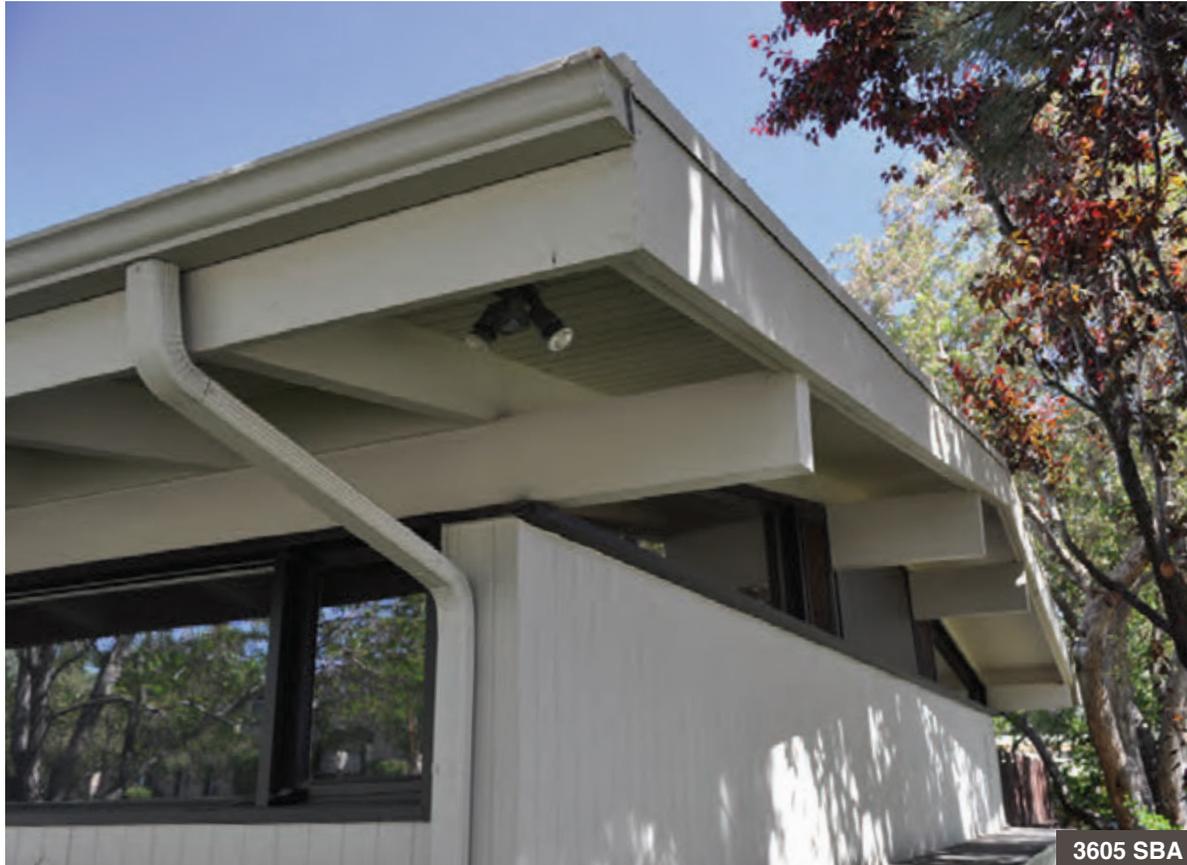
The fascia is the vertical board attached to the edge of the roof plane. Here, it's positioned parallel to the wall plane below.

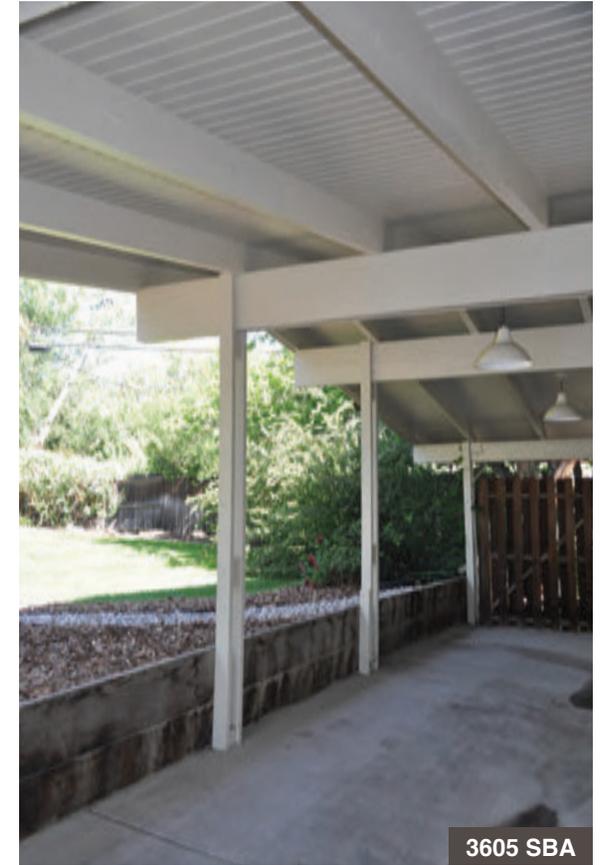
In addition to the eaves around the body of the house, the roof structure is also expressed within carports.

Wood columns form the open side wall of the carport, carrying the exposed beams.

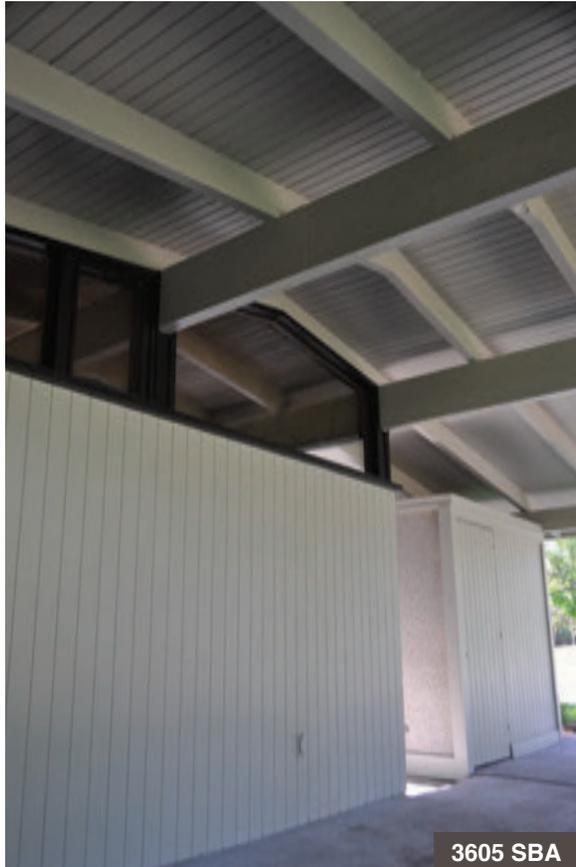
3605 SBA

The open beams and rafters continue into the interior of the house as well, visible above through the window composition at the roofline.

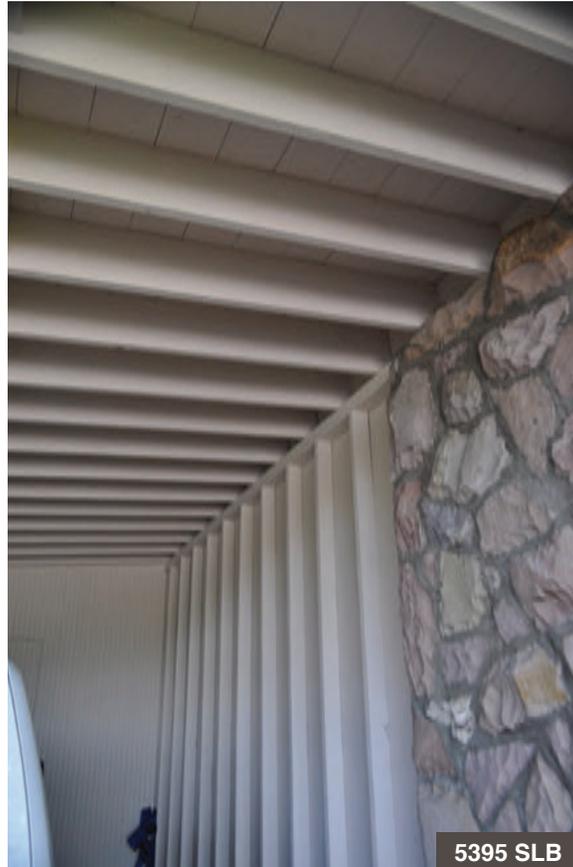
5395 SLB

On the interior of this carport, the exposed rafters align with the battens of the adjacent vertical board-and-batten wood siding.

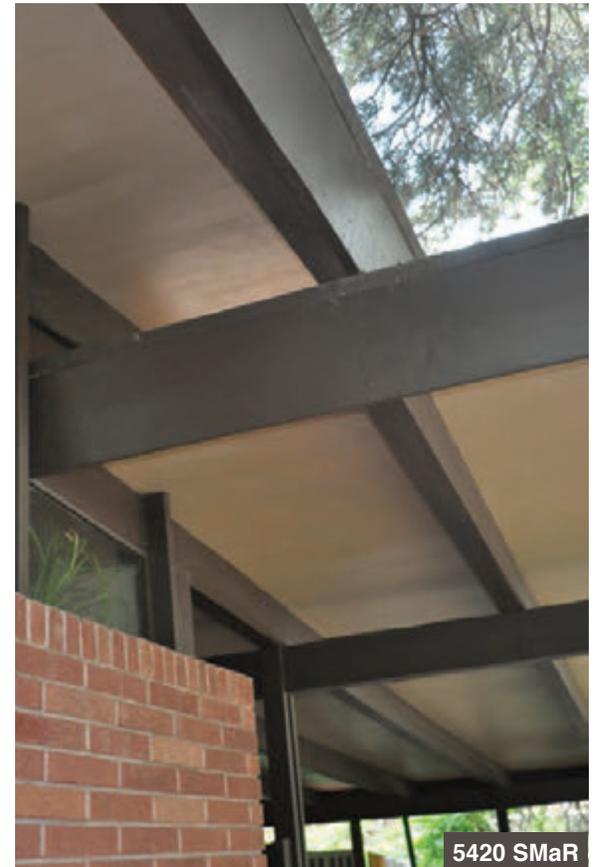
5420 SMaR

These overlapping house and carport roofs both feature exposed beams.

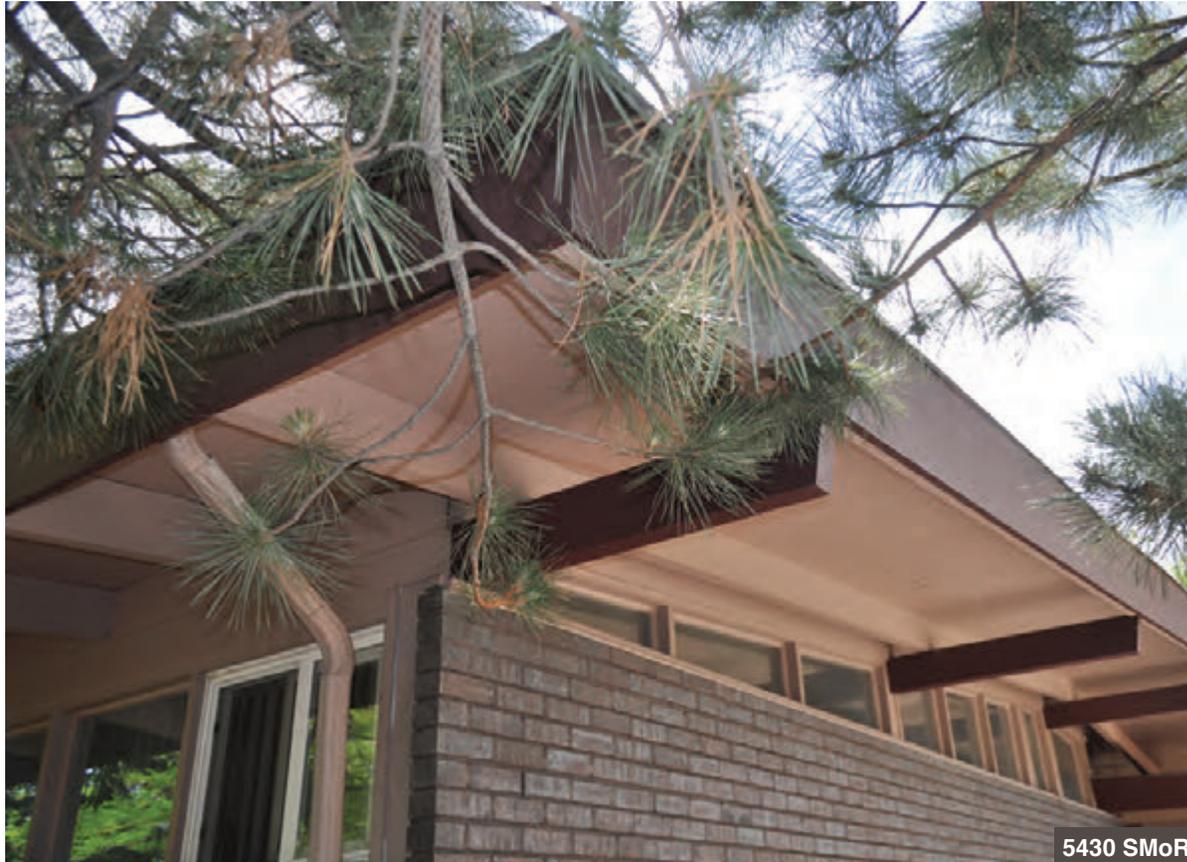
On this front-gable roof, the exposed rafters are painted the same color as the roof deck above. The exposed beams are painted to match the fascia.

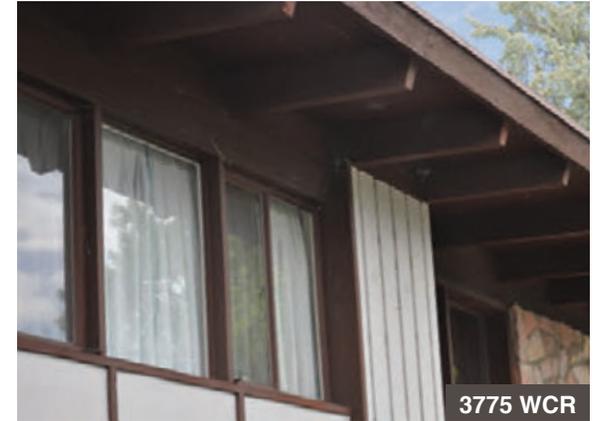
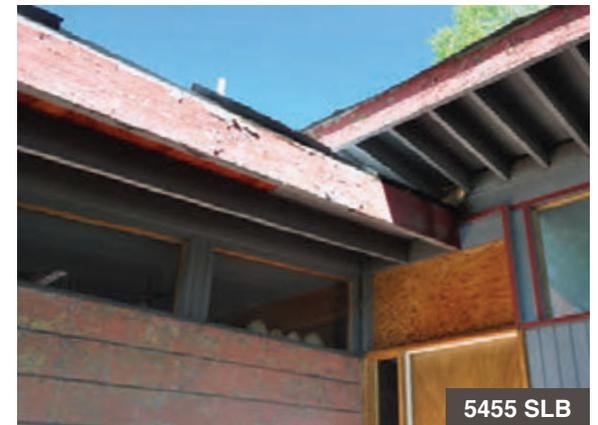
The exposed beams, rafters and roof deck of this shed roof are painted the same color.

The rafters of both of these opposing and overlapping shed roofs are exposed.

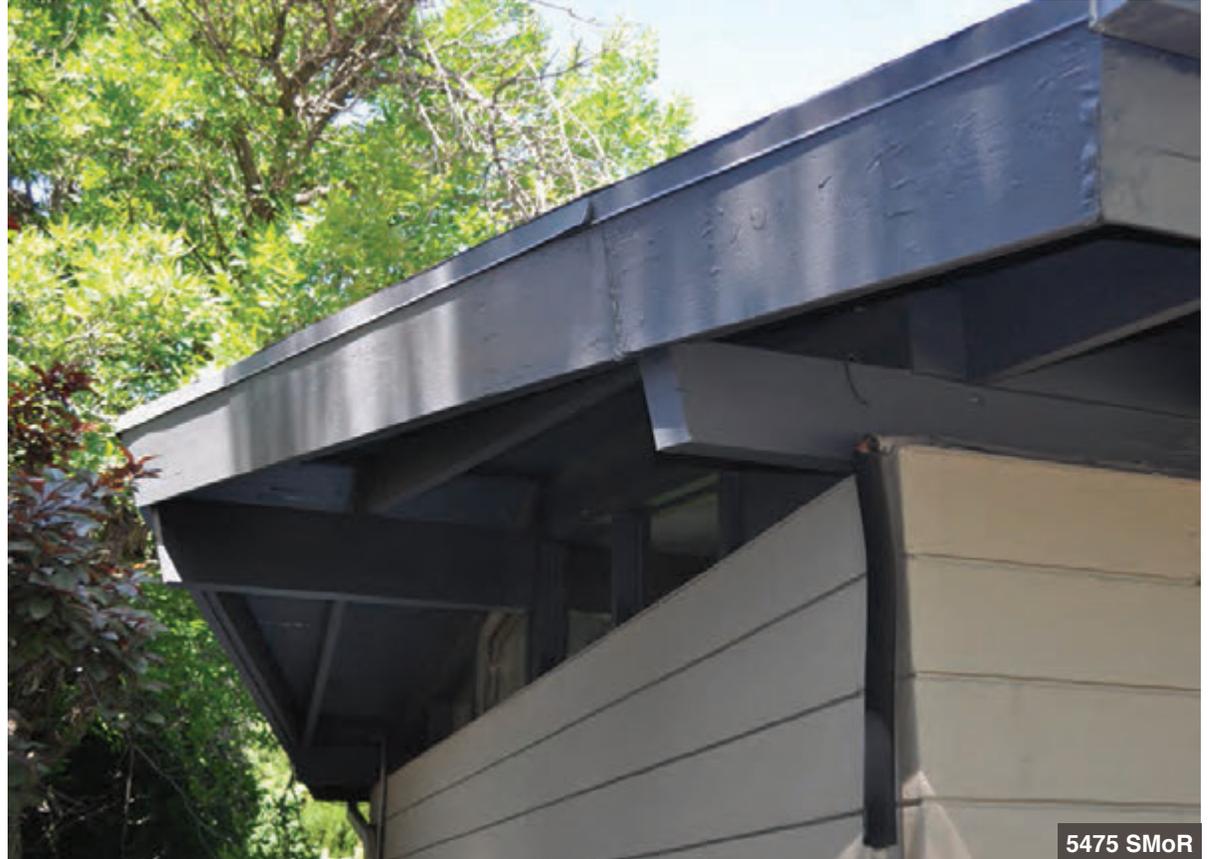
5475 SMoR

Above the primary rectangular volume of this house, a polygonal side-gable roof plane creates a projecting prow. The entire eave composition is painted the same dark gray.

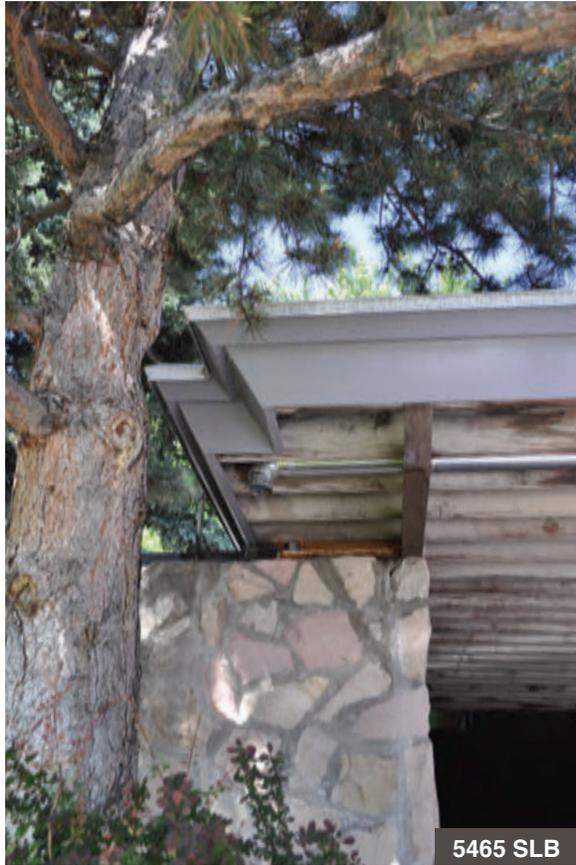
This complex eave detail appears over an open carport. The prominent fascia has two angled facets. It steps back as it turns onto the adjacent elevation, forming an indented corner.

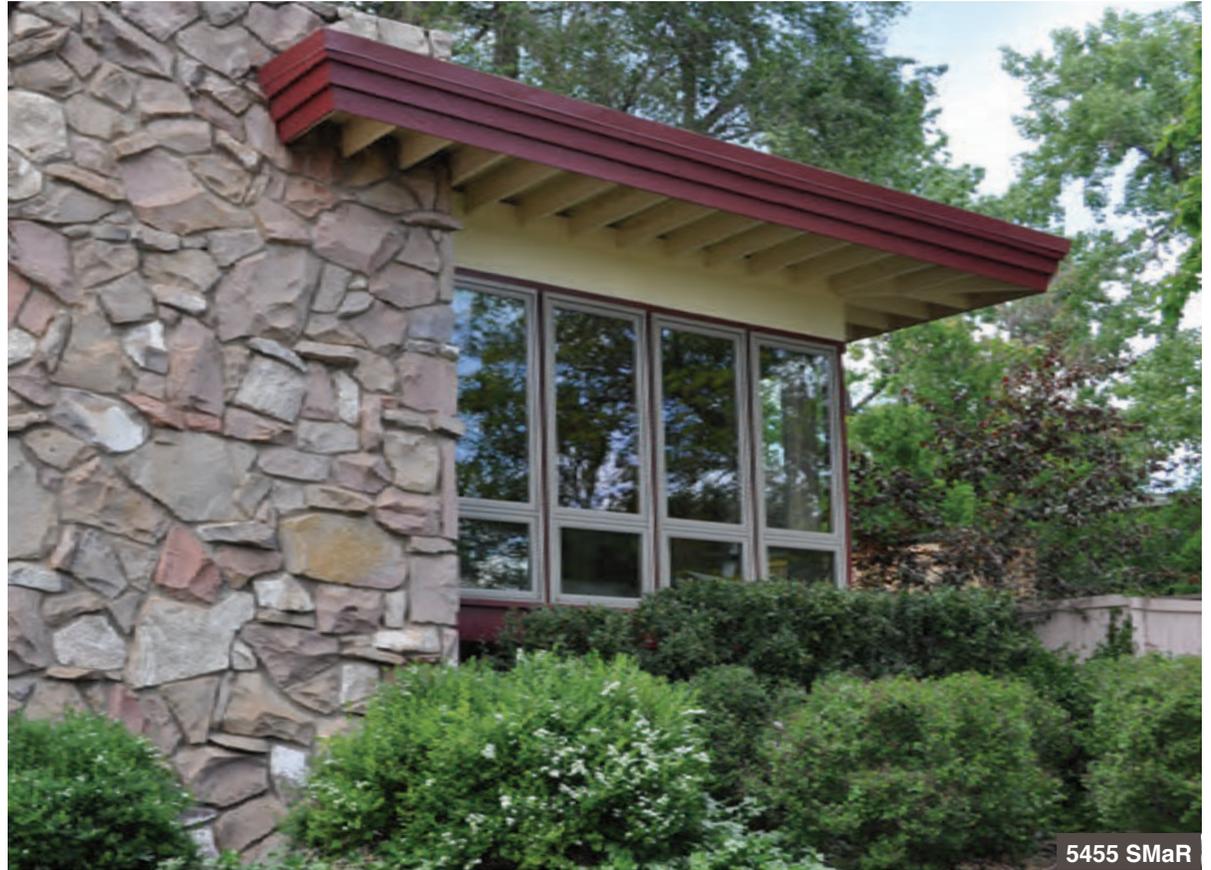
An eave composition with angled three-course lapboard fascia shelters a full-height window on the wall below. It extends onto the face of the adjacent chimney.

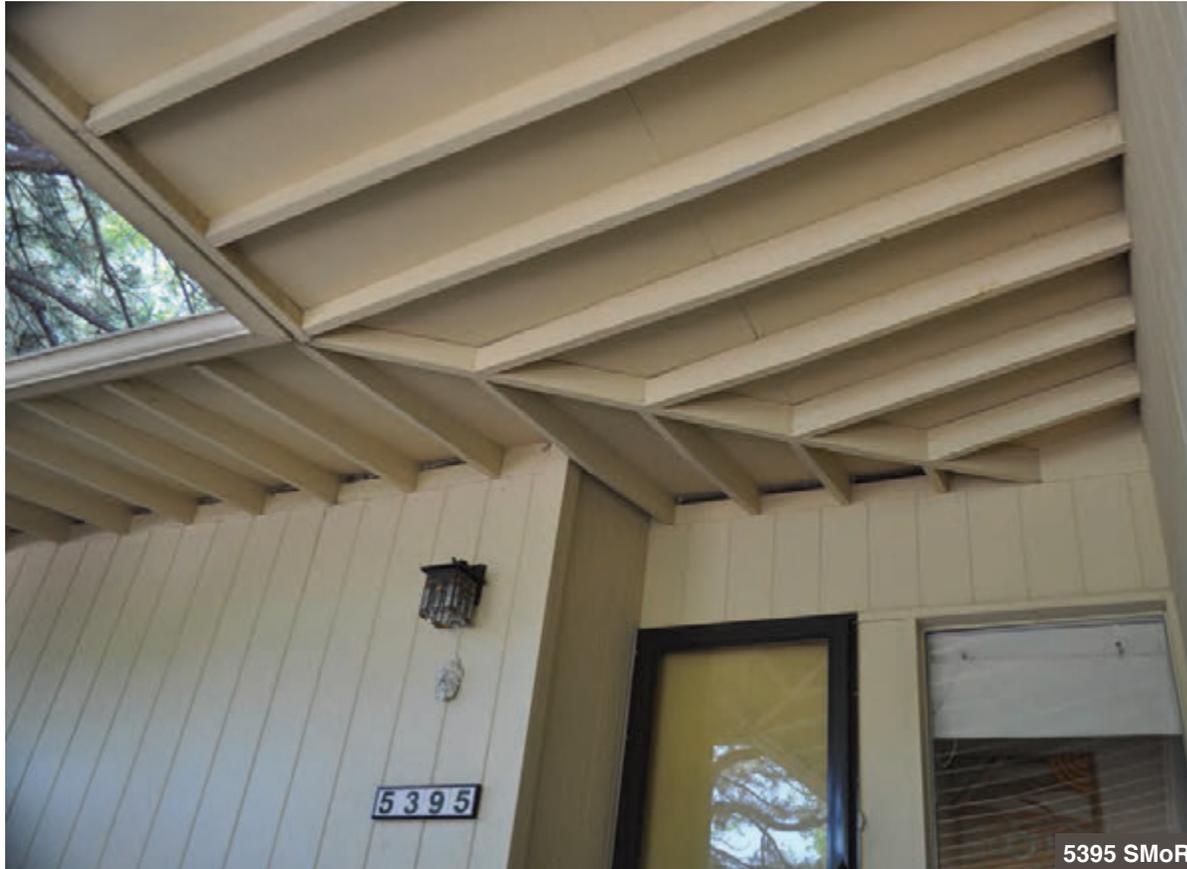
The roof planes of these two primary volumes join to shelter the primary entrance of the house. The exposed rafters form this decorative detail above the front door.
