MILE HIGH PHOTO - DENVER

**Prepared for the City of Littleton
Office of Community Development**

BRIEF HISTORY / ARAPAHO HILLS

PROPOSED NATIONAL REGISTER HISTORIC DISTRICT / ARAPAHO HILLS

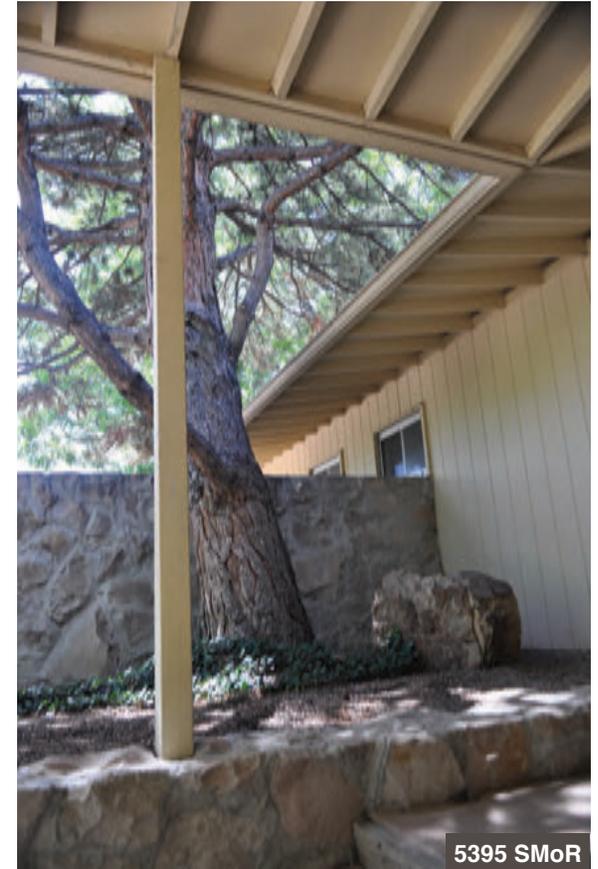
A wood column carries the cantilevered roofline above the entry stairs.

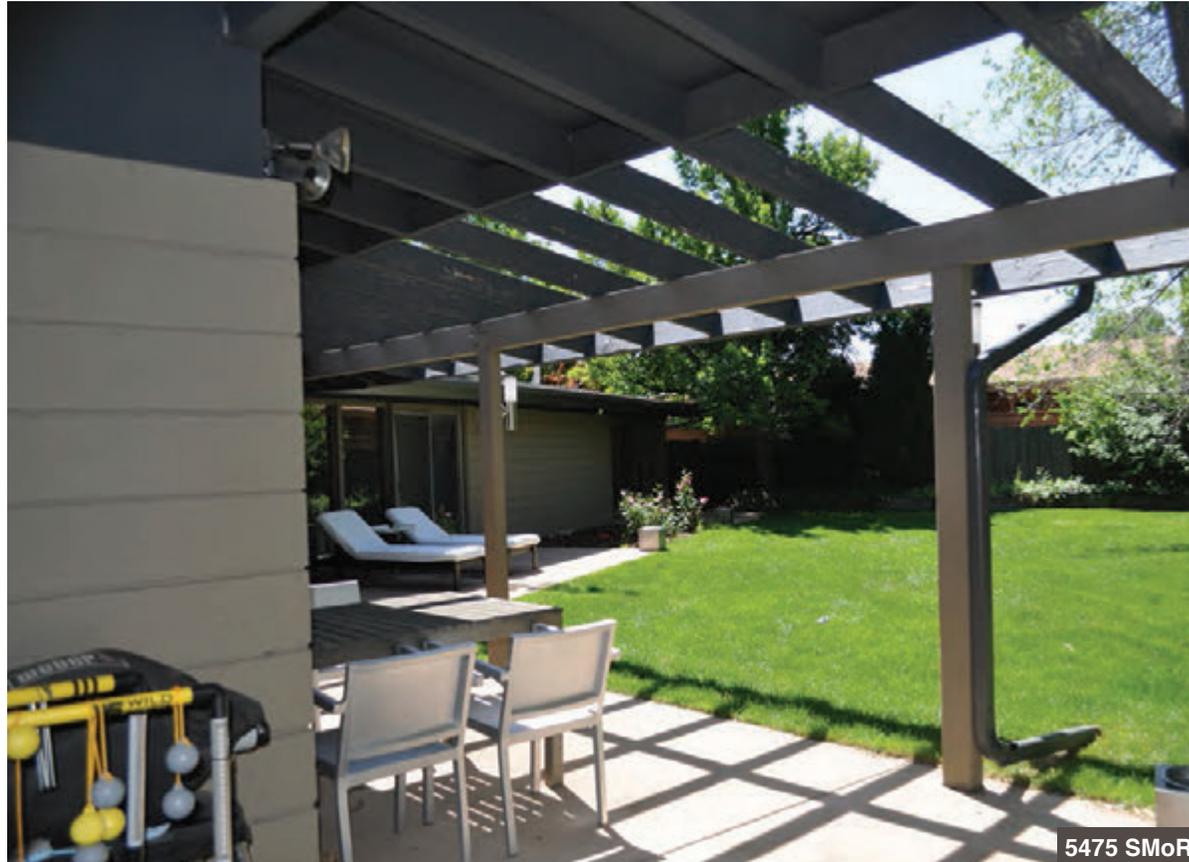
This eave is partially opened to allow sun to the patio below while still shading the interior of the house.

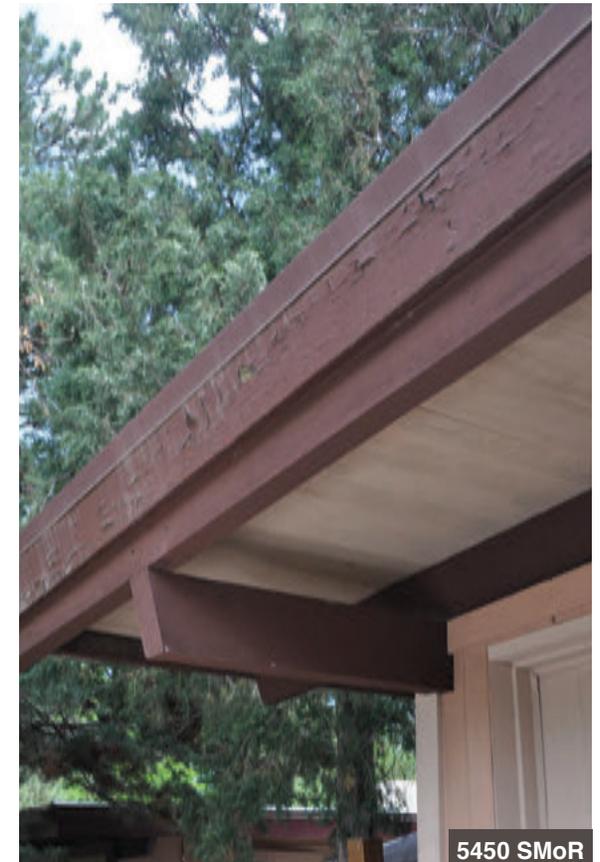
Soffits are sometimes closed to partially or completely conceal the roof structure.

This soffit features tongue and groove siding set perpendicular to the wall. It conceals the rafters, while the beams are exposed.

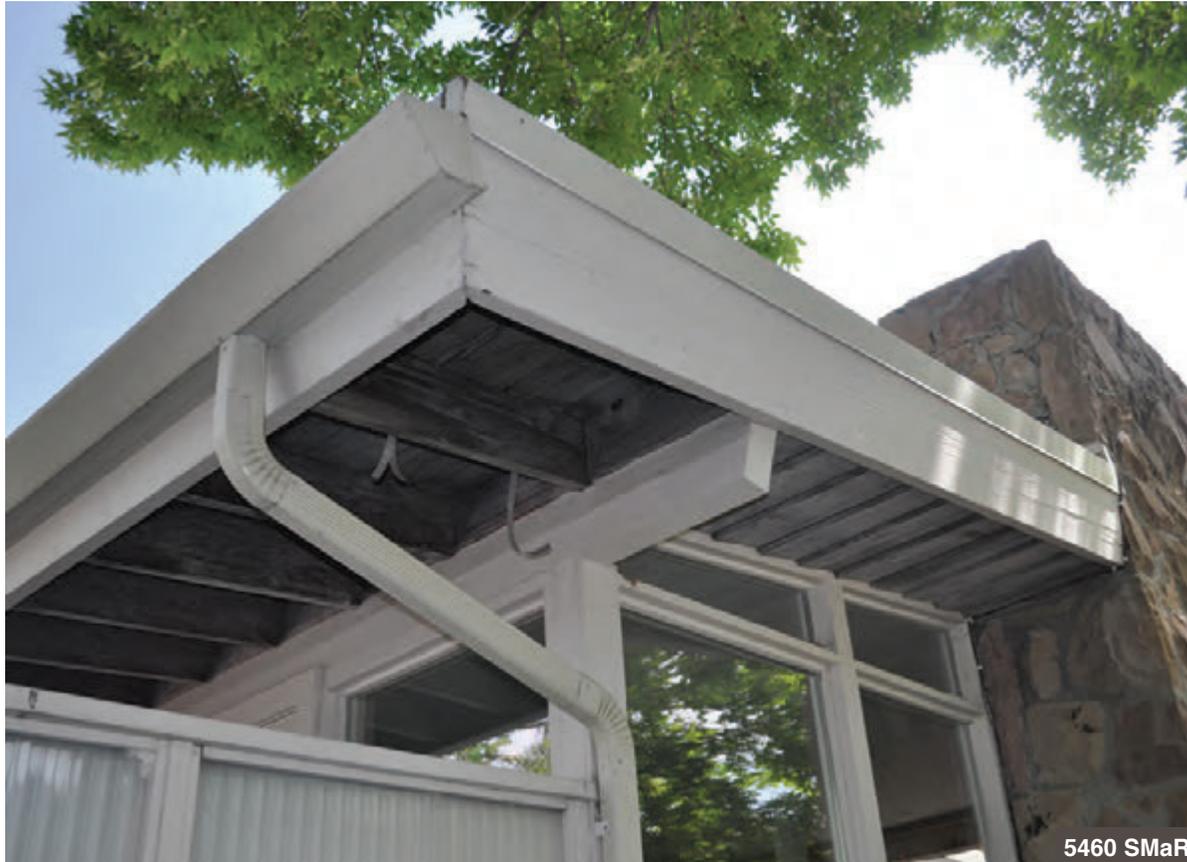
Rafters running parallel to the fascia, at right, are concealed above a lapboard soffit. At left, like the beams, they're exposed.

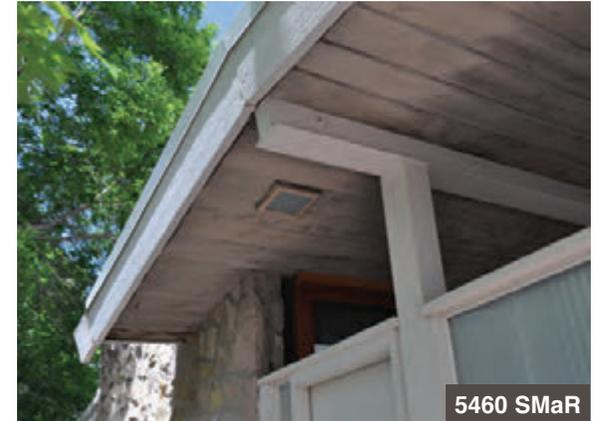
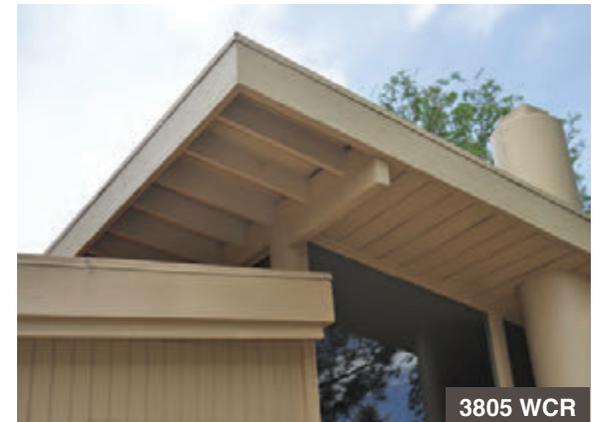
A similar detail appears above. The rafters are exposed at left and concealed at right, where the round concrete flue of the chimney penetrates the roofline.

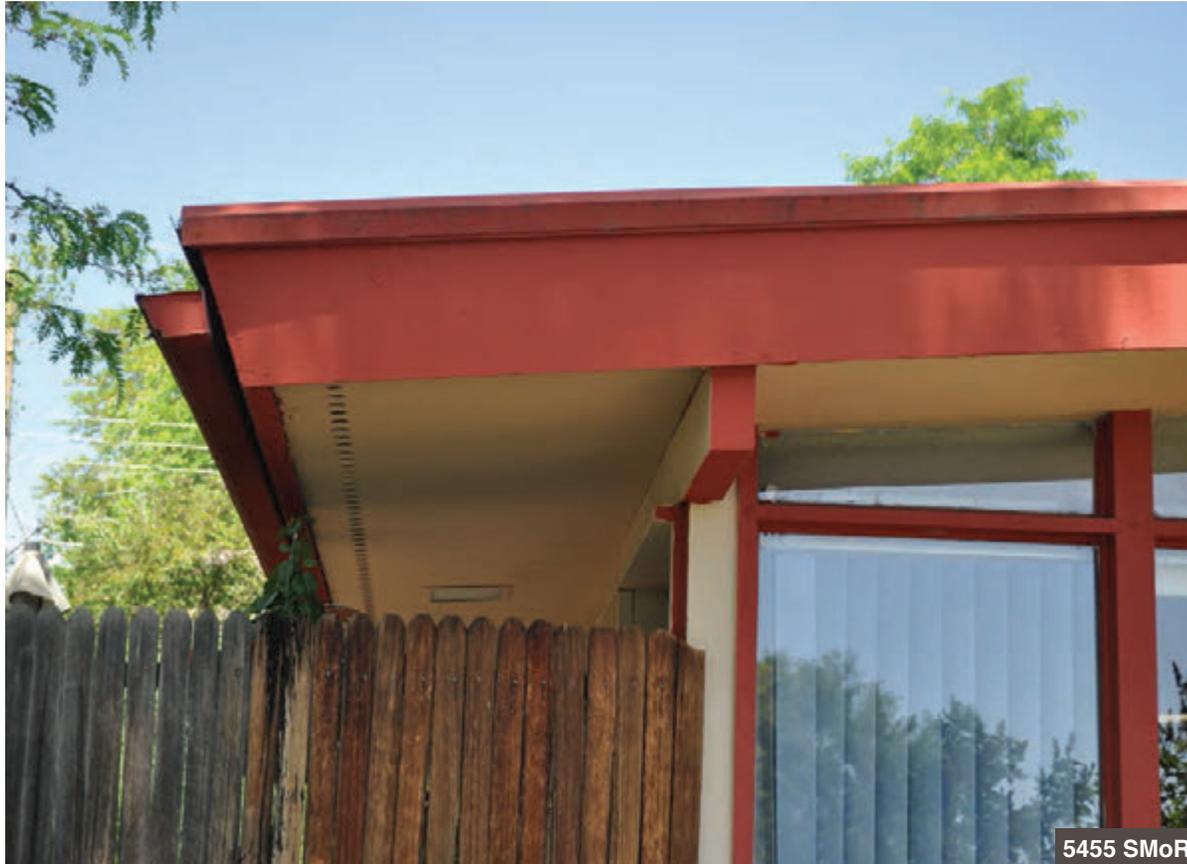
On this house, the rafters are completely concealed above plywood panels with circular vents that run the length of the roof line.

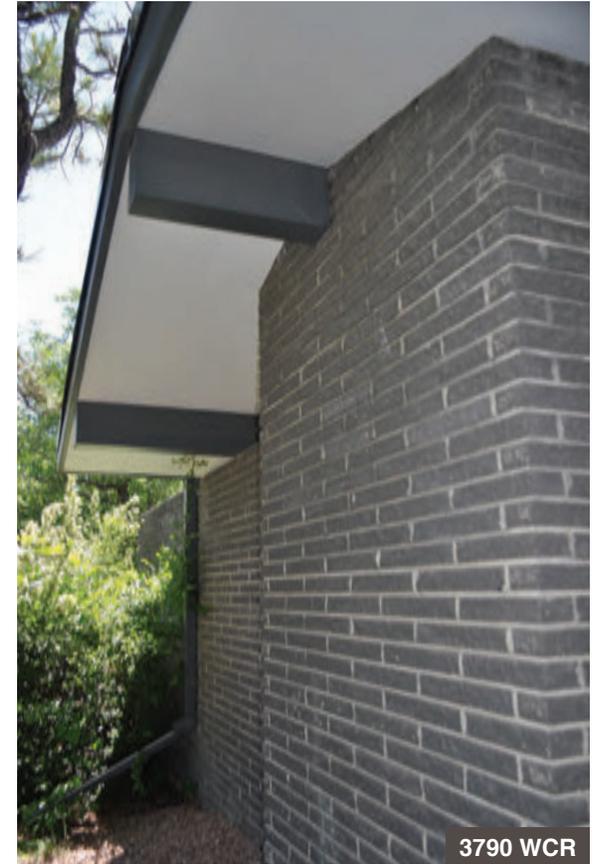
These rafters are concealed above a plain panel while the beams remain exposed.

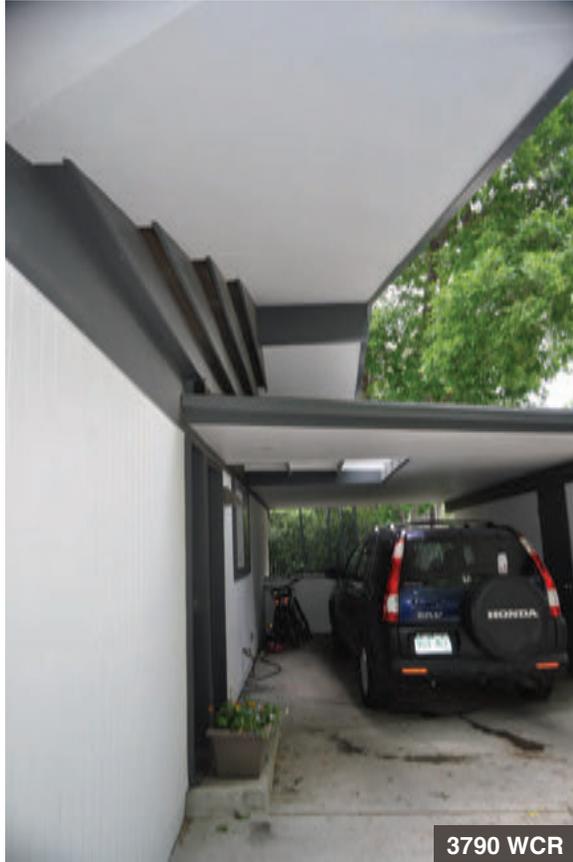
3790 WCR

Between this carport and house roof, lap-board set into the front gable of the house roof provides ventilation.

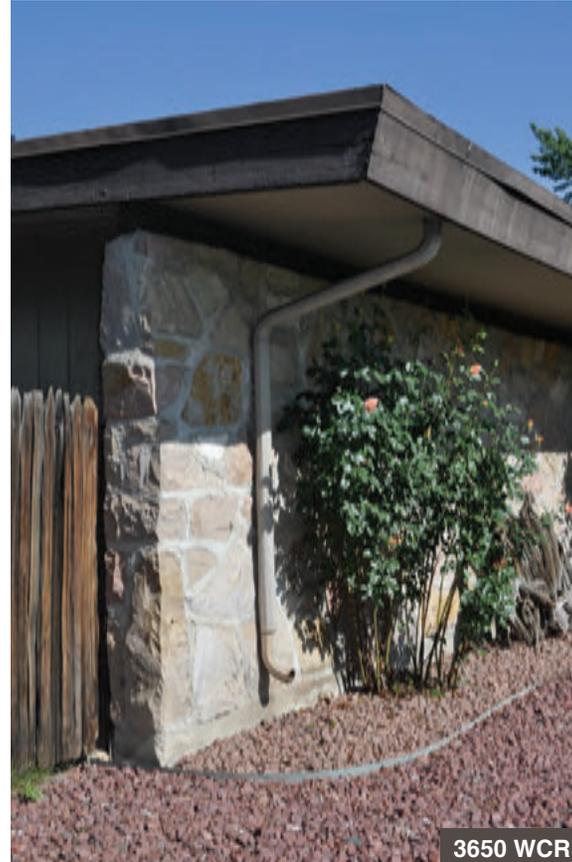
3650 WCR

Original downspouts of round corrugated metal penetrate overhanging roof planes, then angle back to the wall plane. In this way, the detailing of the eaves isn't obscured.

Surface-mounted gutters hide and clutter eave details.

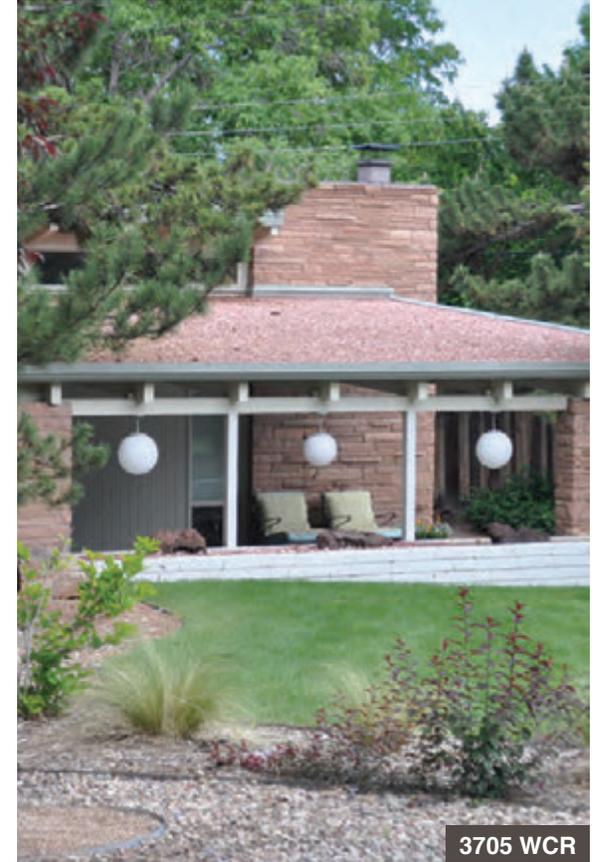
3705 WCR

Exposed rafters carry the roof above the main beam supporting the open wall of this carport.

Roofs were characteristically finished with a built-up roofing system and covered with loose crushed stone.

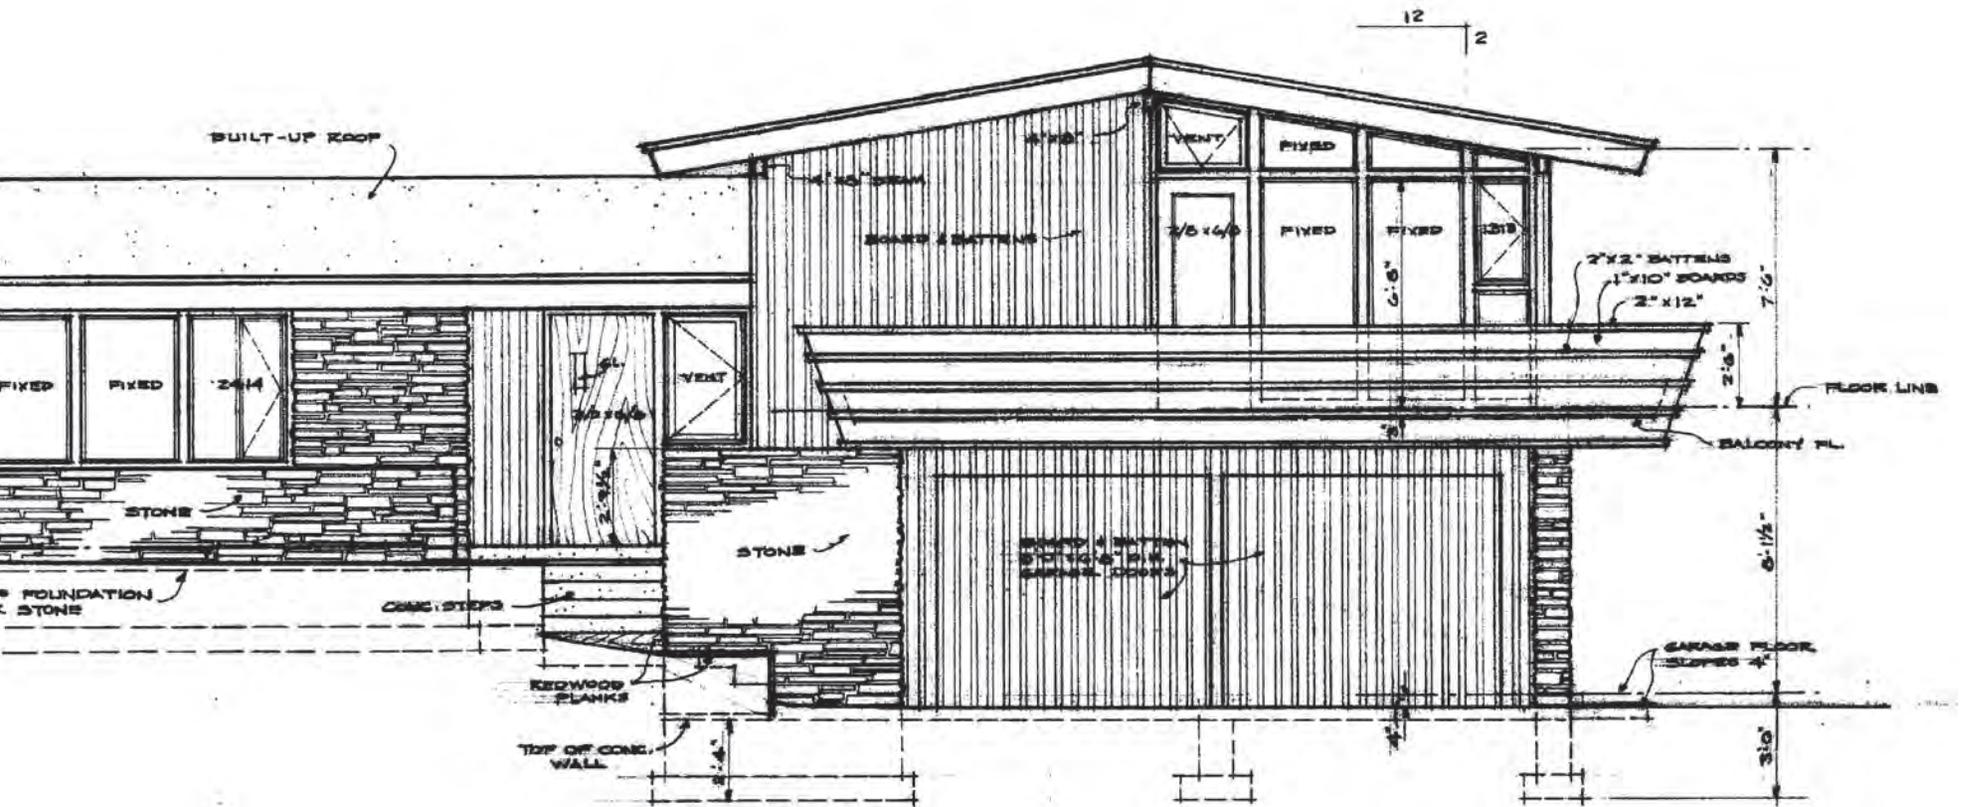
SOUTH ELEVATION

Bruce Sutherland's architectural design for 3865 West Chimayo Road dated March 31, 1957. Drawings courtesy the Arapaho Hills Archive.

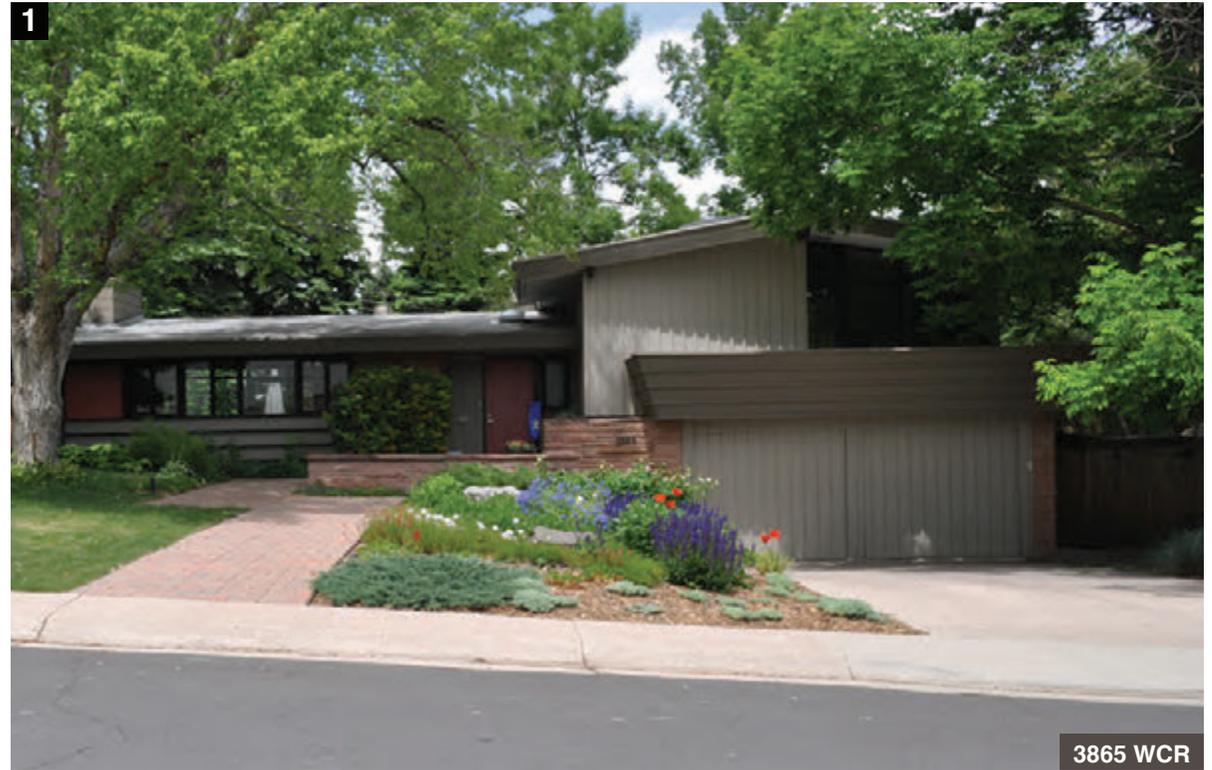
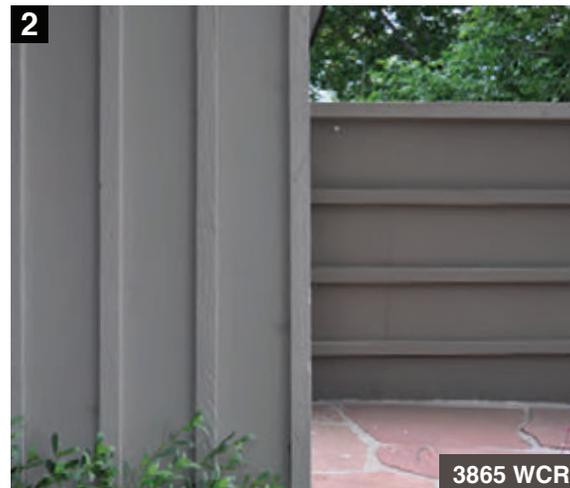
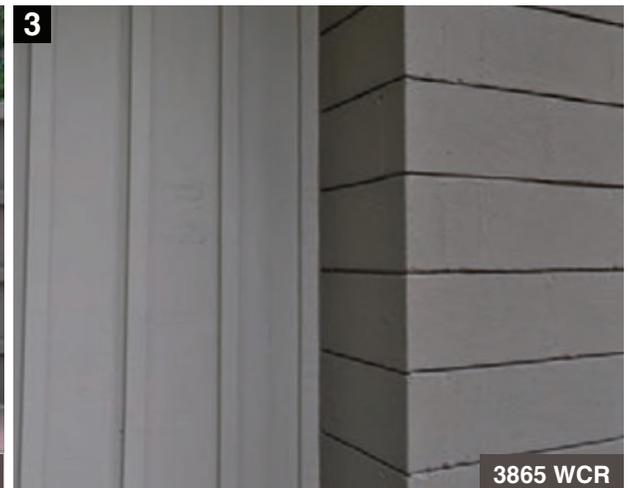
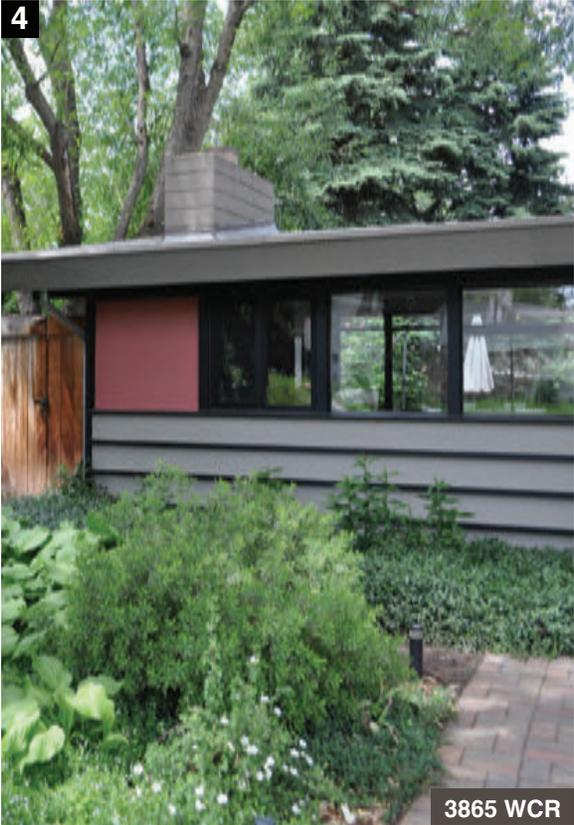
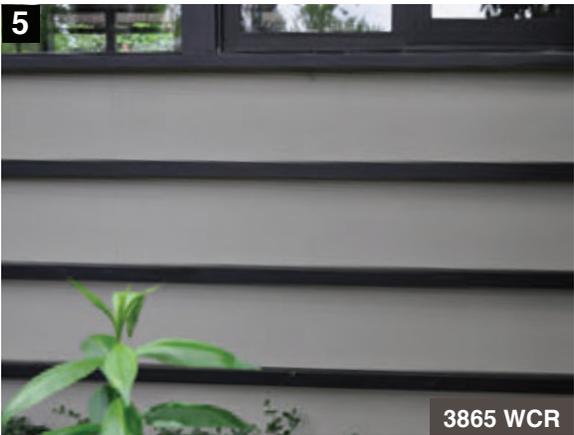
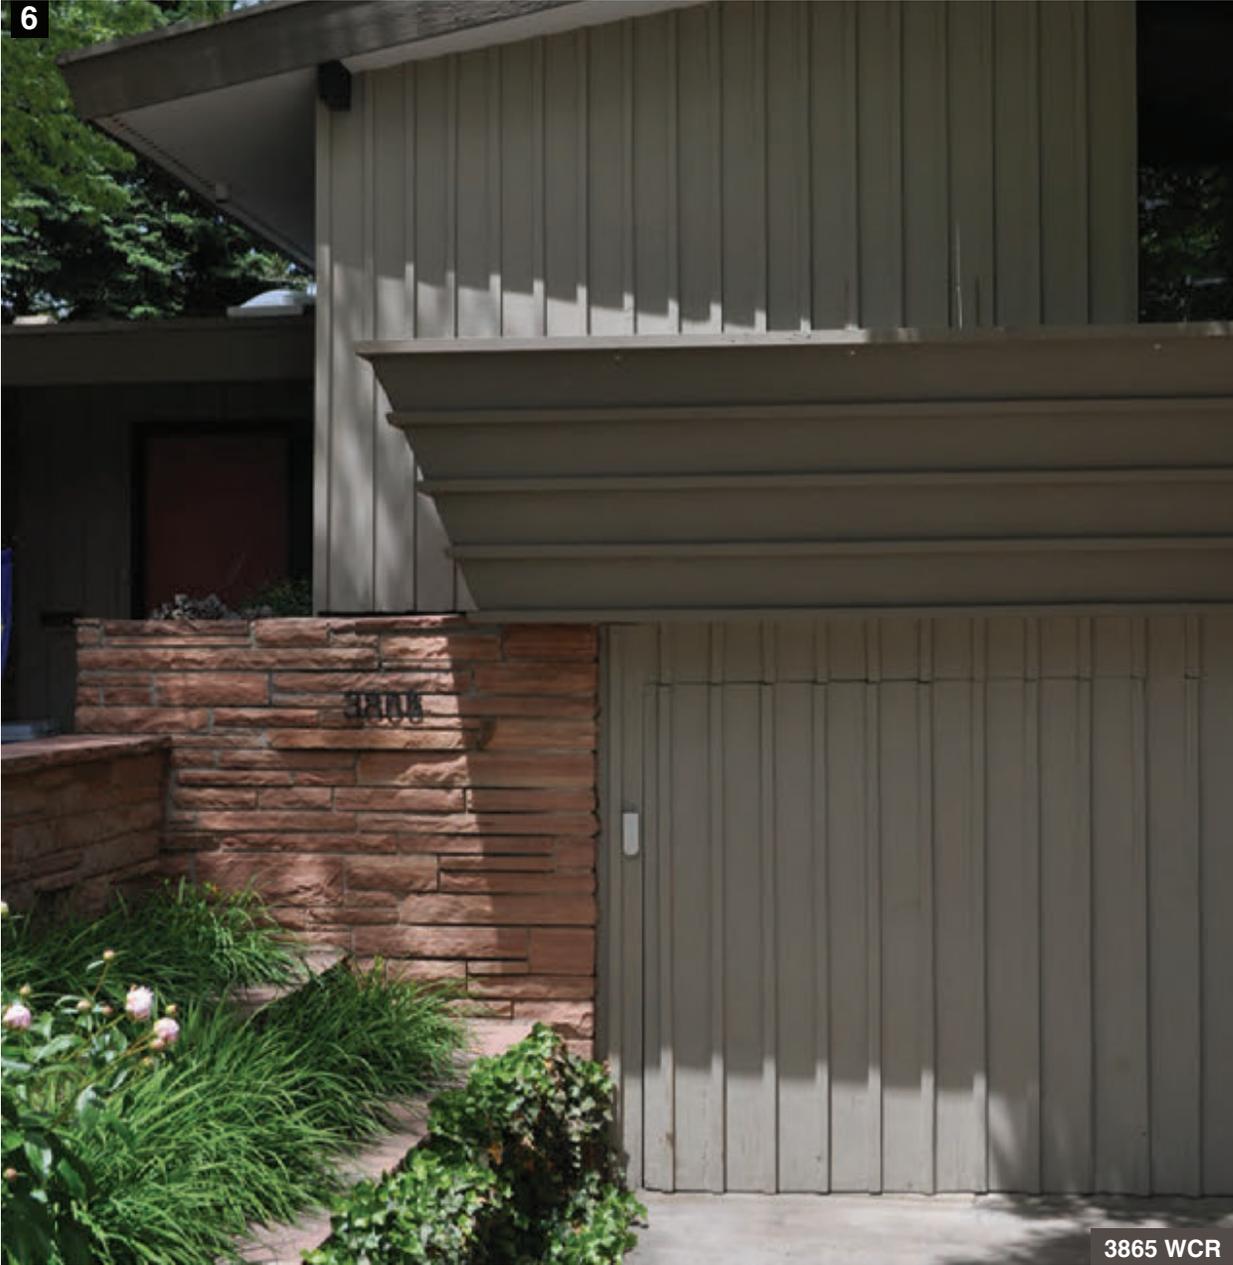
- 1 A view of the south elevation of the house.
- 2 Vertical and horizontal board-and-batten siding appears adjacent to a red sandstone patio.
- 3 Vertical siding joins a concrete block masonry wall with flush vertical and deeply raked horizontal mortar joints.
- 4 The varied materials are unified by their color palette and horizontal lines.
- 5 The boards and battens of the horizontal wood siding are painted a single color on the balcony fascia and contrasting colors on the wall adjacent to the entrance. This siding replaced the red sandstone originally shown on the drawings.
- 6 The proportions of the boards and battens vary between the vertical and horizontal siding.

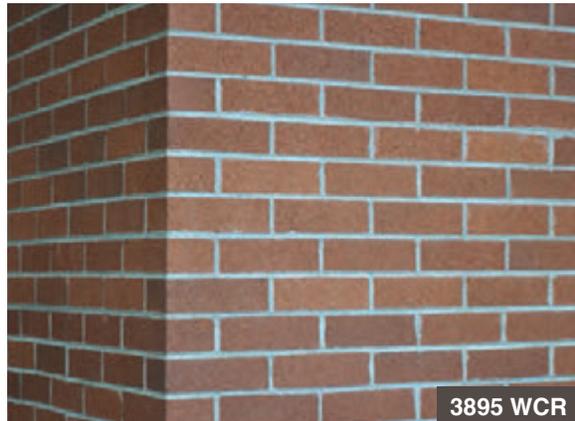
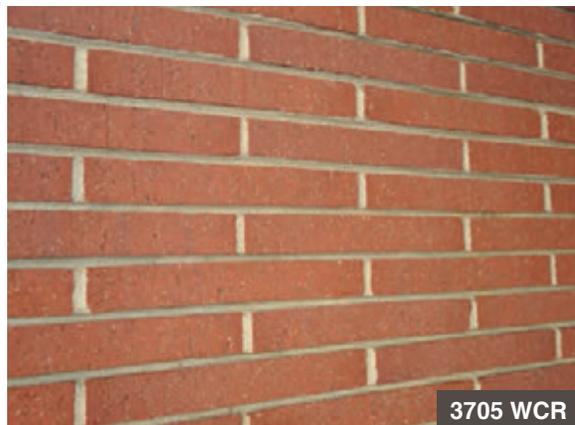
This standard-size hard-fired brick, so commonly seen in houses of the period, is a rarity in Arapaho Hills. The traditional mortar joints are uniformly finished to produce a shallow, concave surface.

More common are long, narrow Norman bricks, the vertical joints flush with the surface and the horizontal joints deeply raked.

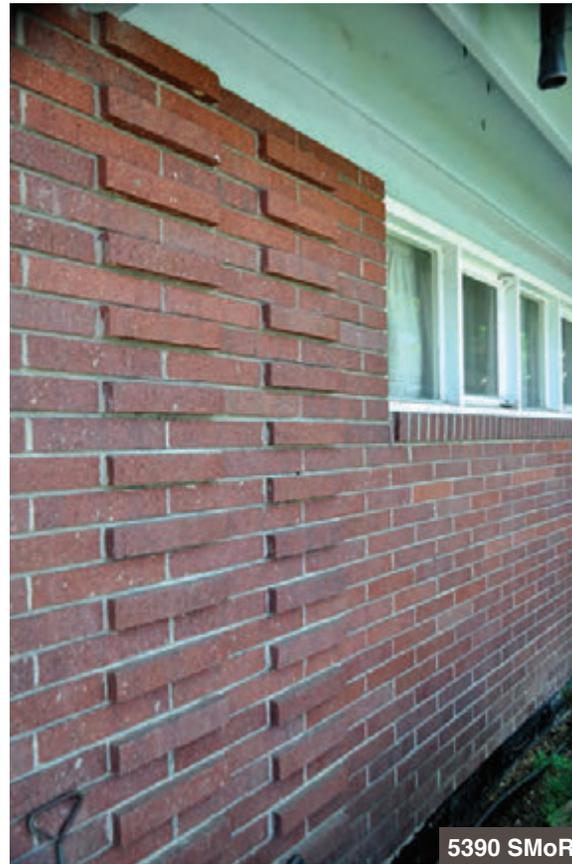
The proportions of the brick and the treatment of the joints emphasizes the overwhelming horizontality of the houses and the neighborhood as a whole.

This masonry is enlivened by two vertical rows of projecting bricks.

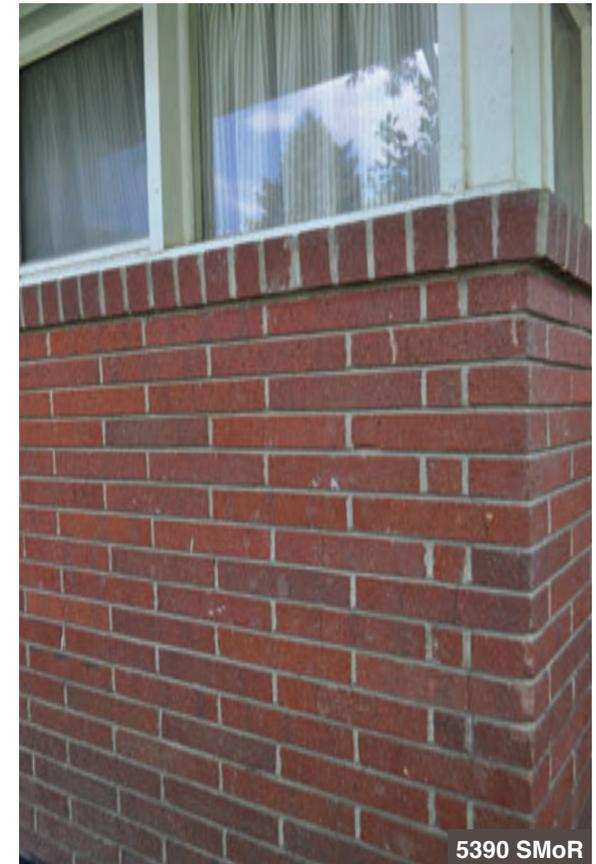
The masonry of the wall is laid running bond, with the vertical joints of one row centered on bricks in the rows above and below. The window sill is formed by a header course, with the bricks laid perpendicular to the wall.

A decorative vertical end course appears near the corner of the masonry wall.

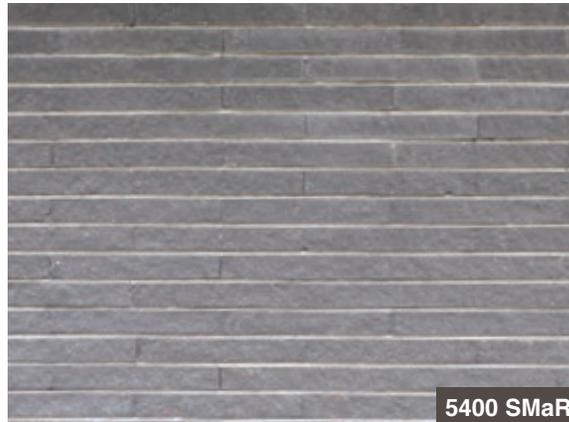
5400 SMaR

Gray brick is also common in Arapaho Hills. Here, a broken-faced brick is laid running bond. The vertical joints are filled, the horizontal joints raked.

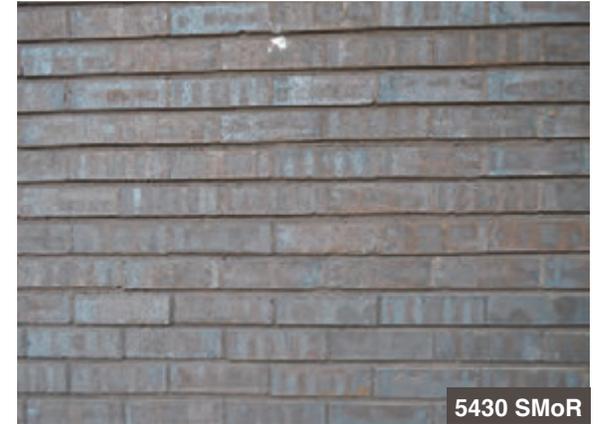
A similar brick is laid with flush vertical joints with no visible mortar, and deeply raked horizontal joints.

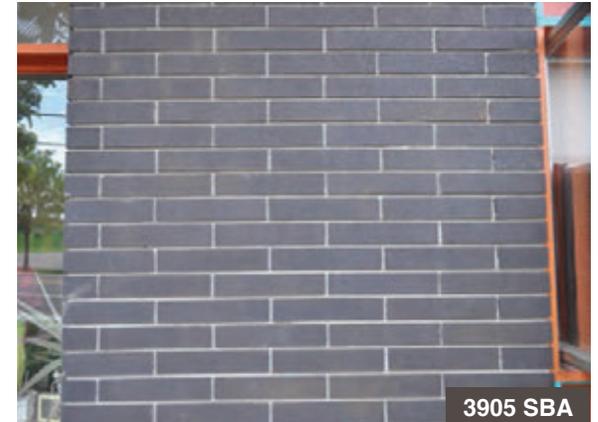
3905 SBA

A blue and brown Norman brick is laid running bond with a dark-colored mortar.

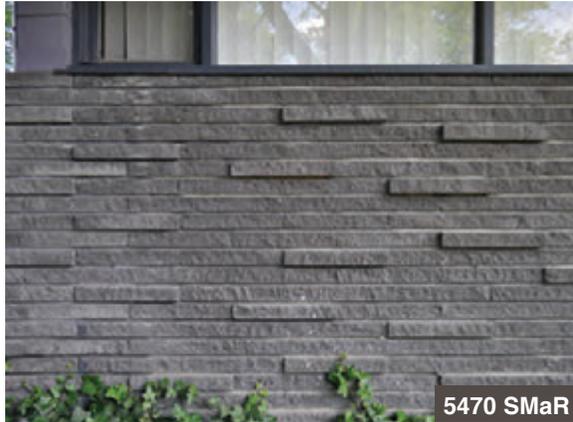
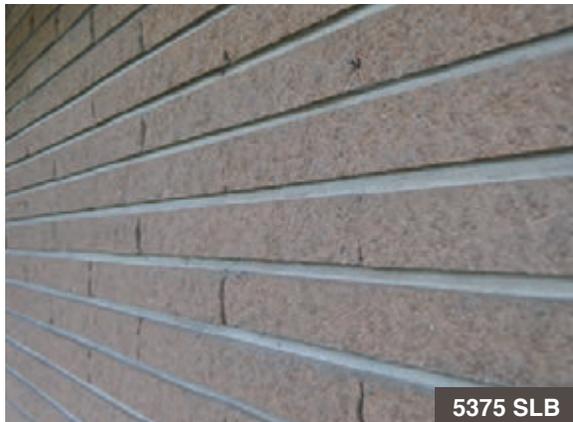
This wall features a surface pattern of raised brick.

A long narrow broken-face pink brick is laid with flush vertical joints with no visible mortar. The horizontal joints are deeply raked.

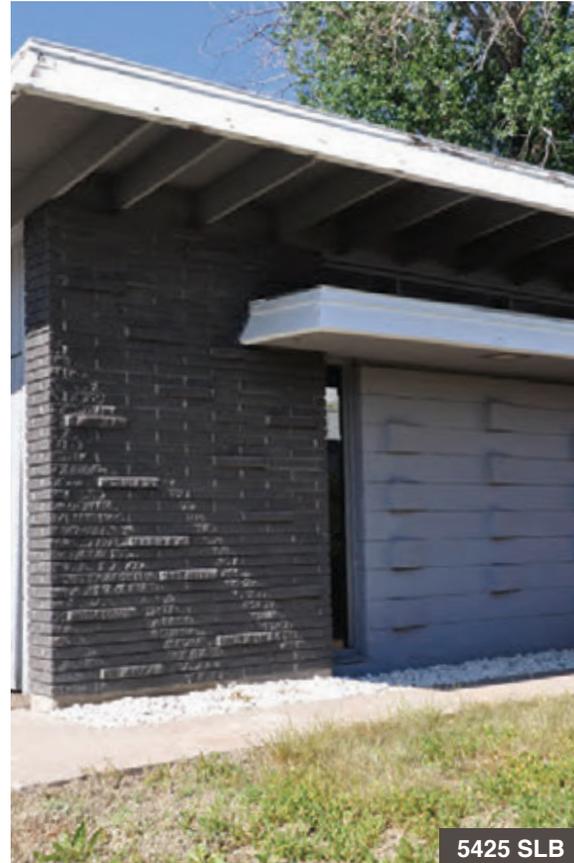
In addition to brick, painted concrete block also commonly appears. It shares many of the same bond and mortar treatments.

Here, a gray broken-face brick is combined with concrete block. Both feature a pattern of projecting units. Raised bricks project perpendicular to the wall, raised blocks project at an angle. Both cast shadows that vary with the time of day.

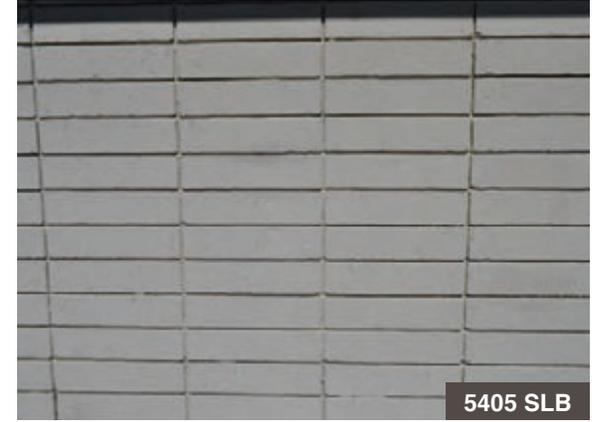
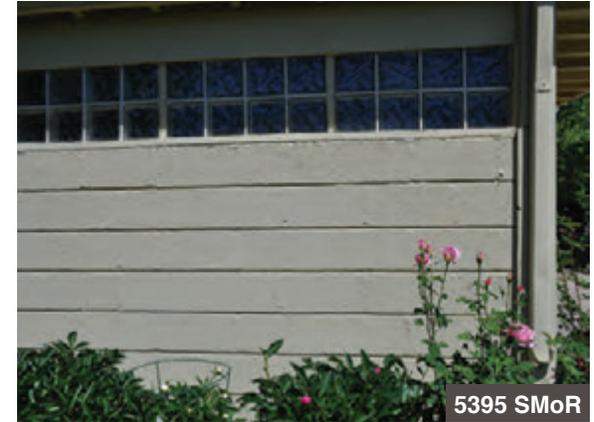
This long, narrow concrete block is laid stack bond, with the vertical and horizontal joints aligned. Here, all the mortar joints are raked.

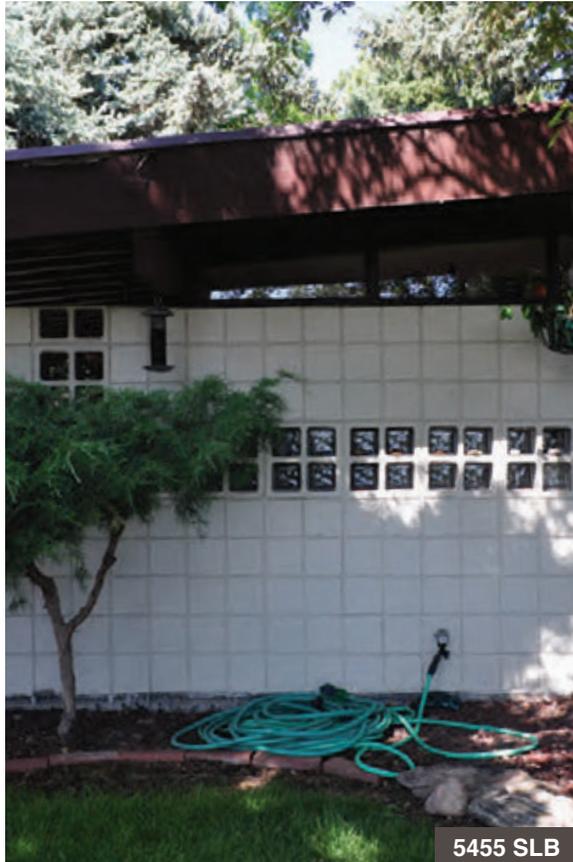
5455 SLB

A small square concrete block is laid stack bond. Raked vertical and horizontal joints create a grid pattern.

The blocks with pierced openings form a geometric pattern on the wall. The openings are infilled with glass block or, where the wall extends beyond the house, left open to the garden.

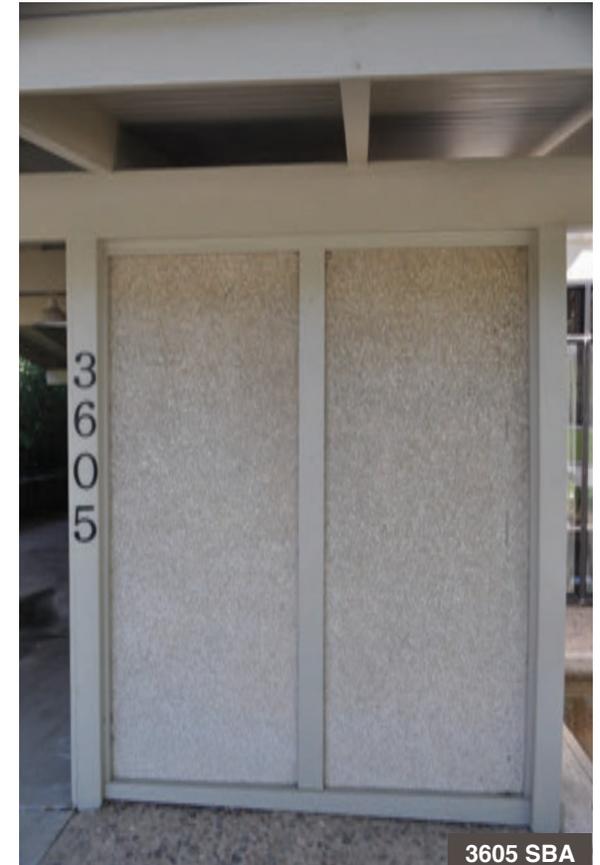
3605 SBA

Pre-cast aggregate panels were purchased by Mannon from a sale of excess building material at the United States Air Force Academy in Colorado Springs, under construction from 1955 through the early 1960s. Secured by battens, they appear as a primary exterior material on a few homes.

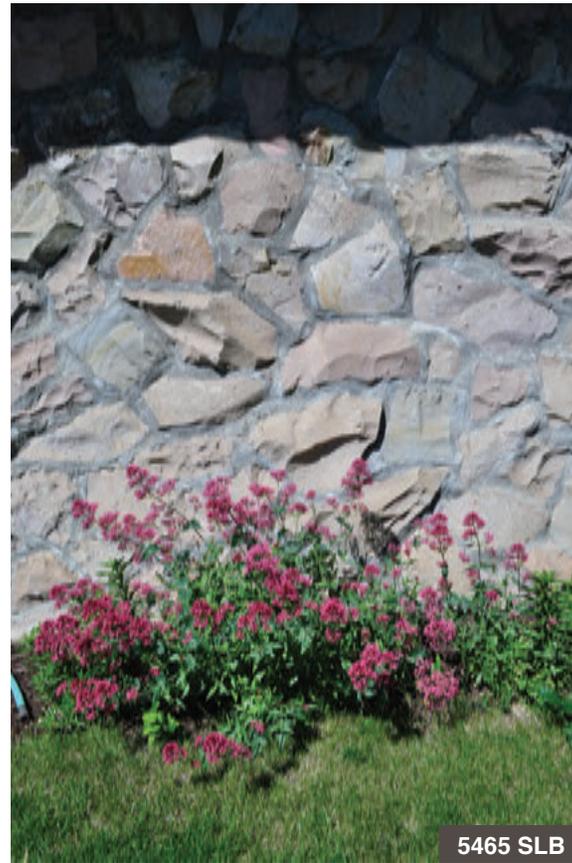
5465 SLB

On this wall, more variety appears in the color and surface texture of the stones and a darker gray mortar is used.

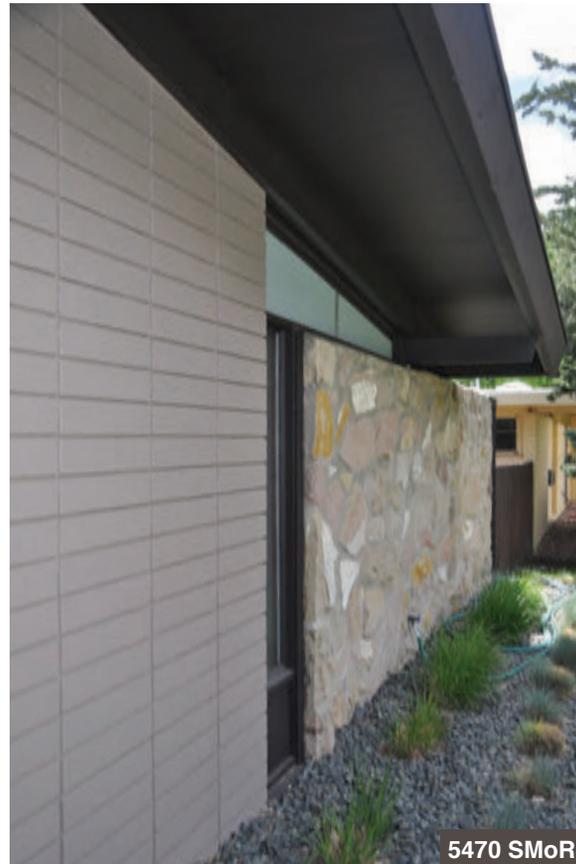
Multiple masonry and wood wall finishes appear on many houses.

Random stone masonry and stack-bond concrete block with raked vertical and horizontal joints are combined on this house.

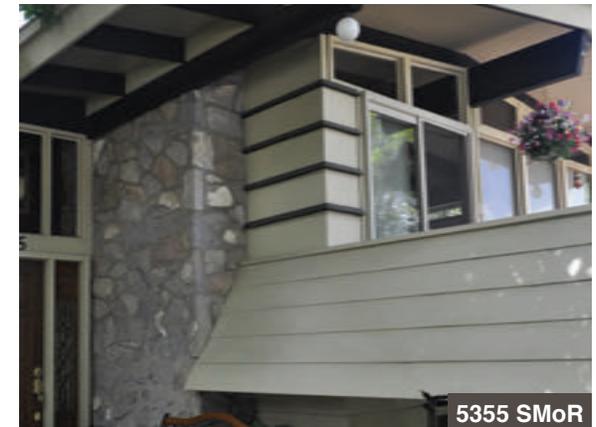
5355 SMoR

Tongue-and-groove siding and a narrow concrete block with raked horizontal joints flank this full-height window.

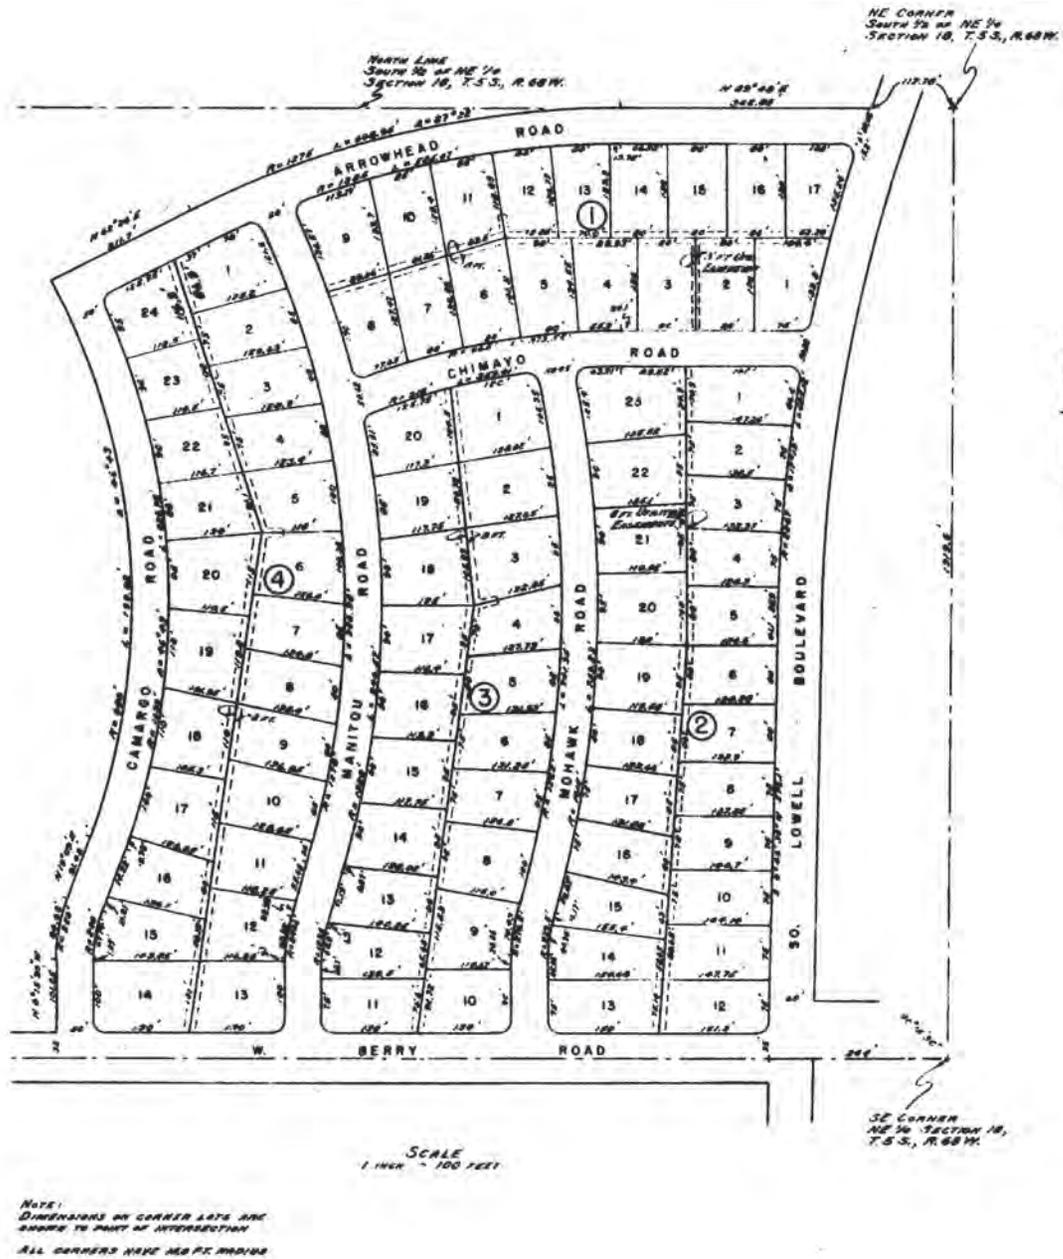
ARAPAHO HILLS SUBDIVISION PLAT
 The original Arapaho Hills Subdivision Plat was filed with Arapahoe County in May, 1955. It included eighty-three planned homes on thirty-seven acres of land.
